Audi VW 2.0 TFSI T FSI Inlet Intake Manifold Swirl Flap Runner Delete Repair Kit Plate Blanks Install Instruction Guide

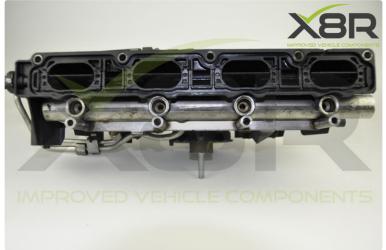
Remove the runner flaps completely from the manifold using our kit. Our precision engineered CNC billet aluminium parts allow you to remove the runner flaps. Our parts replace the runner bearing blocks and the crank arm; sealing the manifold and vastly improving airflow. Ideal for stock vehicles to improve airflow and prevent carbon build up- even better for tuned engines. Customers with tuned engines have noted quicker throttle response, less turbo lag, improved torque and BHP gains when deleting the runner flaps.

1X Crank arm blank

1X Manifold gasket

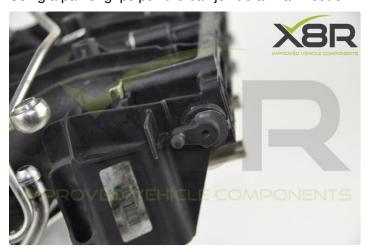
Step 1: Remove Ball Joint Crank Arm

Locate the ball joint crank arm on the end of the manifold.

Using a small flat bladed screwdriver lever the retaining clip out of position and save for reinstall.

Using a pair of grips pull the ball joint crank arm out of

the manifold.

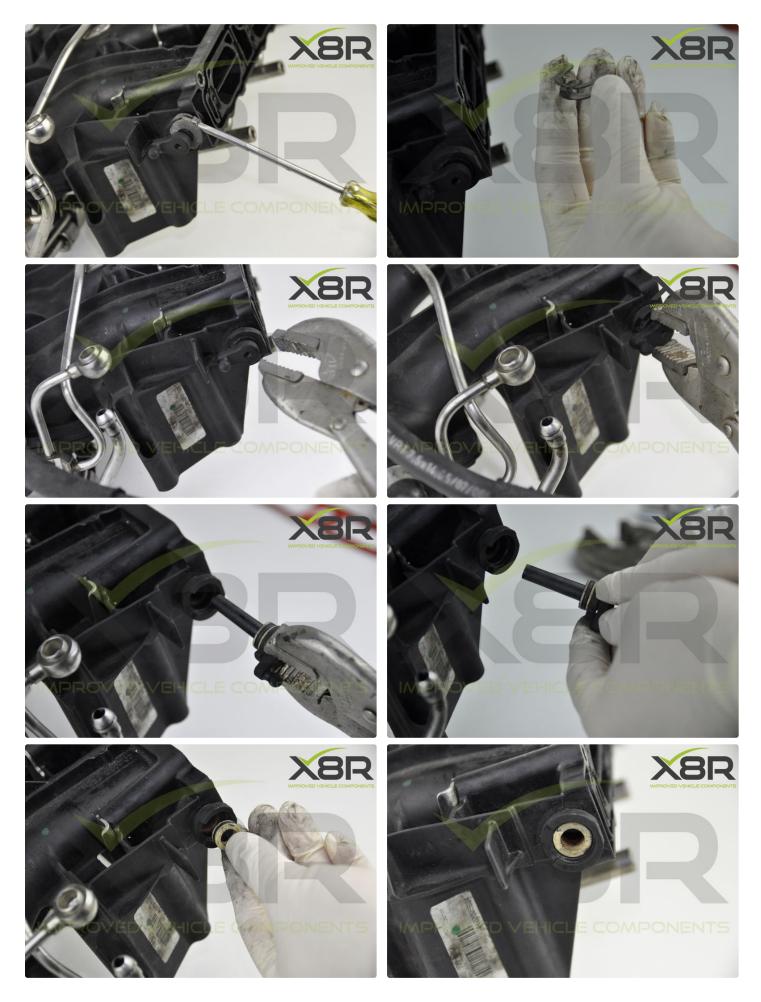
Please note the seal on the crank arm in the images. If this comes out with the crank arm please remove and reinsert in to the manifold, this is important to achieve a seal when blanking off.

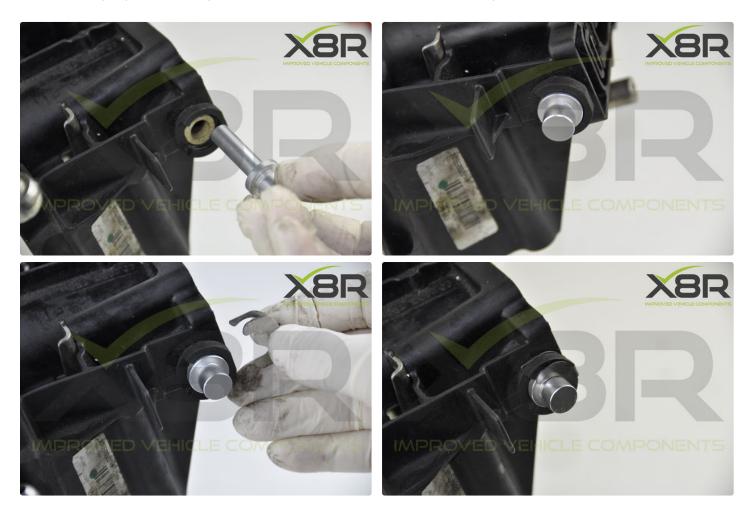
Step 2: Insert Our Crank Arm Blank

Insert our blank in to the hole left by the crank arm.

Refit retaining clip (check image for orientation) this will secure the blank in position.

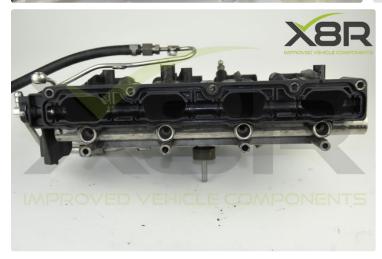
Step 3: Remove the Runner Flaps and Clean Manifold

Using a pair of grips, grip the runner flaps and pull away from the manifold. Pull each flap gently until the complete assembly can be pulled loose from the manifold.

At this point it is a good idea to clean any carbon deposits from the manifold. Particularly where the gasket sits and where the bearing block blanks locate.

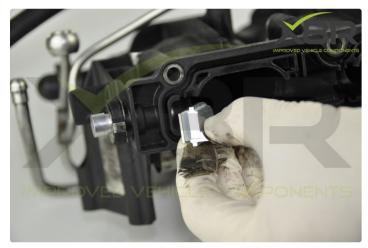
Step 4: Insert Our Bearing Block Blanks

Insert our blanks in place of the bearing blocks from the runner flaps. These simply push in to position.

The blanks are handed left and right, insert 4x left hand and 4x right hand blanks.

Press the blanks firmly in to position to sit flush with the manifold, if they do not fully engage clean any carbon deposits and push back in to position.

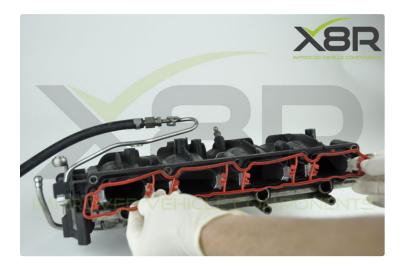
Step 5: Fit Our Replacement Manifold Gasket

Again ensuring the manifold is clean and free of deposits; insert our new gasket in to the groove on the manifold.
