# BMW E46 M3 Exhaust Muffler Back Box Flange Rusted Corroded Flanges Repair Kit Install Fitting Guide Instructions

## **Intro:** BMW E46 M3 Exhaust Muffler Back Box Flange Rusted Corroded Flanges Repair Kit Install Fitting Guide Instructions

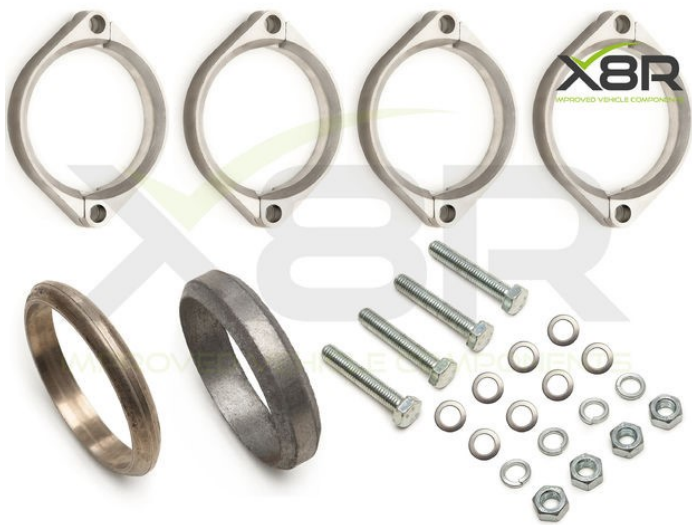
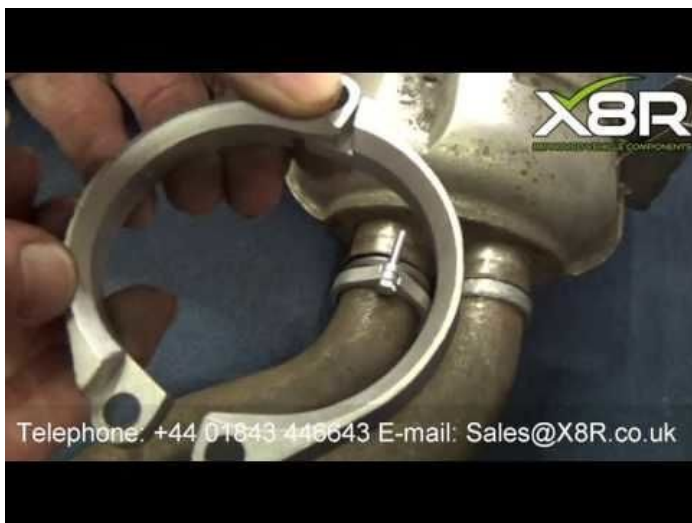
The OEM cast iron flanges rust / corrode and eventually split causing exhaust leaks.

A common fault on E46 M3 models is failure of the exhaust flanges caused by rust / corrosion of this part. Four flanges are used to clamp together and seal the intermediate pipe to the rear muffler / backbox. These are constructed of cast iron (despite being fitted to a stainless steel exhaust) and inevitably deteriorate and split. These parts are integral to the intermediate pipe and rear muffler and are not available separately from BMW. The only option until now has been to buy a new centre section from BMW at vast expense. Or to buy new flanges, cut them up, fit and re-weld them- a tricky job. None of these are an ideal solution to this common fault.

Upon inspection you will be able to see the flanges are rusted and corroded and often split or starting to.

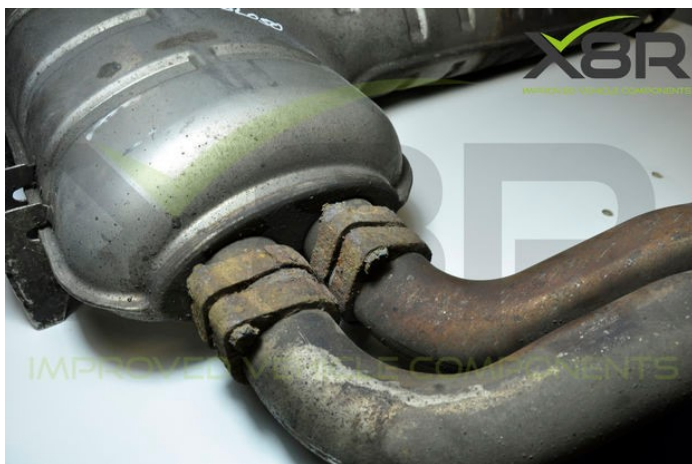
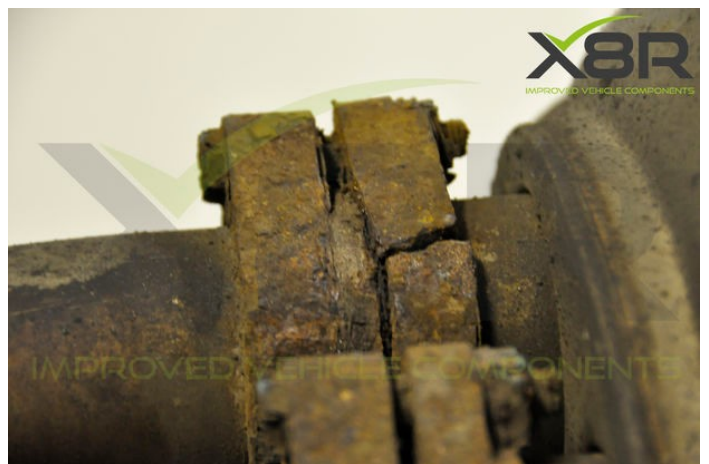
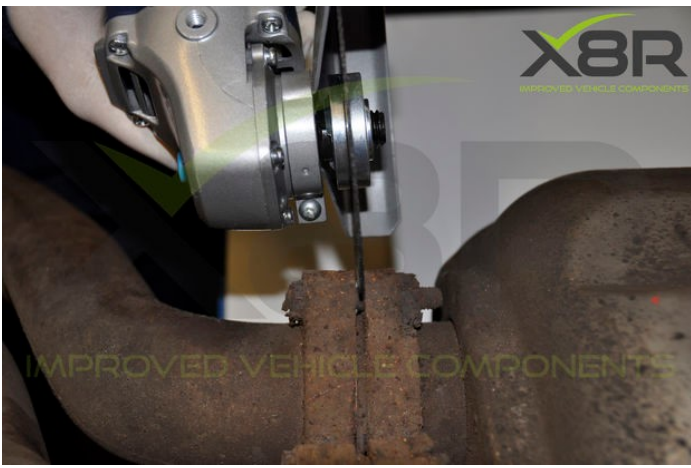
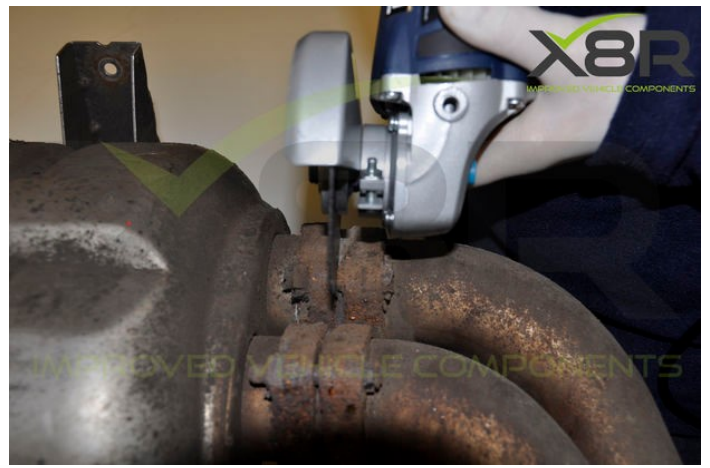
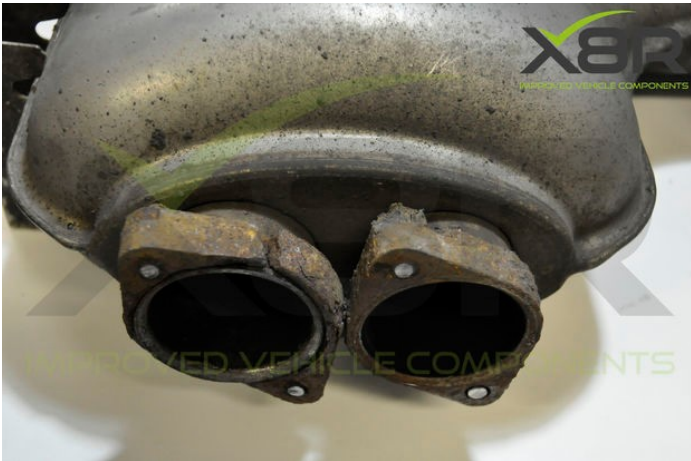
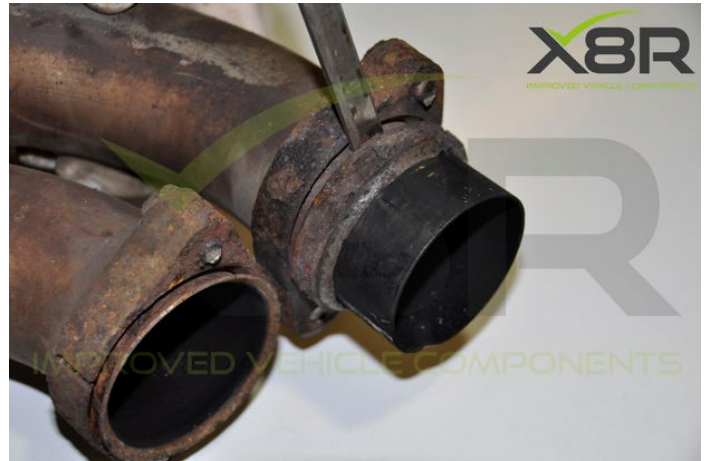
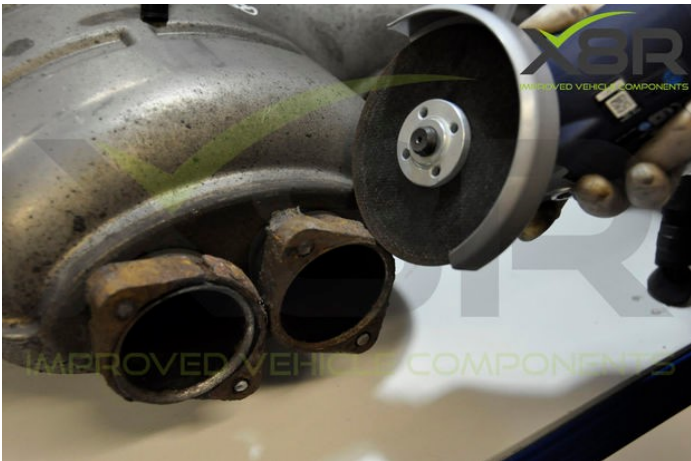
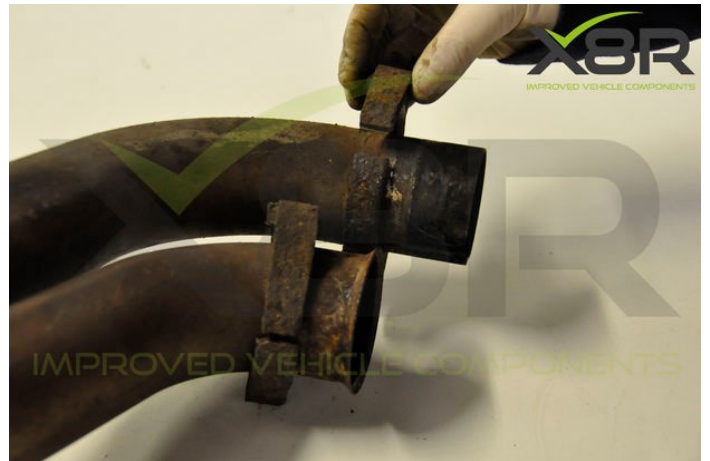
### Step 1: Remove the rusted clamps

Grind off the rusted OEM clamps and remove.  
Cut through the bolts retaining the clamps together and separate the intermediate pipe and rear muffler.  
Remove the OEM gasket seal rings.  
Cut across the clamps center sections and remove from the intermediate pipe and rear muffler.

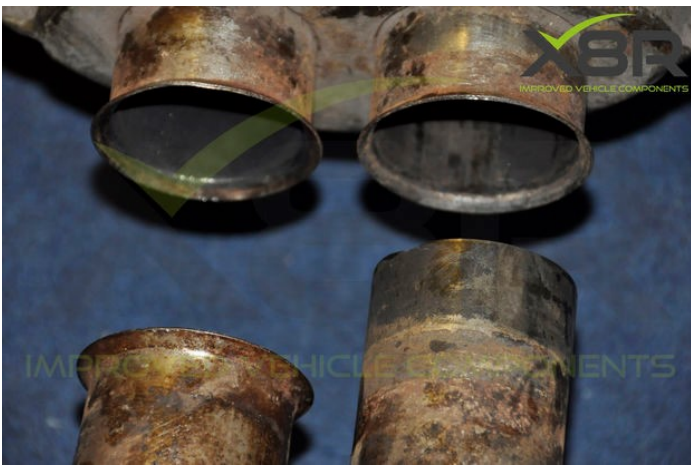
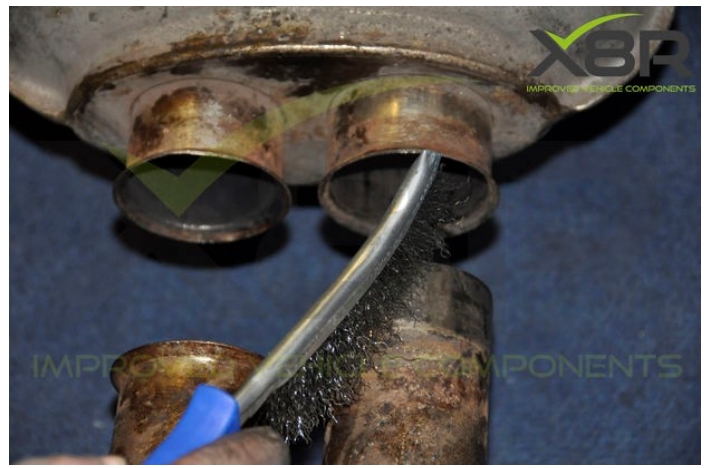
**Step 2: Clean up the pipes and flanges**

Using a wire brush or wire drill attachment clean away the surface rust from the flanges and pipe.

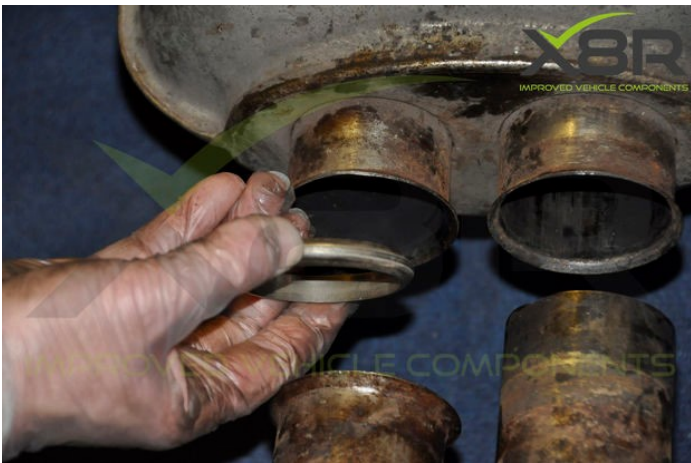
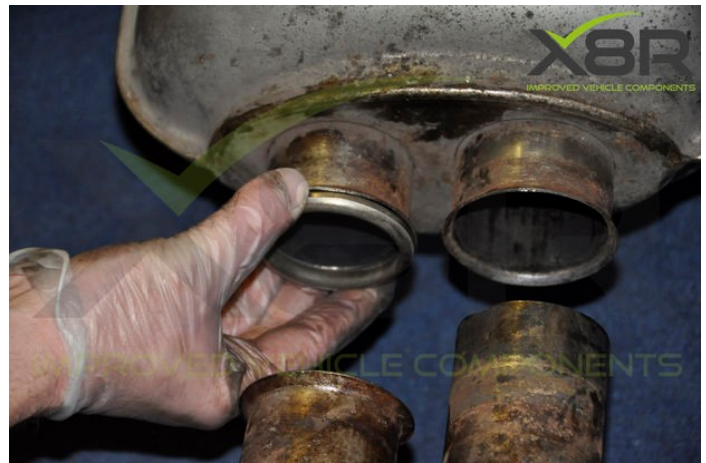
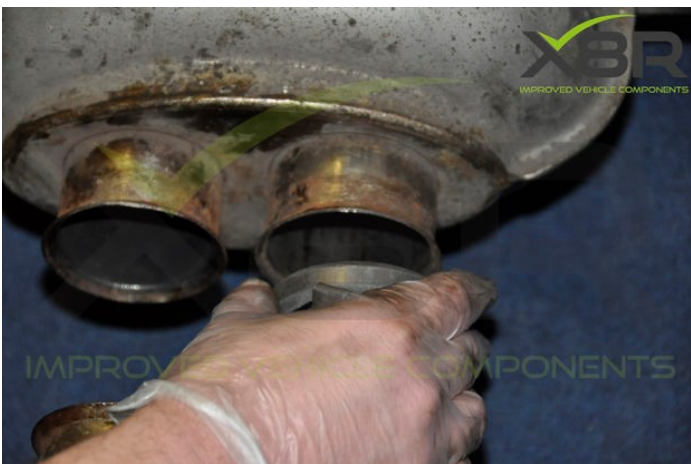
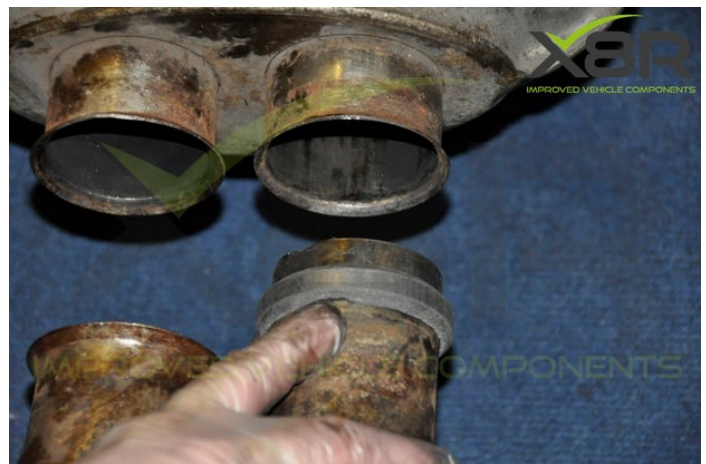
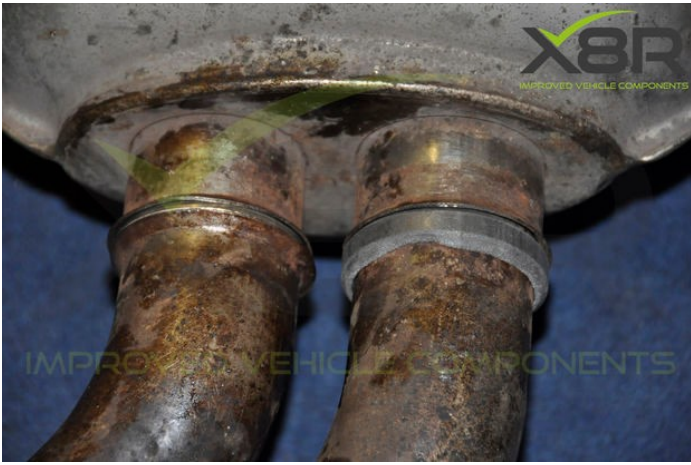
### Step 3: Fit our new gasket seal rings

On the left flange fit our seal ring, this is chamfered on both faces and the flanges mate to these faces.

On the right flange fit our seal ring over the pipe with the chamfered face pointing towards the backbox.

Push the flanges together; the left 2 flanges will seal on the sealing ring and the sealing ring on the right flange / pipe will push in to the flange providing a seal.

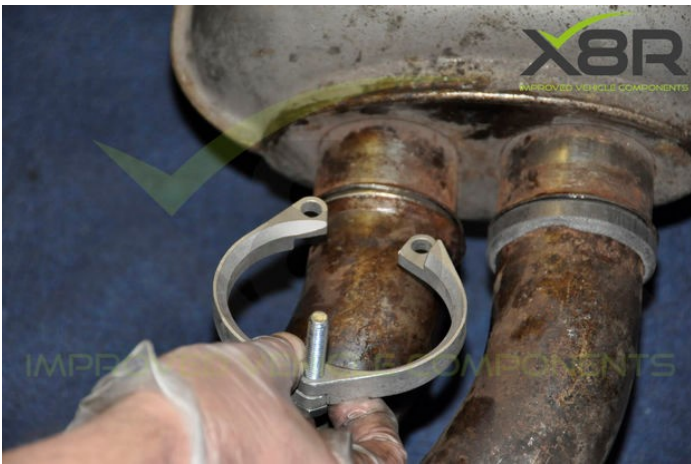
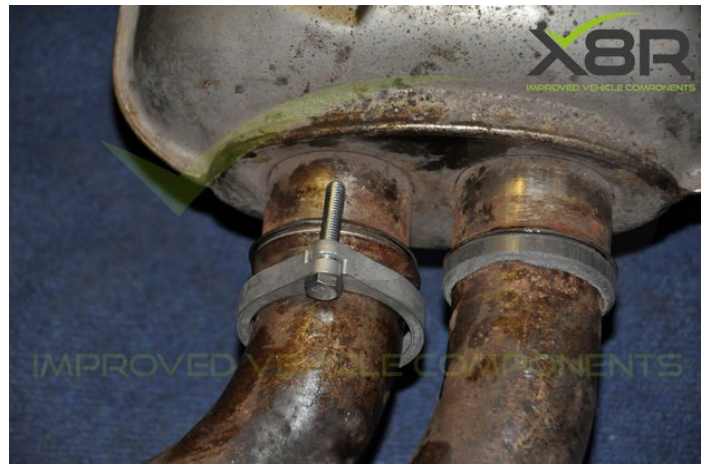
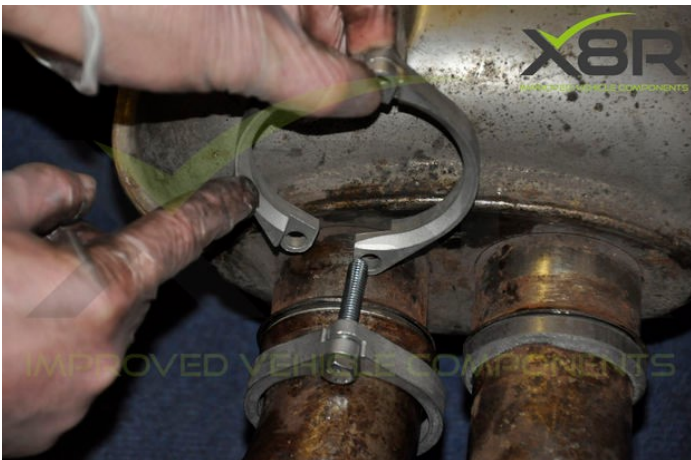
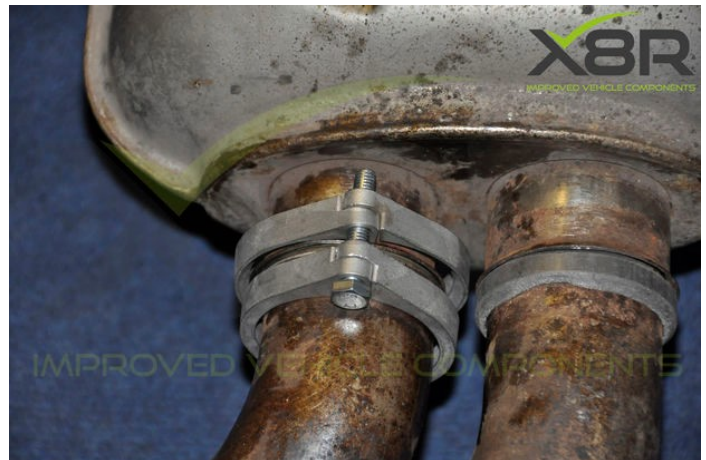
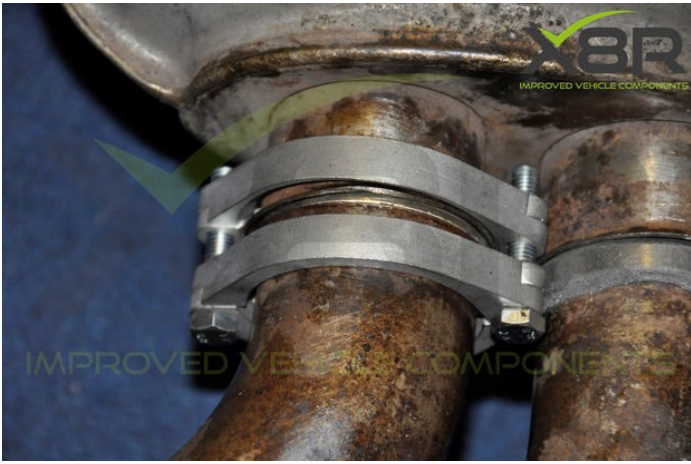
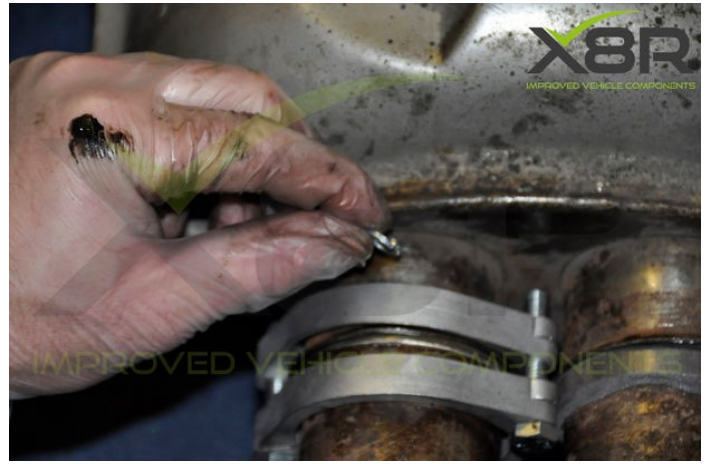
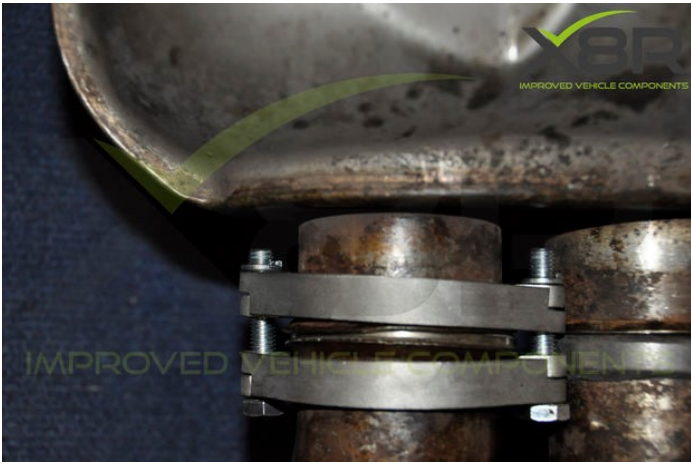
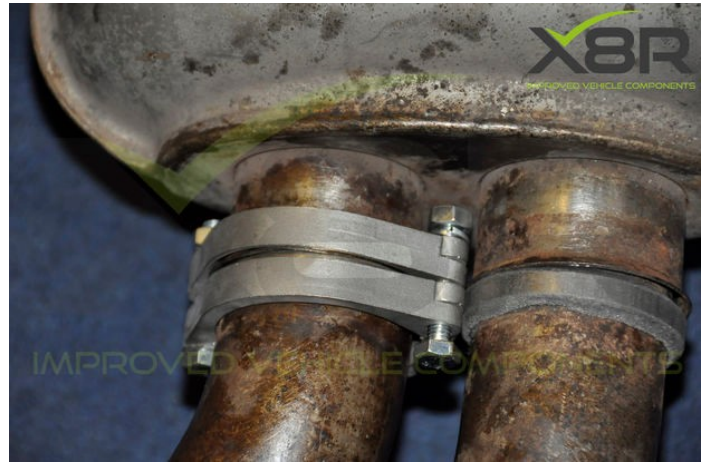
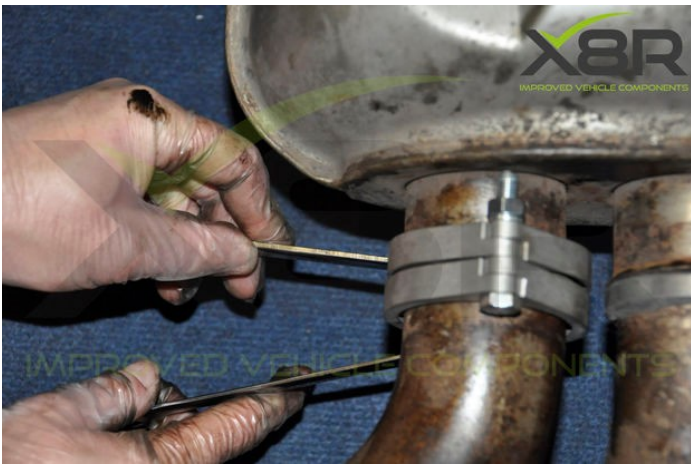
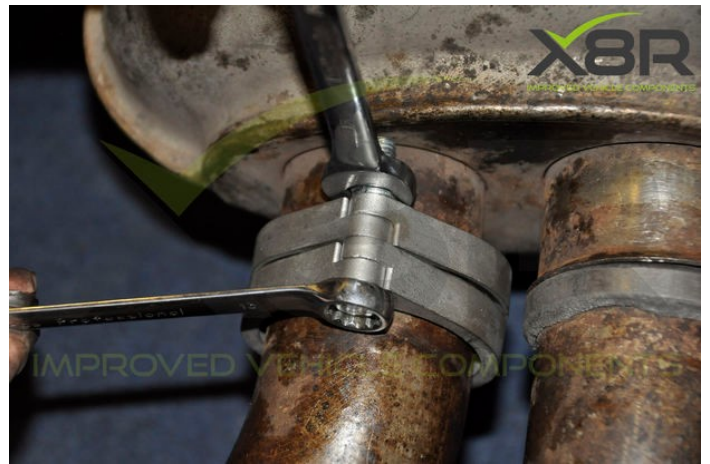
#### Step 4: Clamp the flanges together

Using our stainless steel clamps, clamp the flanges together.

Start with the left hand side flange.

Fit a washer to a bolt and push through the clamps as shown, with the chamfered face of the clamp pointing towards the back box.

Fit clamps on the back box side of the flange with the chamfered face of the clamp pointing towards the intermediate pipe.

Push the bolt through this to form a clamp around the flanges.

Insert another bolt with washer through the lower hole to secure the two clamps together.

Fit a washer, locking washer then nut to both bolts and tighten.

This will draw the clamps together, ensure the seal ring stays in place and tighten the clamps so the flanges clamp to the seal ring.

These should not be over-tightened but just tight enough to keep the flanges clamped to the sealing ring.

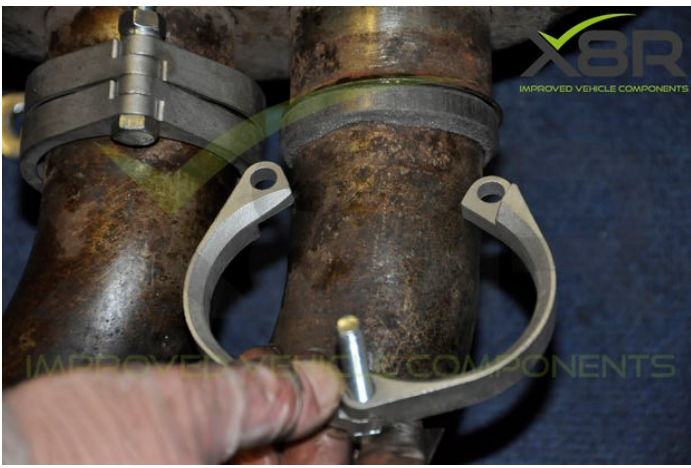
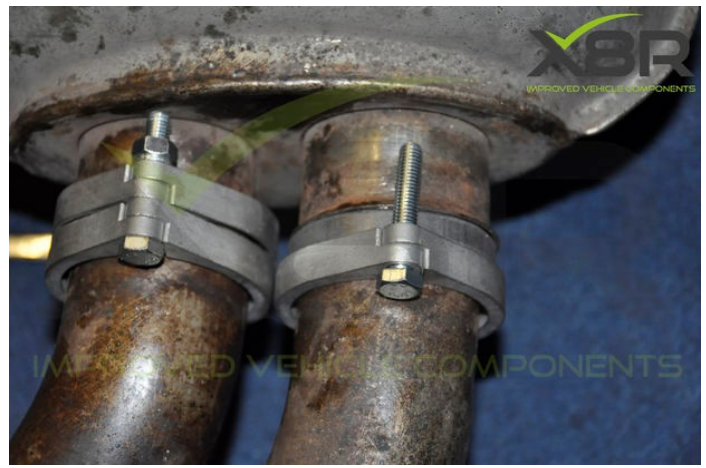
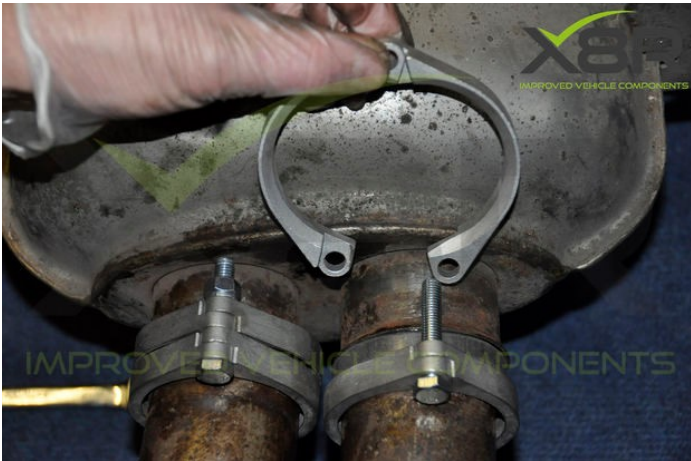
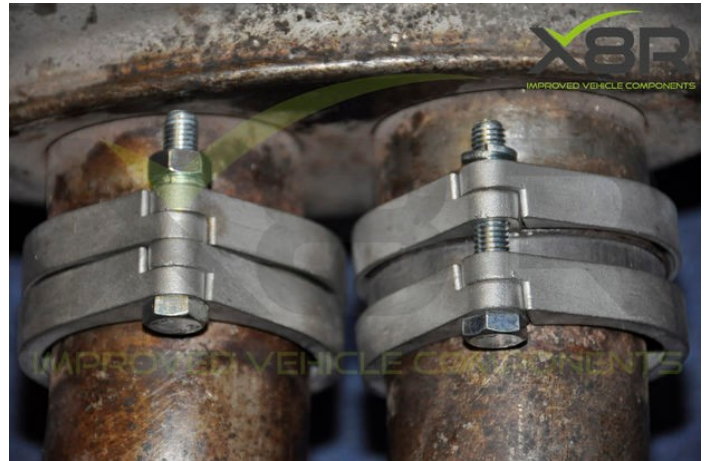
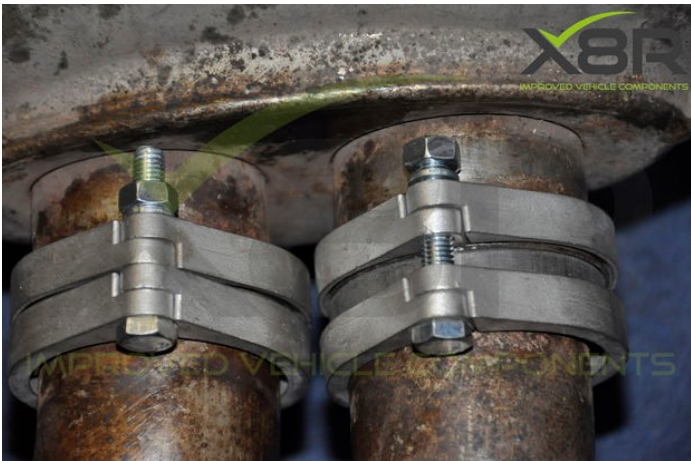
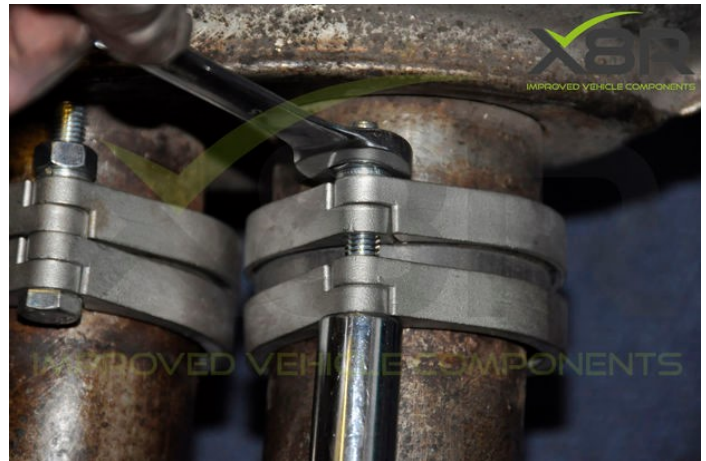
**Step 5: Repeat process for the second flange**

Repeat this process for the right hand side flange. Ensuring again that the chamfered faces point inwards towards the sealing ring / flange. Tighten up bolts to draw the sealing ring in to the flange to provide a seal.
