BMW N47 Intake Inlet Manifold Swirl Flap Removal Delete Metal Blank Plug Bung Repair Fix Kit Install Instruction Guide

by x8rltd

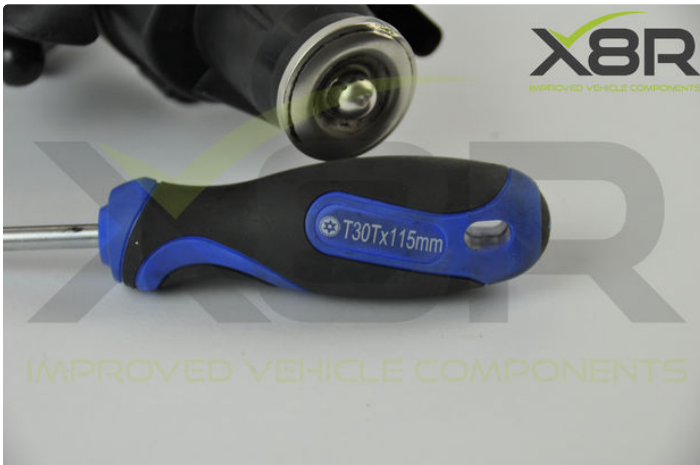
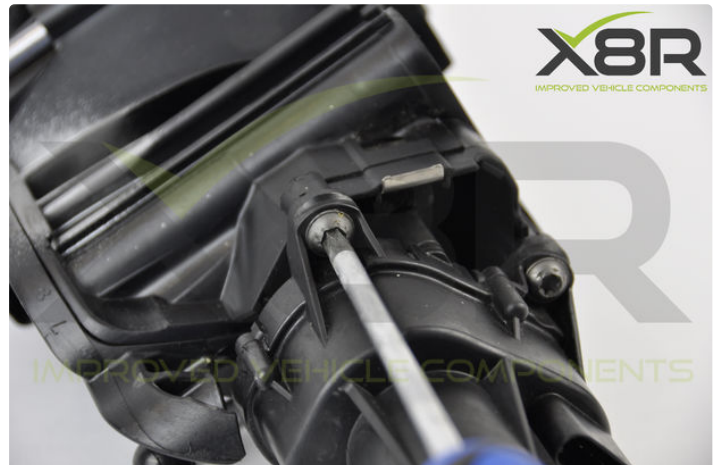
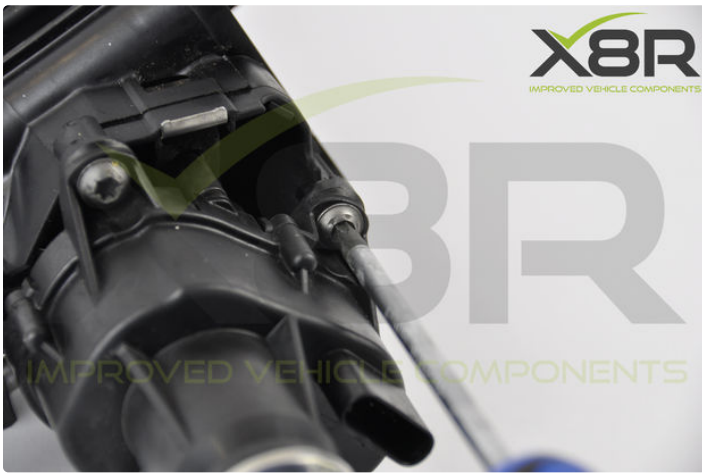
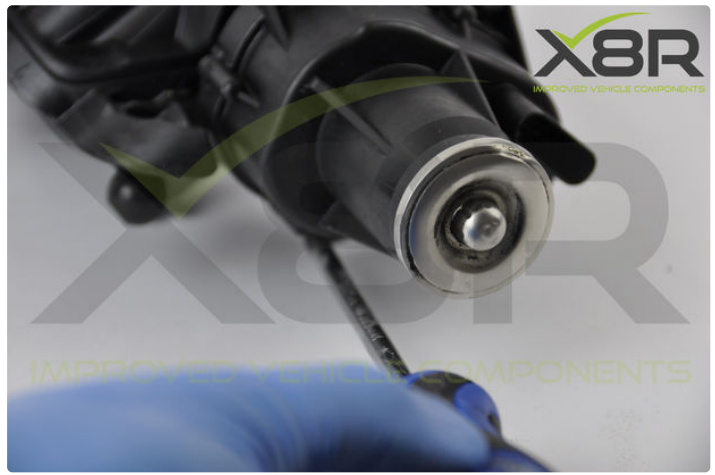
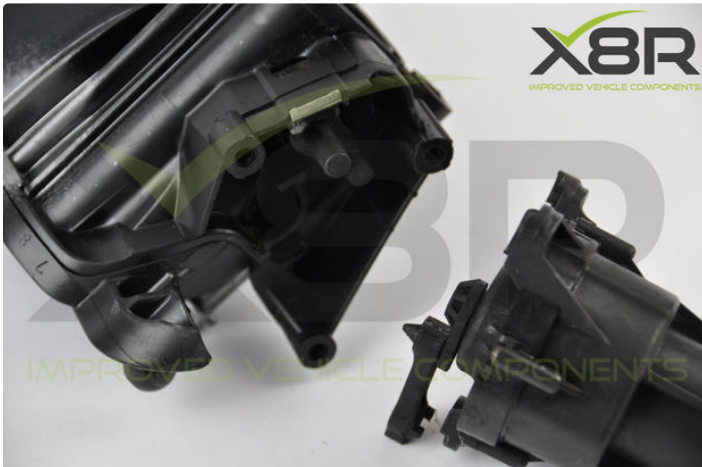
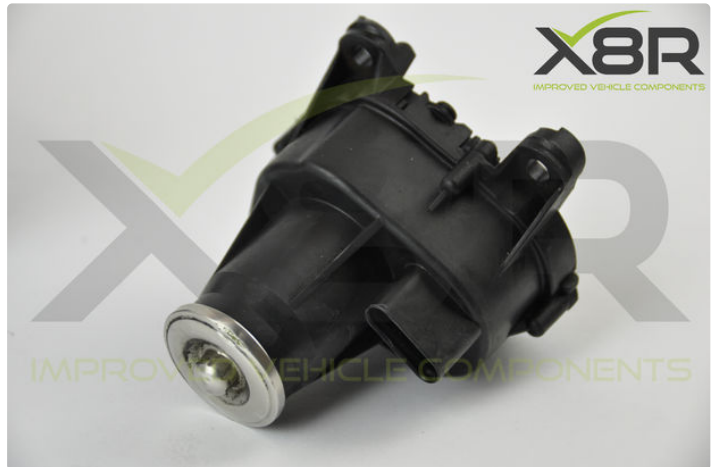
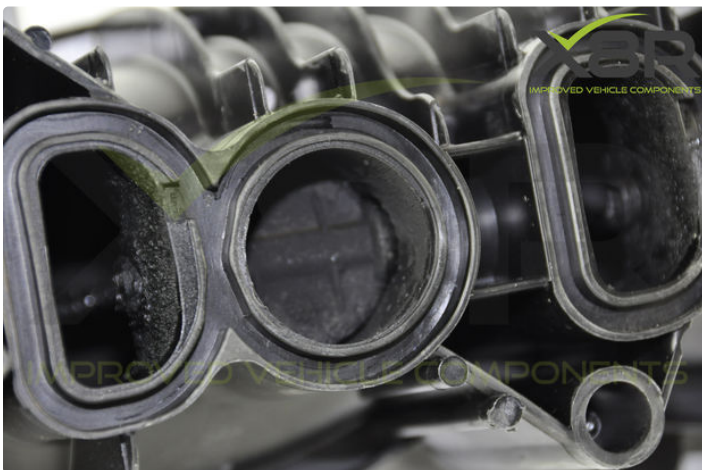
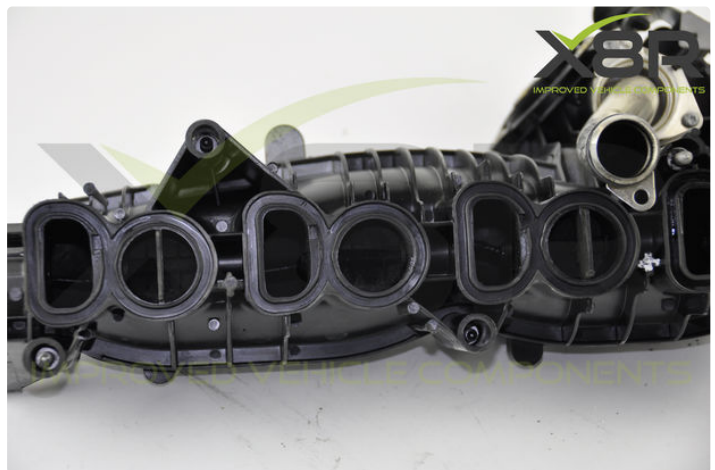
Step 1: Remove Actuator Motor

Using a T30 Torx screwdriver remove the 3 screws that hold the motor in place.

You can remove the hanging arm on the motor (this should just pull off) as this will not be needed during reassembly.

You can now turn the swirl flap rod by hand and see the swirl flaps moving in the manifold (note the carbon deposit build up).

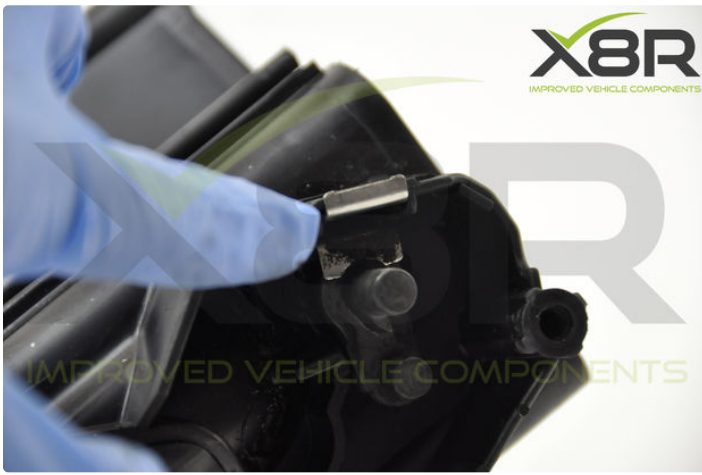
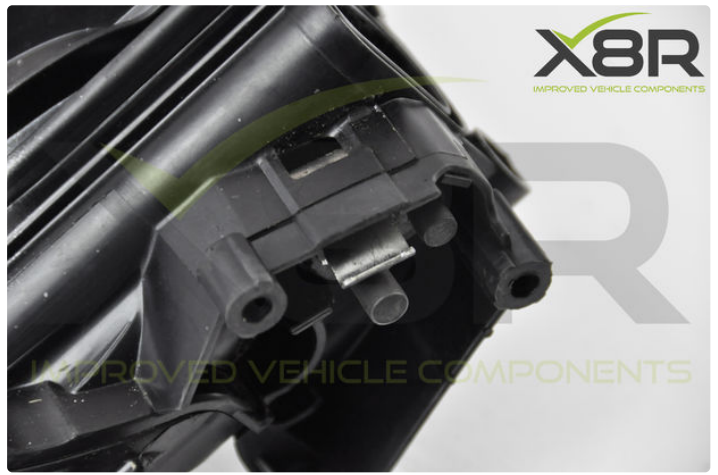
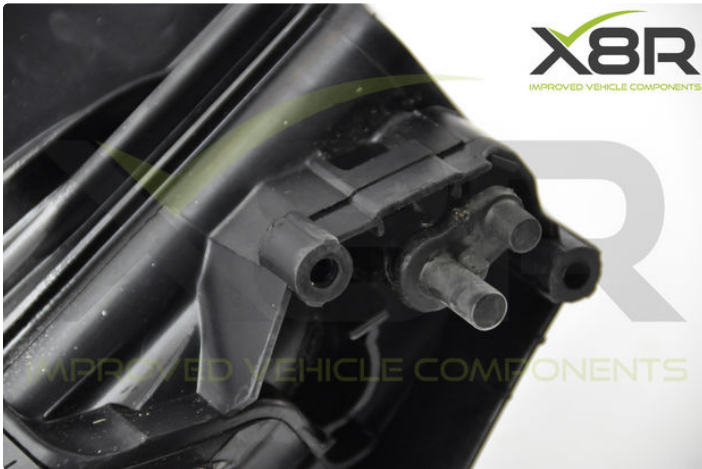
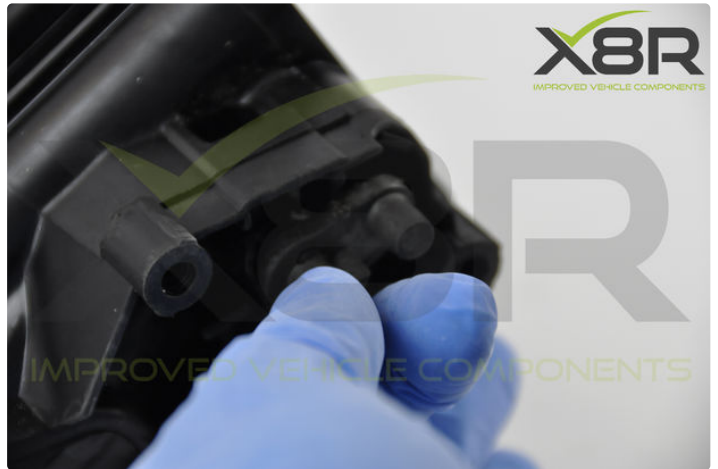
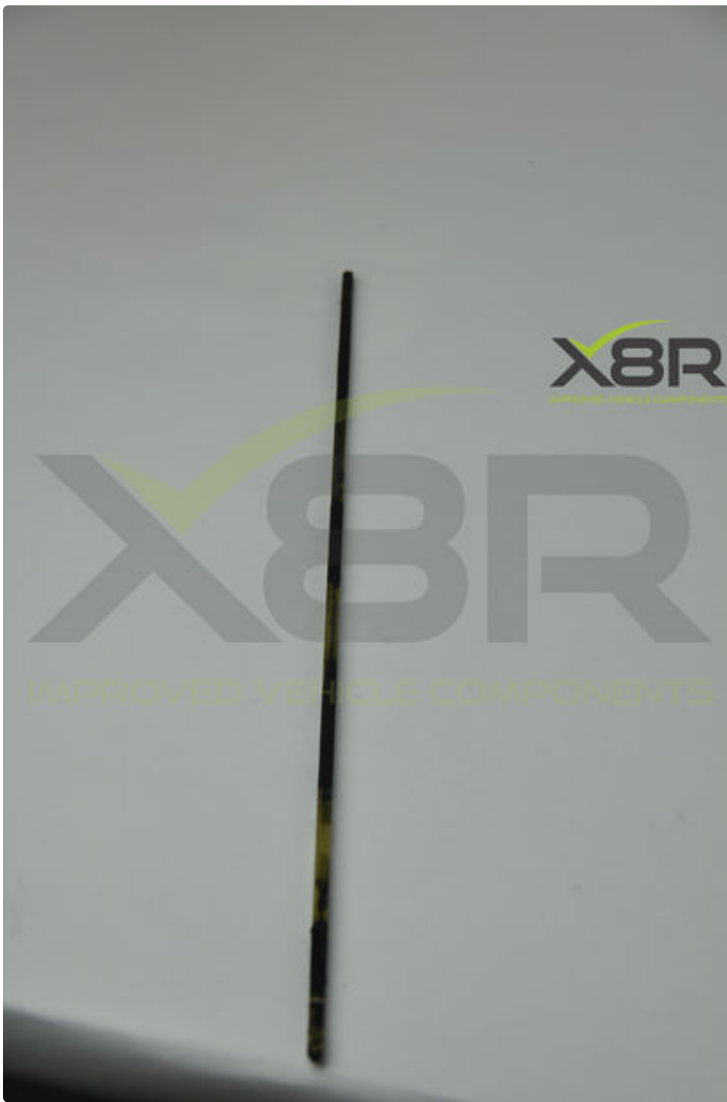
Step 2: Remove Rod

Remove the Silver colour retaining clip that holds the rod in place. This can be done by pulling downwards and then outwards.

Once this clip is removed you can pull the rod out. It is likely to be quite sticky because of the deposits so

may take some effort. The plastic end of the rod will likely pop off, use a pair of pliers to grip the end of the rod and pull it out. You will likely need to hold the manifold firm in a vice to do this.

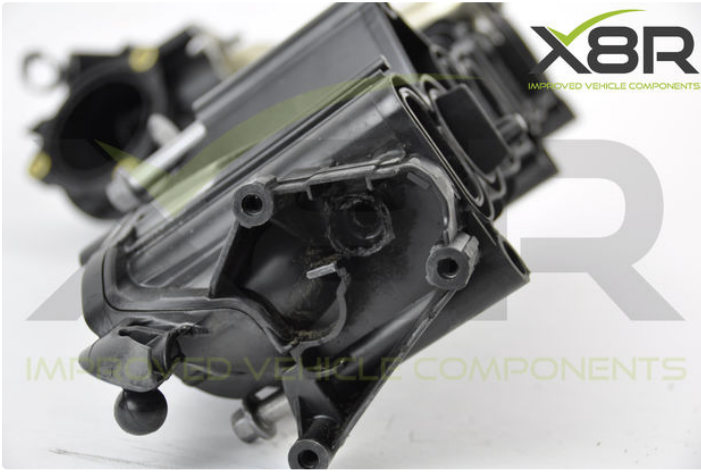
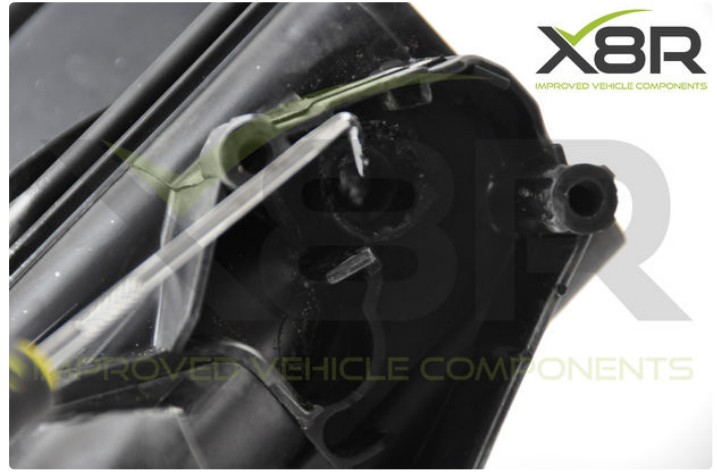
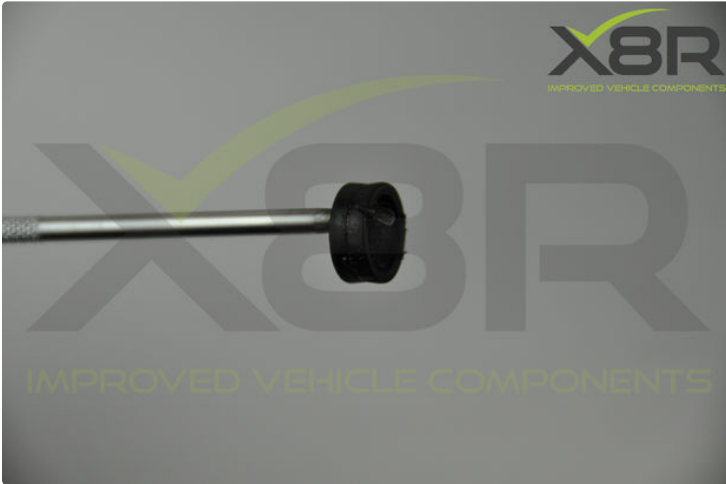
Step 3: Remove Small Seal

Once the rod is out, use a pick tool to hook out a small rubber seal left behind in the hole. If this is not done our replacement bung will not seat correctly.

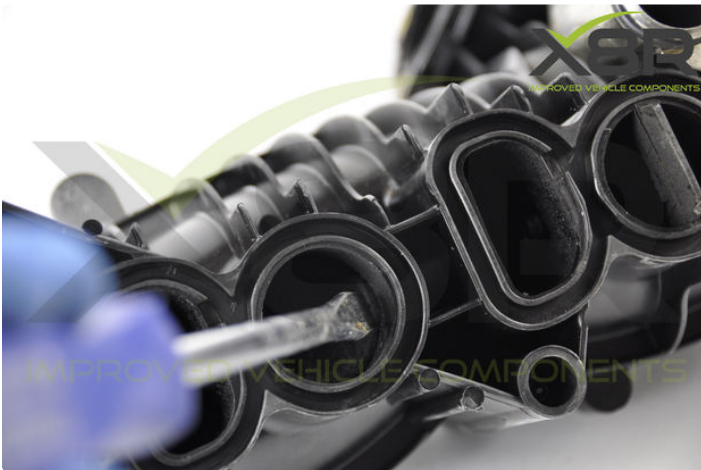
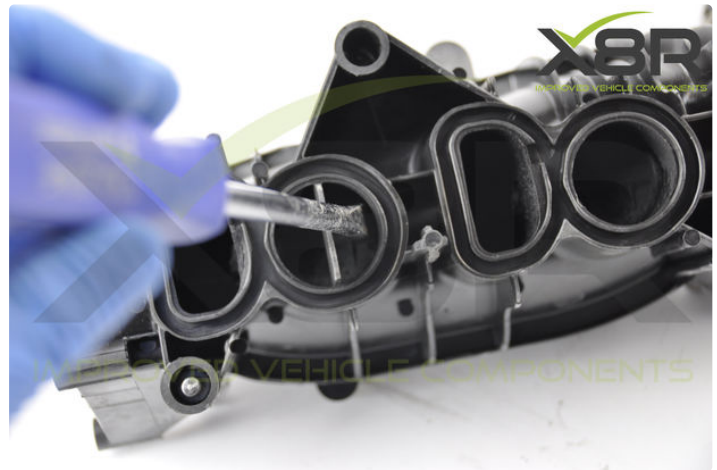
Step 4: Remove the Swirl Flaps

Lightly tap near the edge of the swirl flaps where the rod would have once been to loosen them. Do this with a flat head screwdriver and a mallet. Take care to remove ALL remnants of the swirl flaps from the manifold.

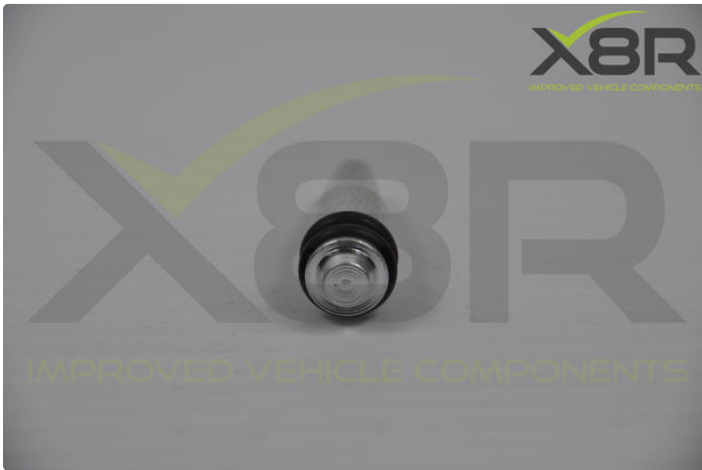
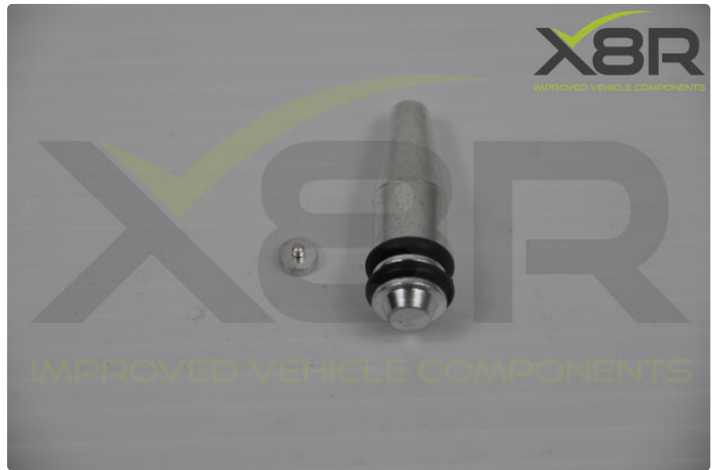
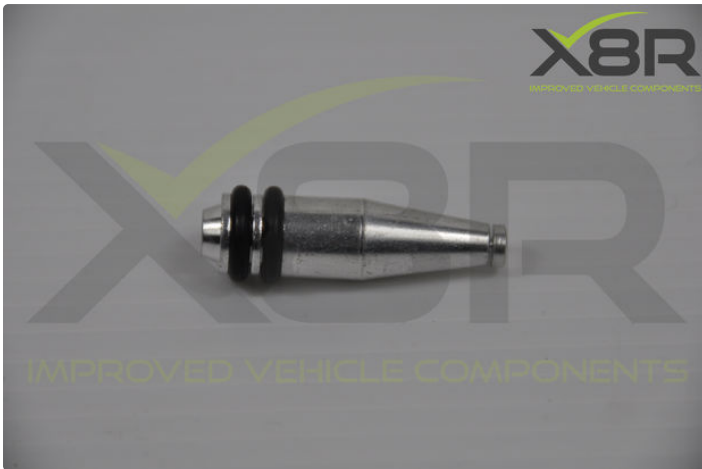
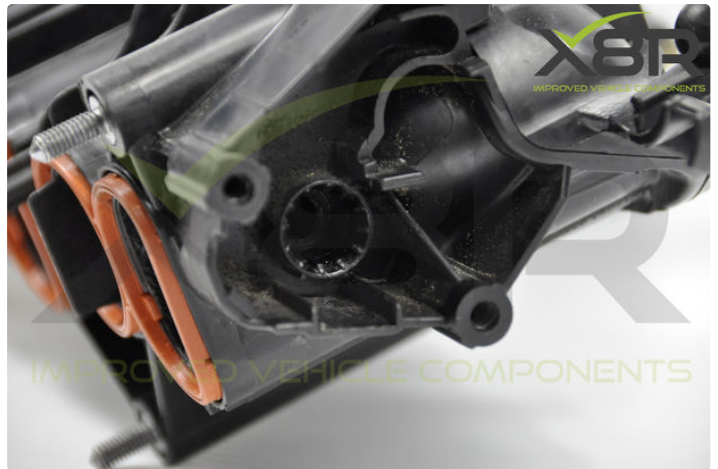
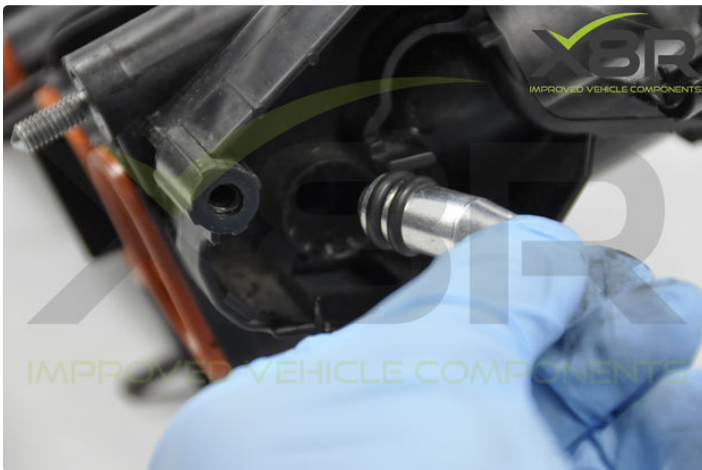
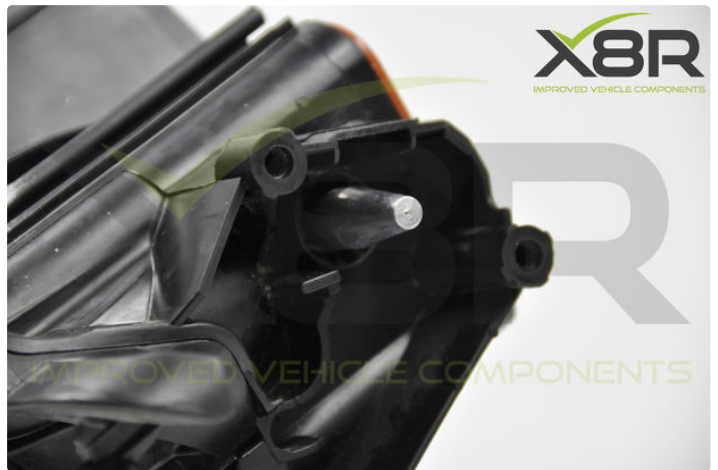
Step 5: Install Our Bung

This is a simple push fit install. Insert the bung into the hole and push firmly until it stays in place on its own. The twin o-rings not only make it secure, they also provide a good seal for the manifold, you should feel this.

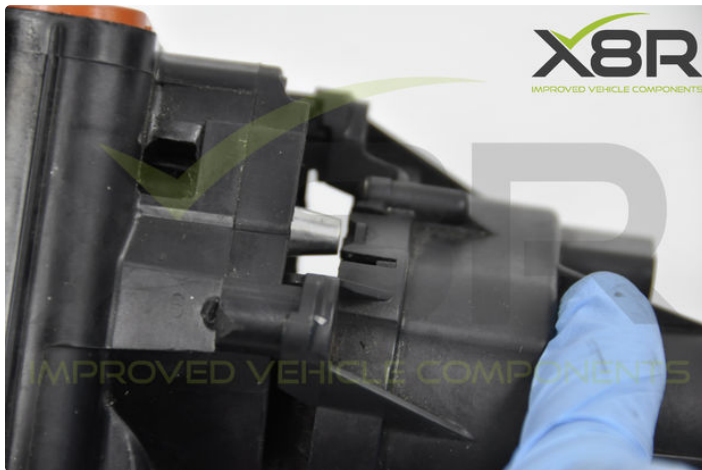
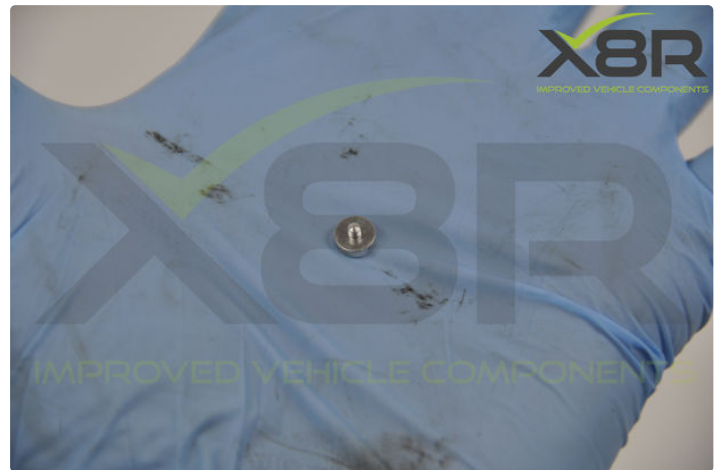
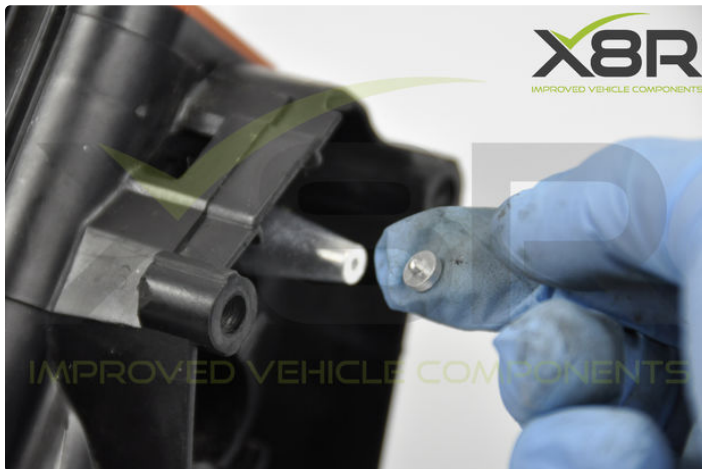
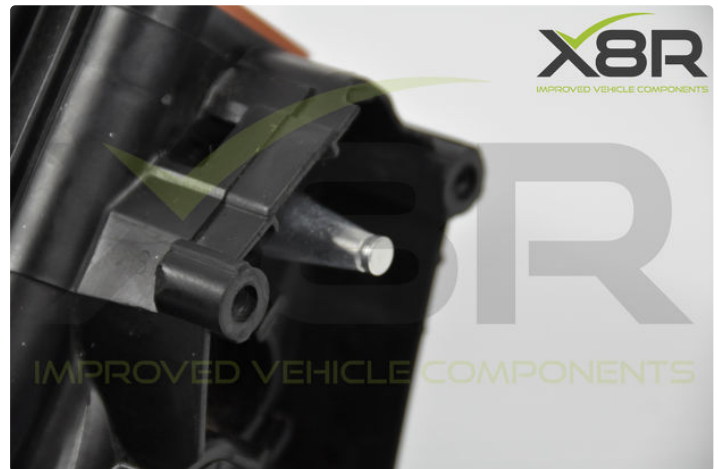
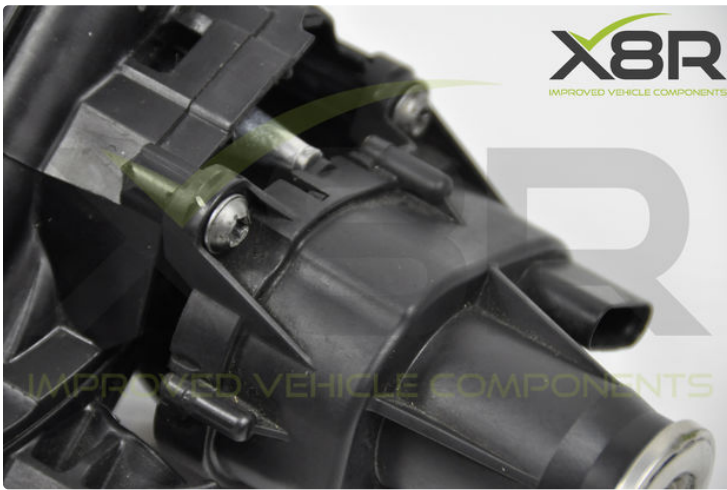
Step 6: Reattach Motor and Install Small Spacer (If Needed)

You can now reinstall the actuator motor. Our bung should fit tightly against the motor casing but if it doesn't, as shown in the pictures, it means that the motor casing has broken over time.

This is where our supplied small spacer is used.

Install our small spacer by pushing into the end of the metal bung as shown in the photos. Making sure this stays in place, line up the actuator motor to the manifold to make sure of fitment.

Fitted correctly, the spacer should line up and then press against the actuator motor.

Once the motor is on and the spacer is securely held in place, screw back in the 3 x T30 torx screws from earlier. Make sure the screws are done up tightly so that the spacer and bung are held in position securely.

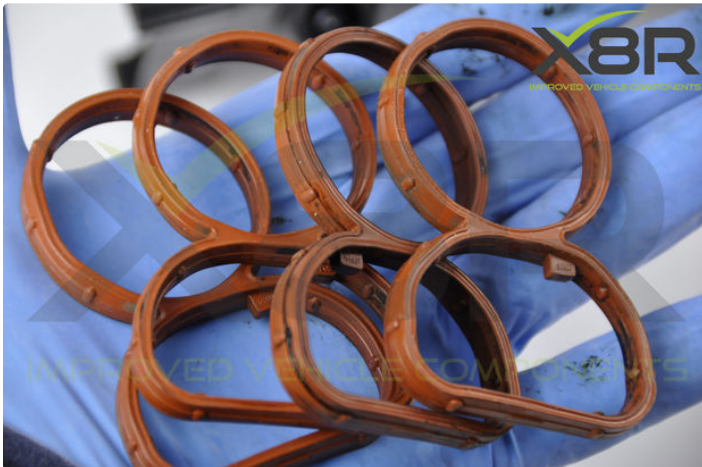
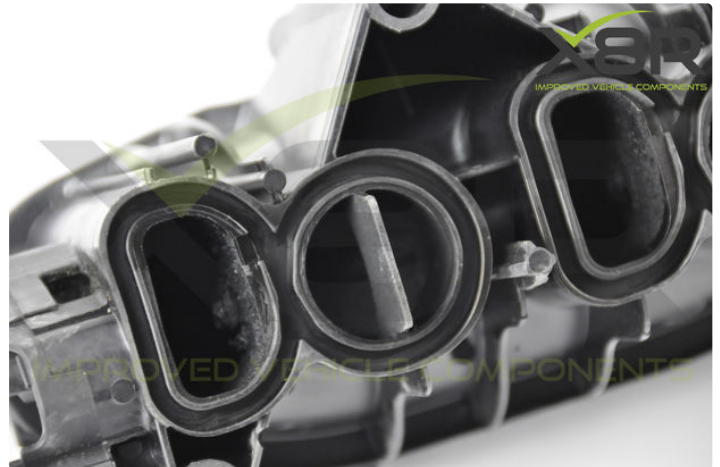
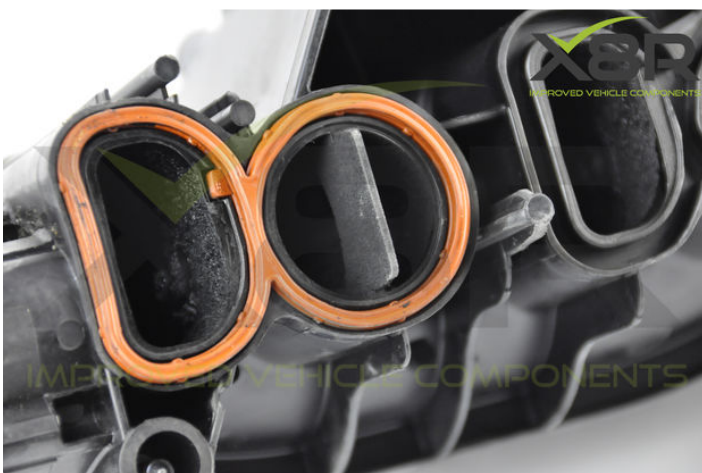
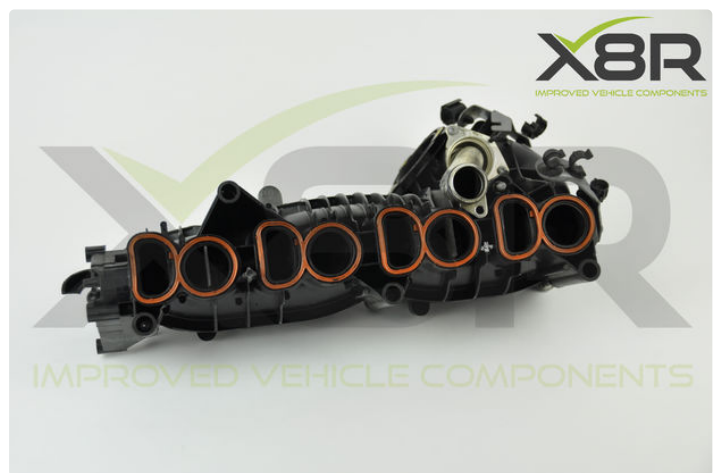
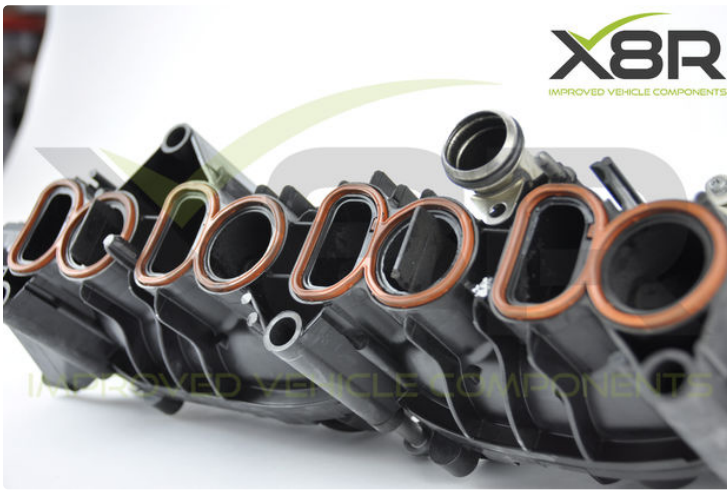
Step 7: Install New Manifold Gaskets

Fit the new gaskets. Once again, these are a simple push fit design. These will only go in one way as there is a small notch on the gasket which fits into a small cut out on the manifold. Push these into place securely.

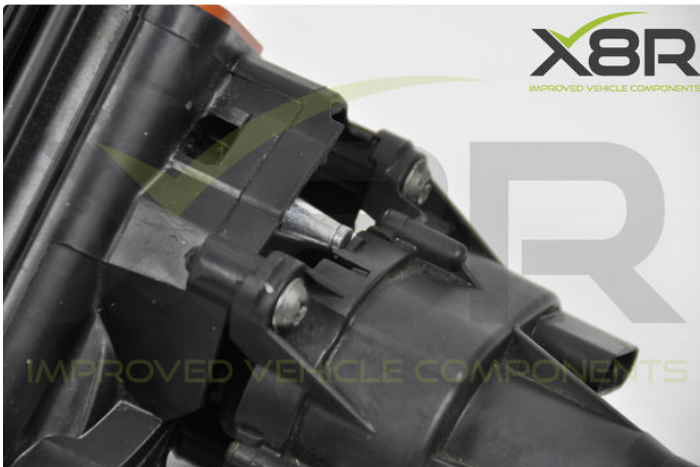
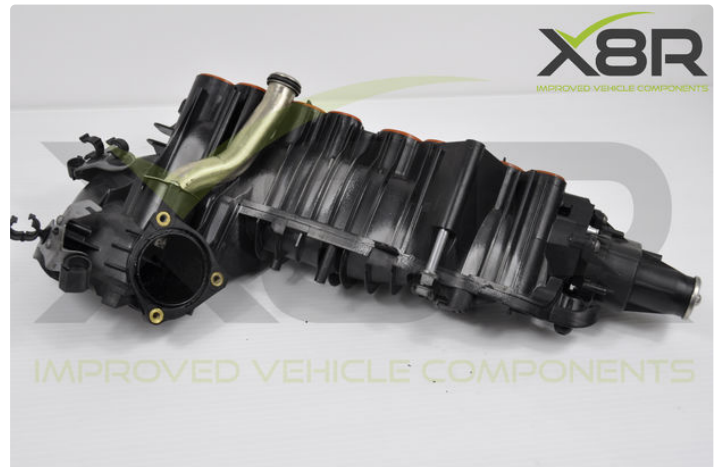
Step 8: Modification Complete

This concludes the modification to remove the swirl flaps from the manifold.

When refitting the manifold to the engine, make sure the electrical connection is refitted to the actuator motor. This will make the ECU think that the flaps and motor are working as they should and will not bring up error codes or warning lights.
