DSG / 0AM Mechatronic Unit 7 Speed Gearbox Hydraulic Accumulator Repair Kit Replacement Overhaul Leaking Crack Repair Fix VW AUDI SKODA SEAT Install Instructions Guide

by x8rltd

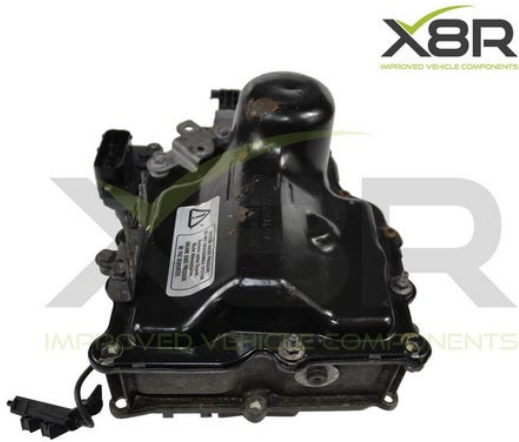
The accumulator mounting within the DSG unit fails causing these faults

Within the DSG Mechatronic unit, the hydraulic pump pushes oil through the filter towards the pressure accumulator which provides the system with oil pressure when the pump is switched off.

The cast metal part that the accumulator seats in to is too thin for the pressure exerted, this causes this part to crack and for the system to lose pressure causing the mechatronic unit to fail.

Our unique design repair restores full function to the DSG unit

Our unique repair kit allows you to repair the failed cast block. Our accumulator base mounts to the cast block restoring full function, our improved design accumulator simply then screws in place, providing a full-term repair for this common fault.

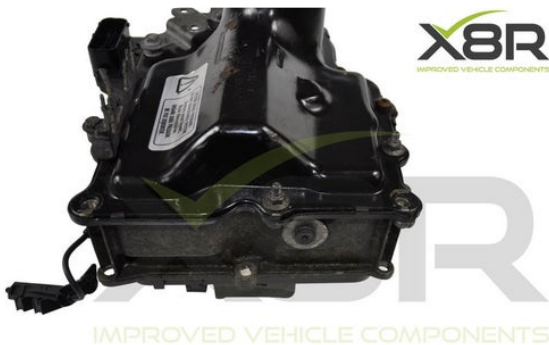
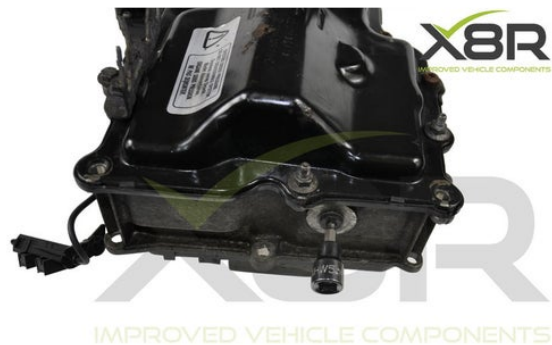
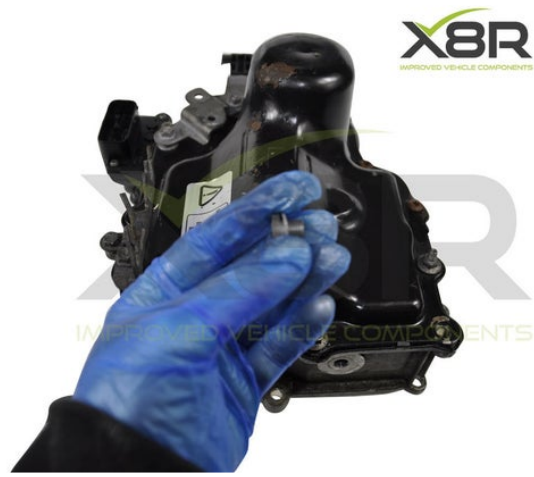
Step 1: Depressurise and Drain Mechatronic Unit

Using a 5mm Allen key socket loosen the screw shown slowly and drain down the Hydraulic fluid from the Mechatronic unit.

The Mechatronic unit is under pressure.

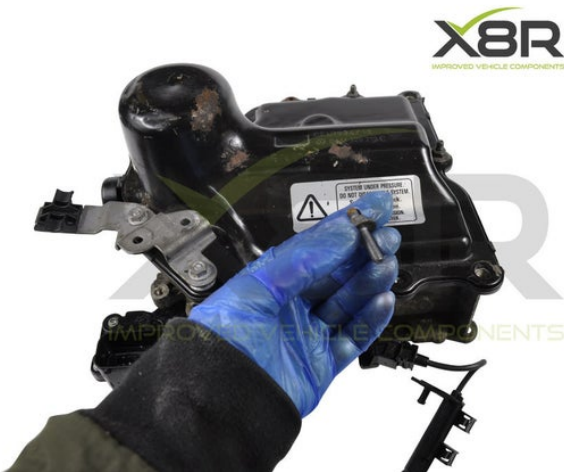
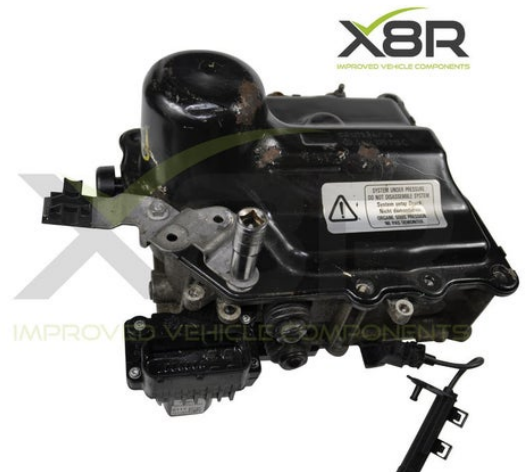
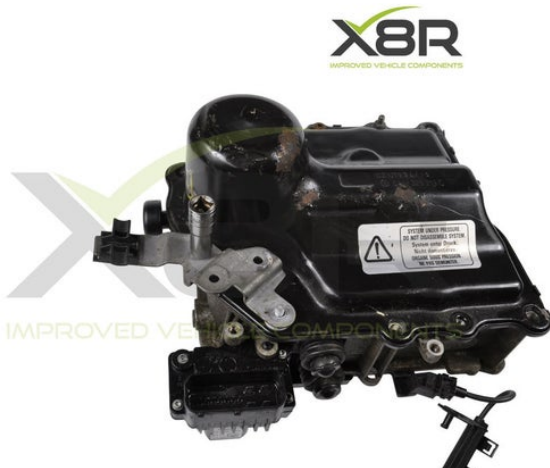
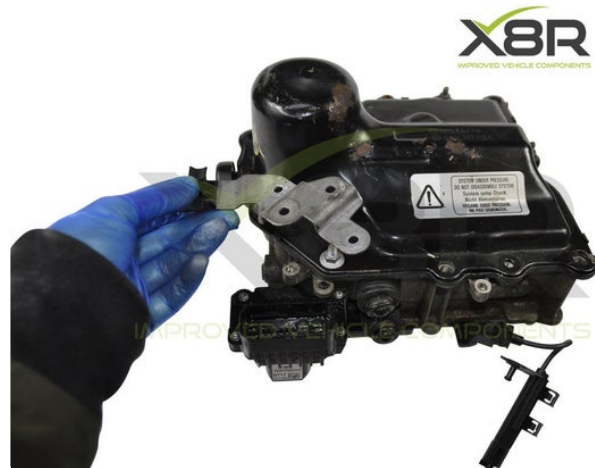
Step 2: Remove Sump Cover

Remove the sump cover fasteners. Take note of the location of each fastener for reinstall. Socket sizes required: 10mm socket, T30 Torx.

Using a flat bladed screw driver lever off the sump cover, taking care not to damage the gasket.

Keep gasket in place on sump cover for reinstall.

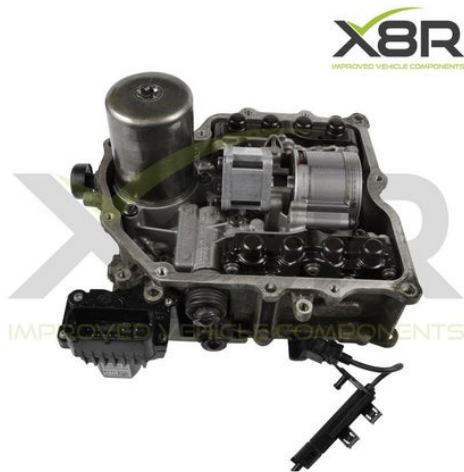
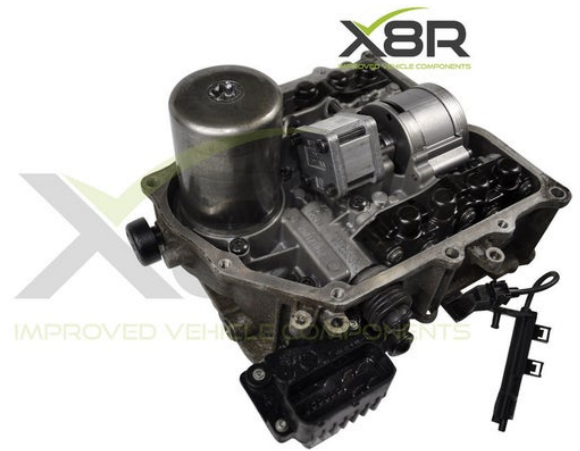
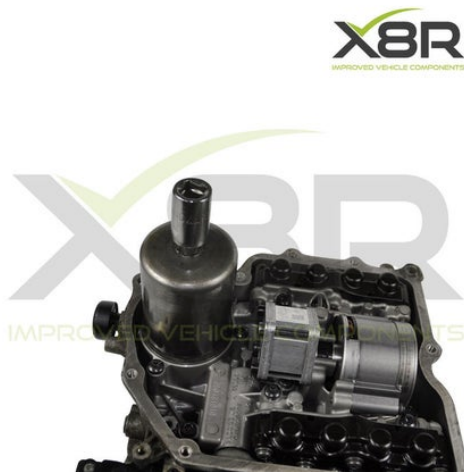
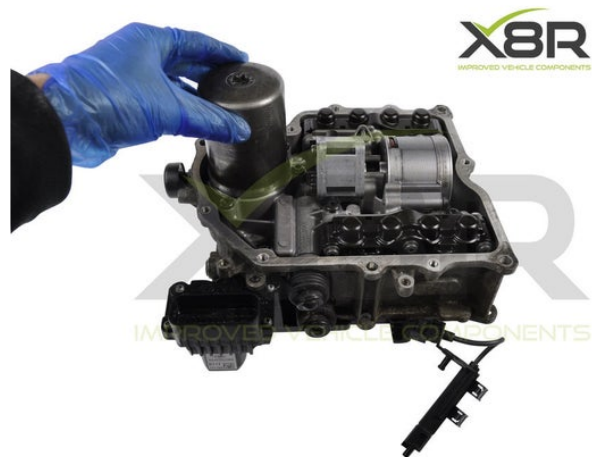
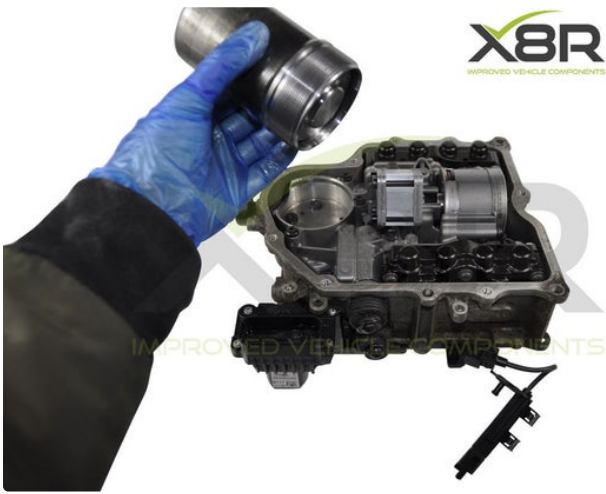
Step 3: Remove Accumulator

Although the Mechatronic hydraulic fluid has been drained down the accumulator could still be under pressure as it is designed to store the fluid under pressure when the unit isn't active. Inspect closely around the base of the accumulator to check for cracks or splits where the accumulator base has failed. If there is no sign of damage the likely hood is that our part won't cure the fault it is also likely the unit

is under pressure and should not be disassembled. Only if damaged is evident and you are confident that the unit is not under pressure should you continue. If you are unsure or not confident; consult a professional.

Using a T70 bit loosen and remove the accumulator.

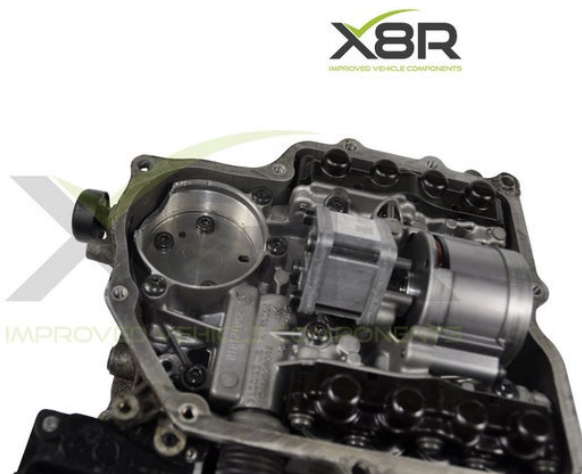
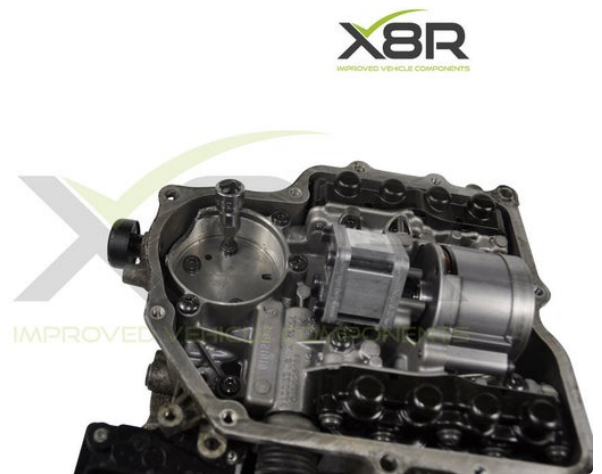
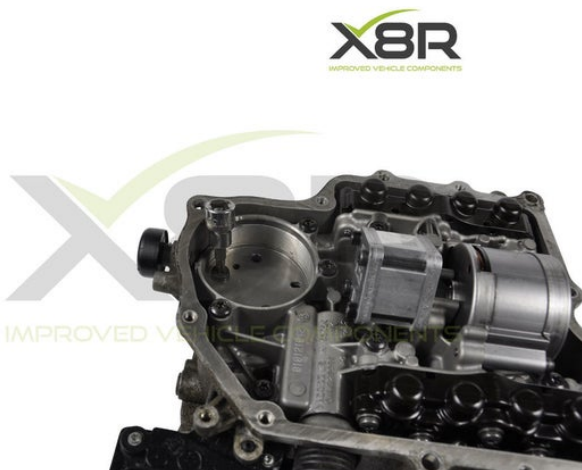
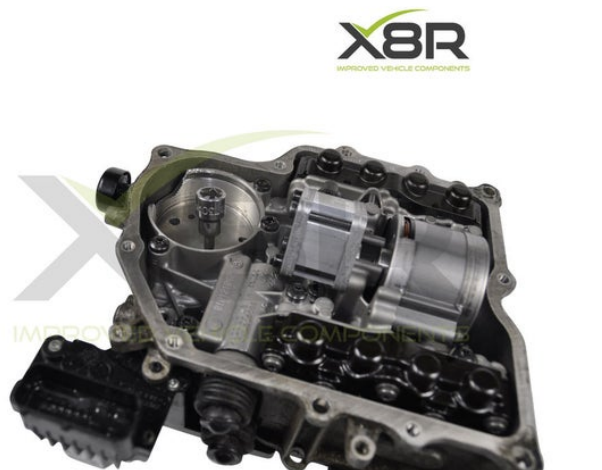
Step 4: Remove Accumulator Base Screws

If the block has fully cracked as shown here; remove all metal parts that have broken away.

Using a T30 bit remove the 3 screws shown.
