Fiat Punto Upgrade Front Wiper Motor Linkage Repair Replacement Push Rod Rods Set 1999-2006 Instruction Guide Install

Intro: Fiat Punto Upgrade Front Wiper Motor Linkage Repair Replacement Push Rod Rods Set 1999-2006 Instruction Guide Install

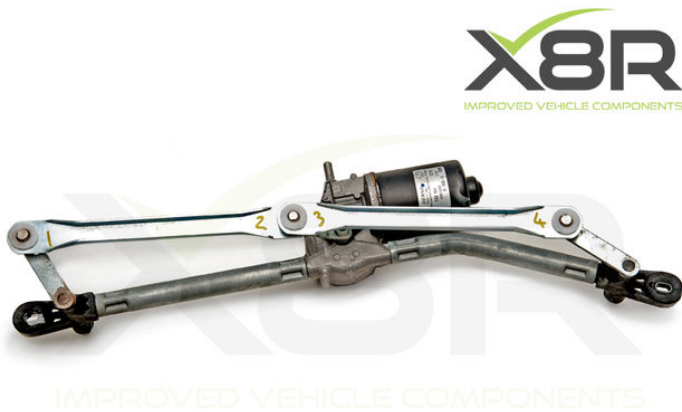
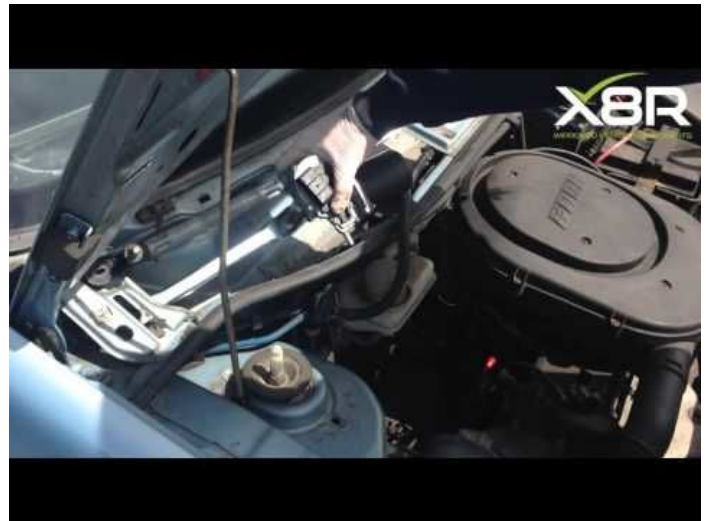
The poor quality bearings on your vehicles wiper linkage rods wear causing these symptoms

The original soft plastic bush bearings on each end of the two wiper linkage push rods wear down leading to the push rods popping off of their respective ball joint. Dependent on which rod pops off or if the rods haven't popped off but there is excess movement in the joint this will cause the symptoms noted above. It is a very common fault on this model. Until now it has only been possible to buy a whole new wiper mechanism at vast cost which would just fail again.

Fit our exclusive high quality replacement push rods and restore your wipers to full health.

Our high quality new rods simply replace the original worn out rods; this is a very simple process, with full instructions included. Save the cost of a complete replacement mechanism that would just fail again. Our rods are fitted with upgraded high quality plastic bearings giving a smoother and more reliable wipe, a vast improvement over the OEM part, designed to last the life of the vehicle not the life of the vehicles warranty.

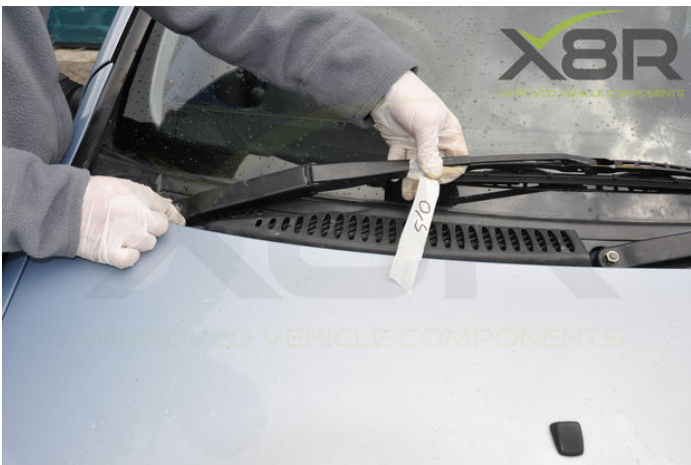
Step 1: Label the wiper arms

Wrap masking tape around the wiper arms and label them n/s for passenger side and o/s for drivers side. This is key for the re-fit to ensure the correct arm is on the correct spindle.

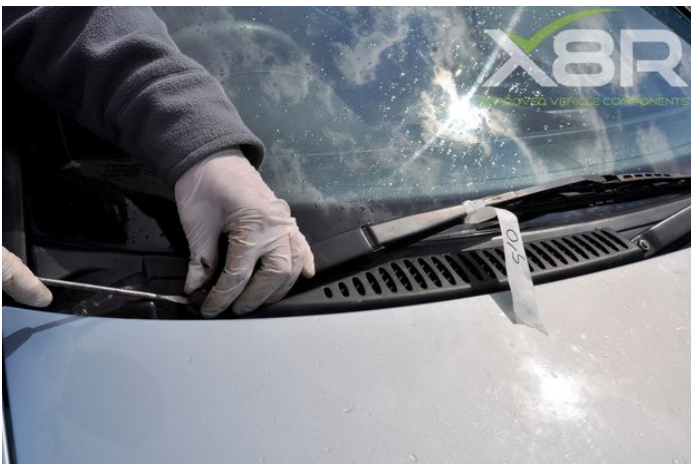
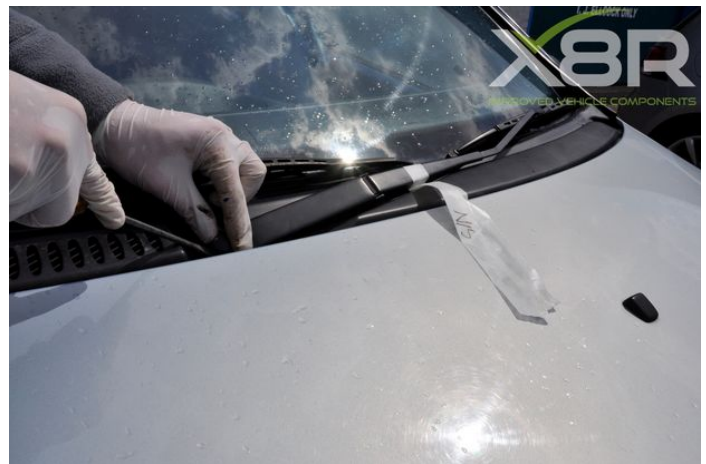
Step 2: Remove the wiper arm nut covers

Remove the wiper arm nut covers using a flat blade screwdriver or small pry bar.

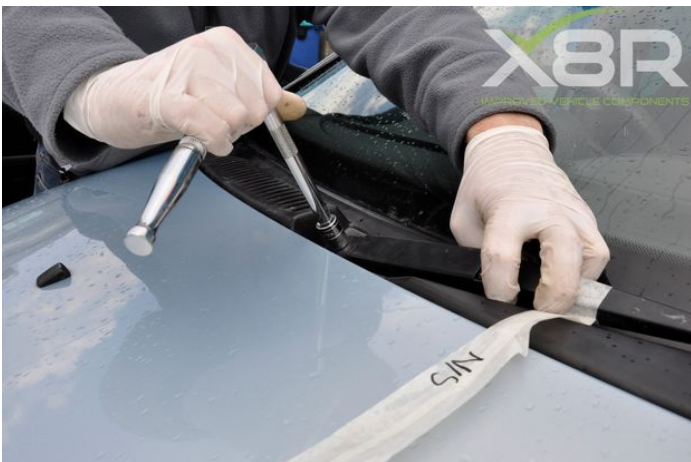
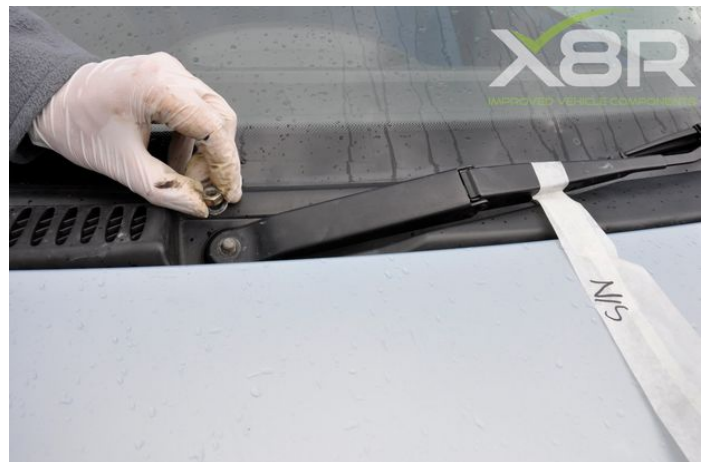
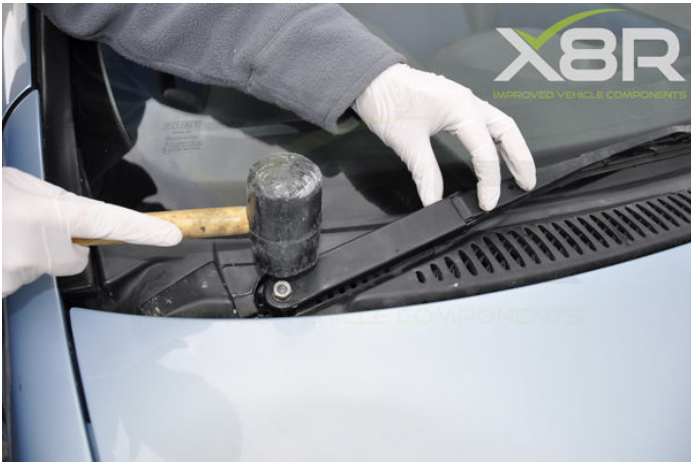
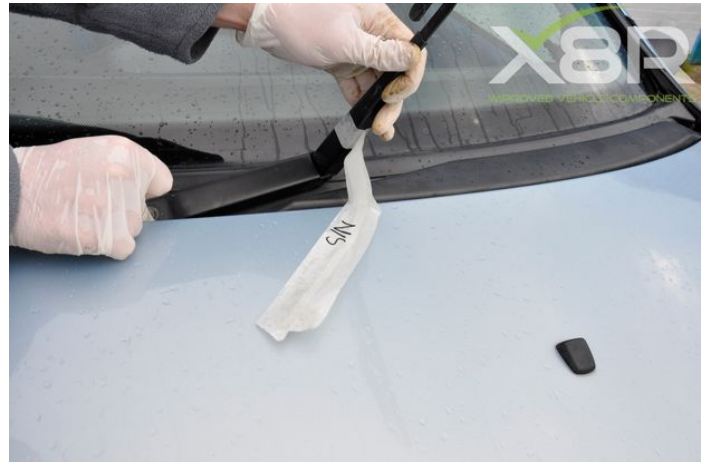
Step 3: Remove the wiper arms

Remove the 13mm nut from each wiper arm and retain the small washer from under the nut.

Once the nuts are removed from the arms pull on the arms to remove them from their spindle.

If the arms can't easily be removed re-fit the nuts. With the nuts re-fitted shock the nuts using a small hammer or mallet to shock the arms free, the arms will now be free to be removed.

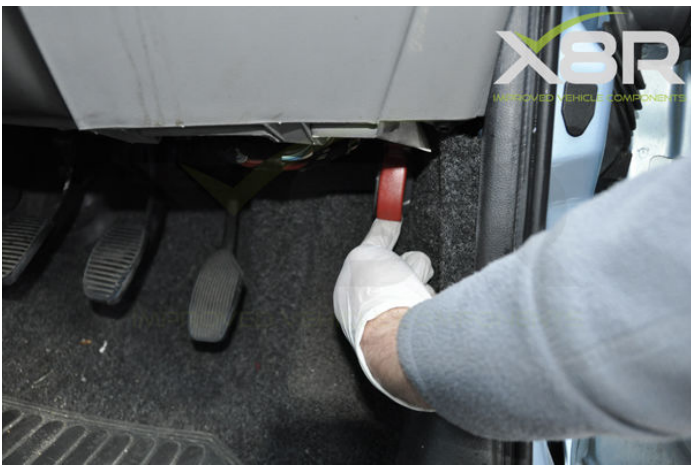
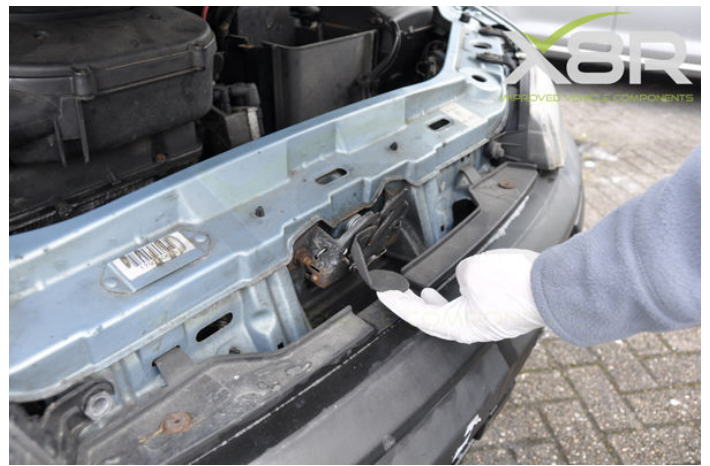
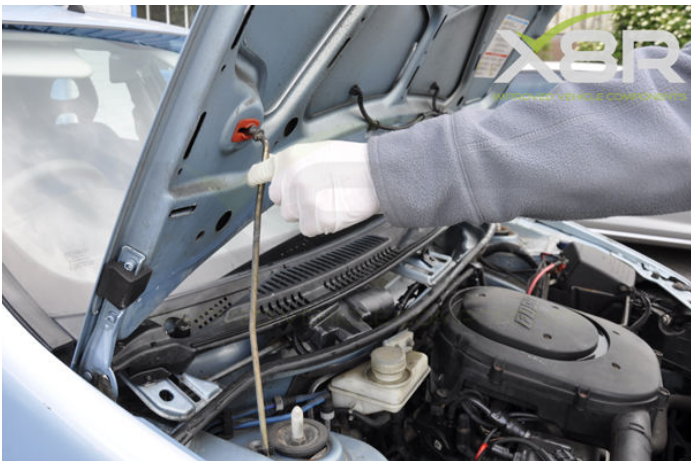
Step 4: Open the bonnet

Open the bonnet; the bonnet release (Red lever pull) is in the driver's side (o/s) footwell.

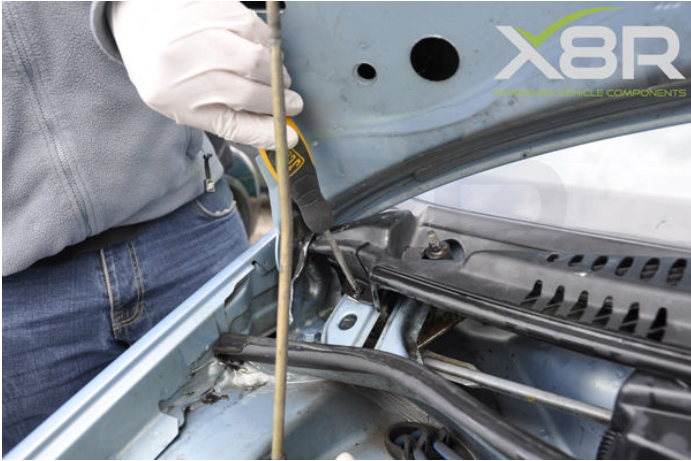
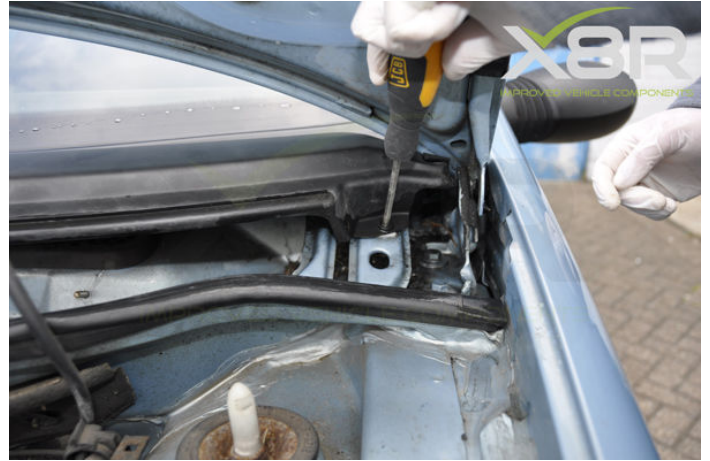
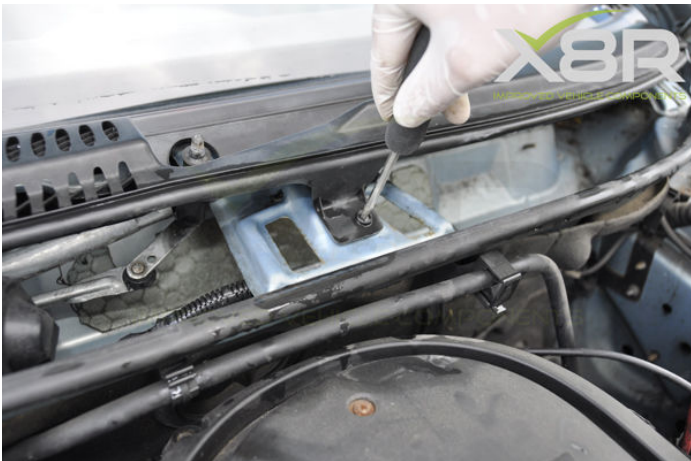
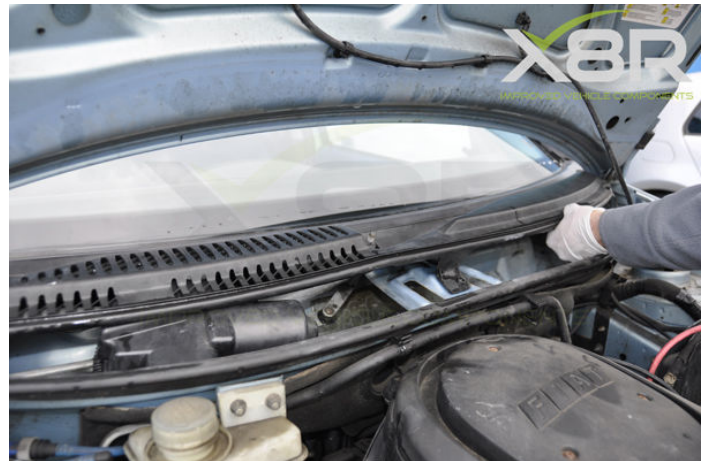
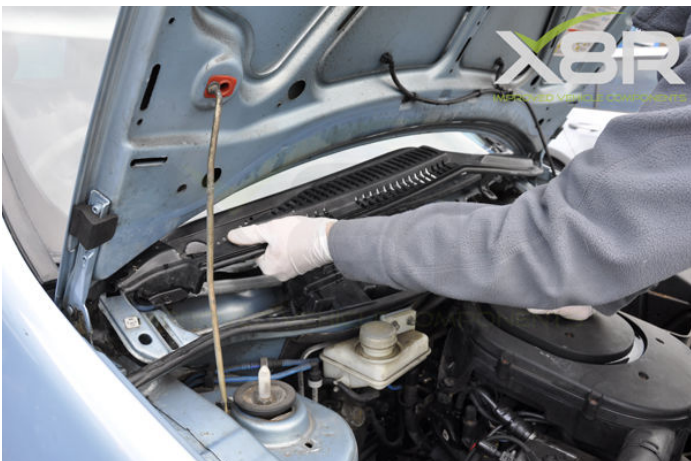
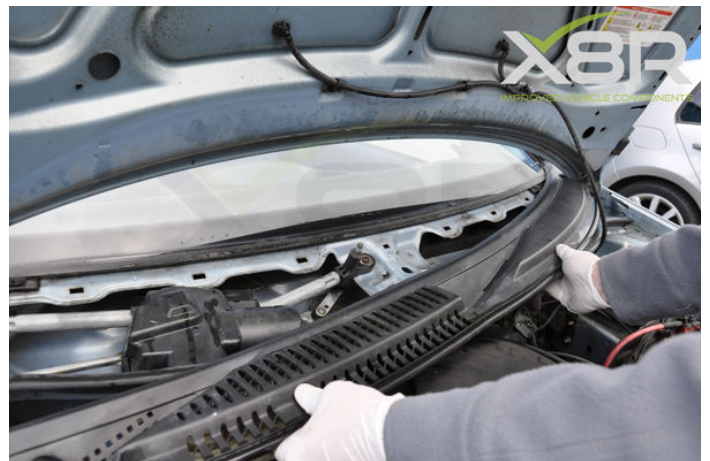
Step 5: Remove the scuttle panel

Unscrew 3x Philip screws.

Lift scuttle out of position, the scuttle will bend in the middle to allow you to remove.

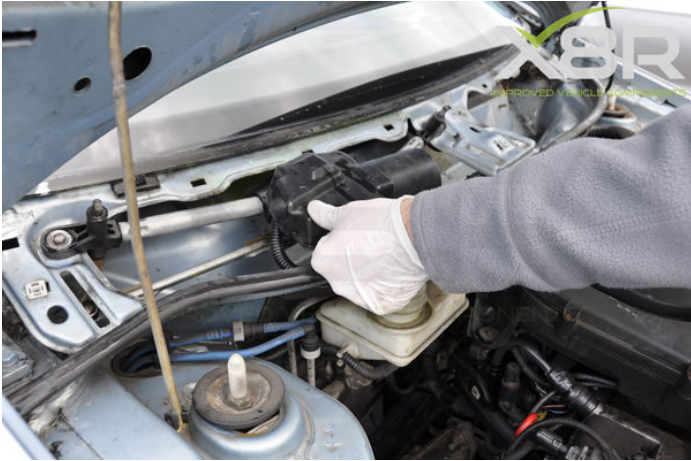
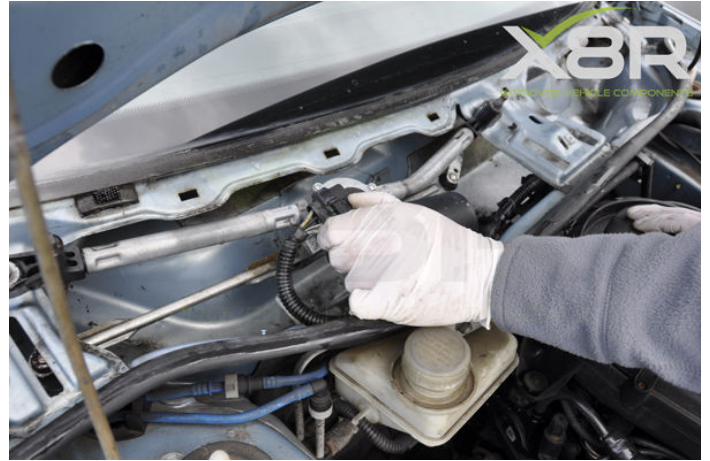
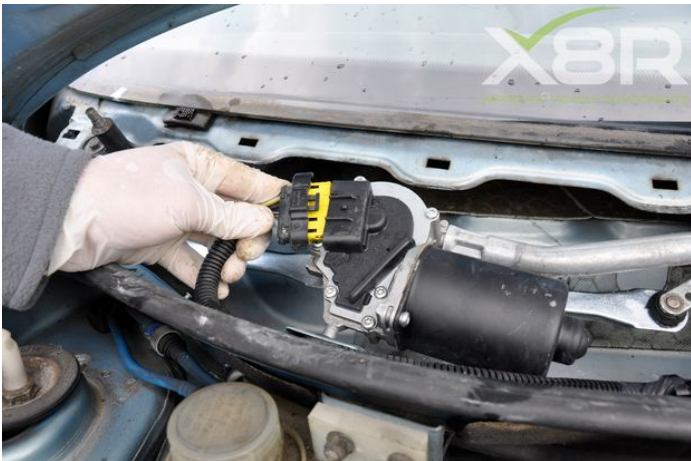
Step 6: Unplug the wiper motor

Remove the plastic cover from the wiper motor, this will simply lift off.

Unplug the electrical connector to the wiper motor; the tab on the plug should be lifted up and the plug pulled back. Tuck the wires / connector out of the way.

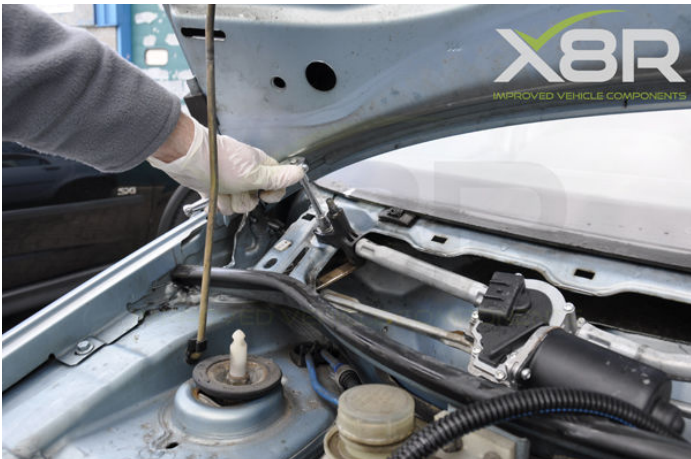
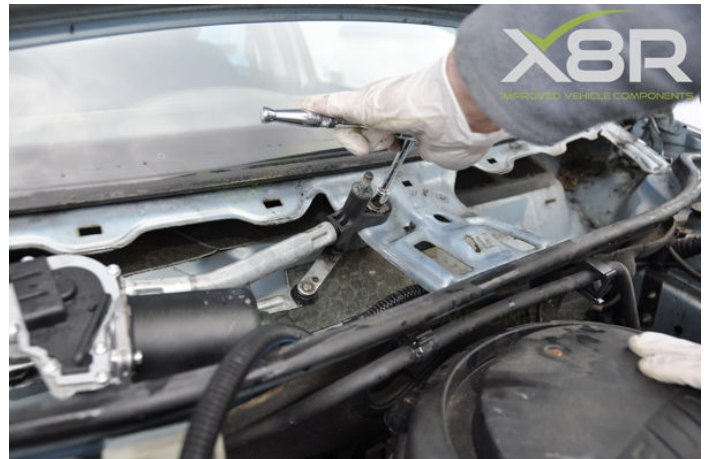
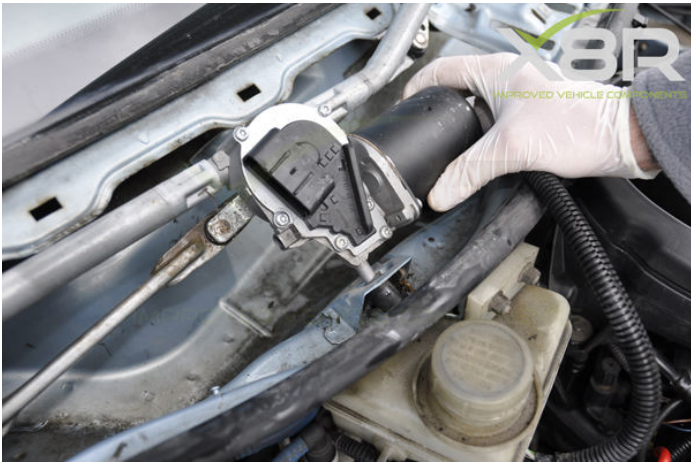
Step 7: Remove the wiper motor / linkage

Remove the 2x 10mm bolts holding the linkage mechanism in place.

Please note that the linkage mechanism has a tab at the front which slots in to the car through a small rubber fitting, the linkage needs to be angled up to allow the linkage to be removed from this fitting.

Remove the linkage mechanism from the vehicle.

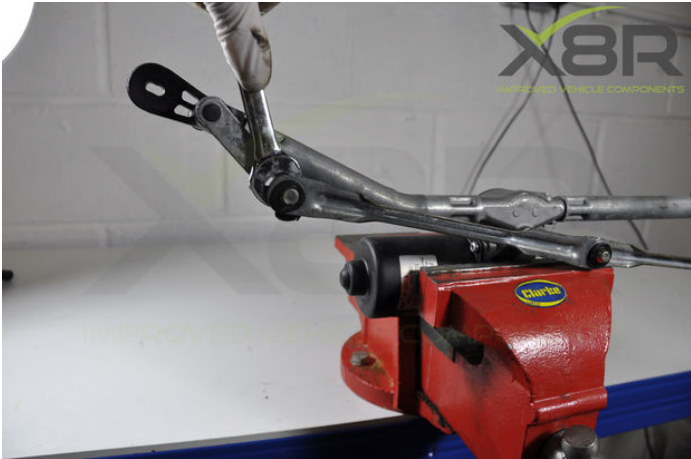
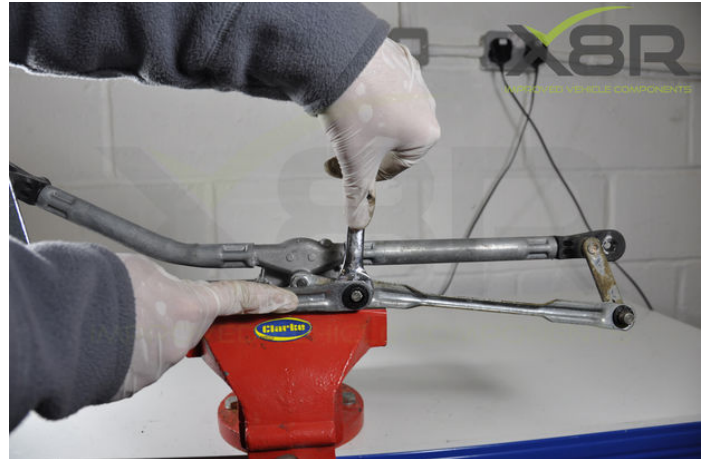
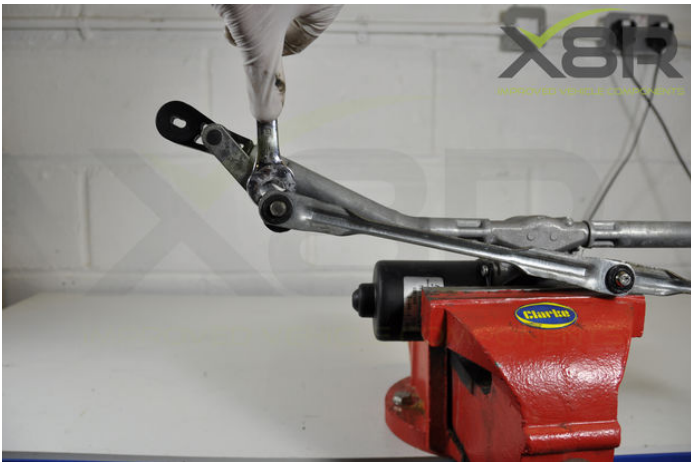
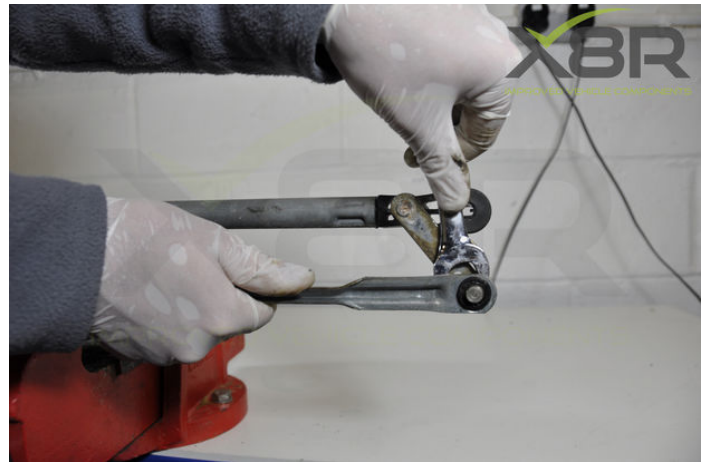
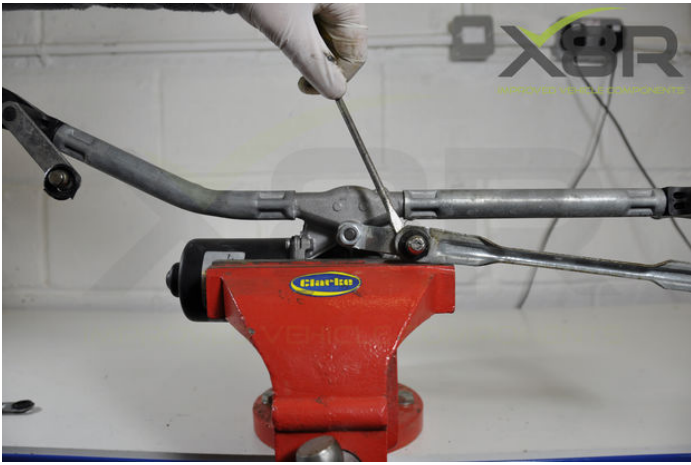
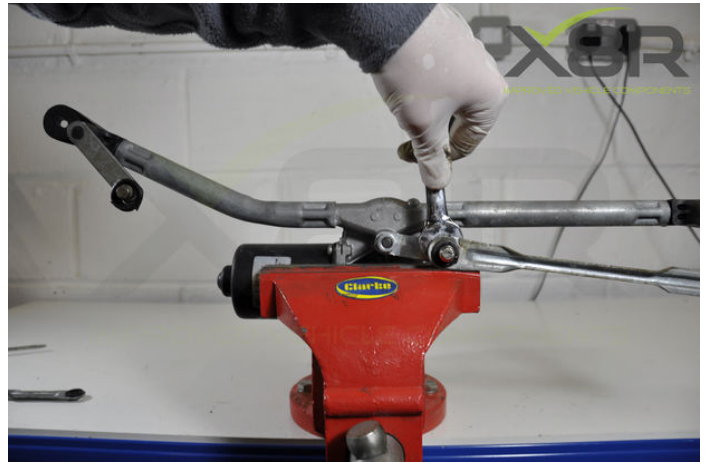
Step 8: Remove the old wiper rods

Position the wiper linkage mechanism in a vice as shown.

Using a 15mm spanner, slot the spanner behind the rod and lever the rod to pop the bush off of the ball joint.

Repeat this process for all 4 bushes; some of the bushes will likely be loose or will have already popped off of their ball joint.

When removing the top rod on the dual linkage this will likely push the bottom bush further on to the ball joint, use a flat bladed screw driver to free up the bush then remove with the spanner.

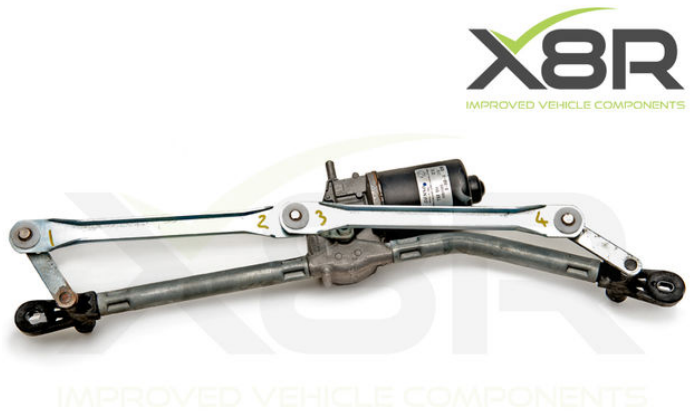
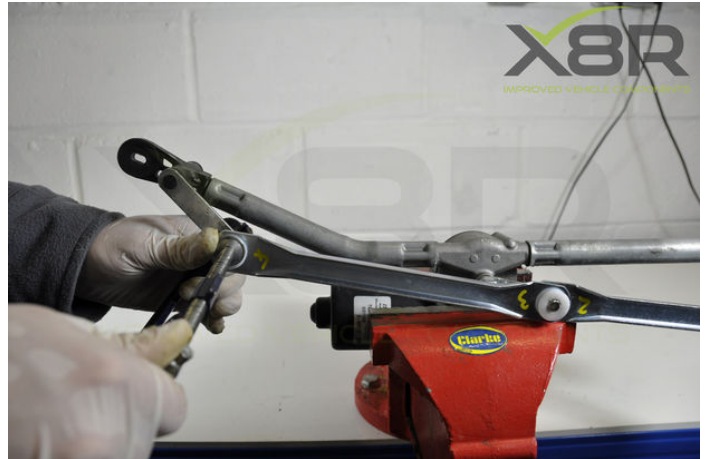
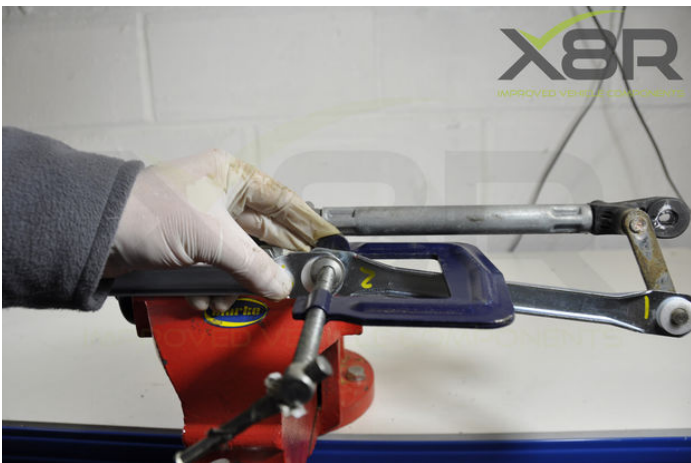
Step 9: Fit our new linkage push rods

Please note the image showing the correct orientation of the new push rods.

Please follow the below to attach the rods to the ball joints:

Position the bush at the end of our push rod over the ball joint, using a G clamp as shown wind the G clamp in; pressing the bush over the ball joint. You will hear a click sound once the bush is fully engaged and secured on the ball joint.

Repeat this process for all 4 bushes.
