Ford Mk4 Mondeo Galaxy S-max Broken Snapped Bonnet Release Cable Fix Inner Repair Kit Stainless Steel New Replacement Instructions Install Guide

by x8rltd

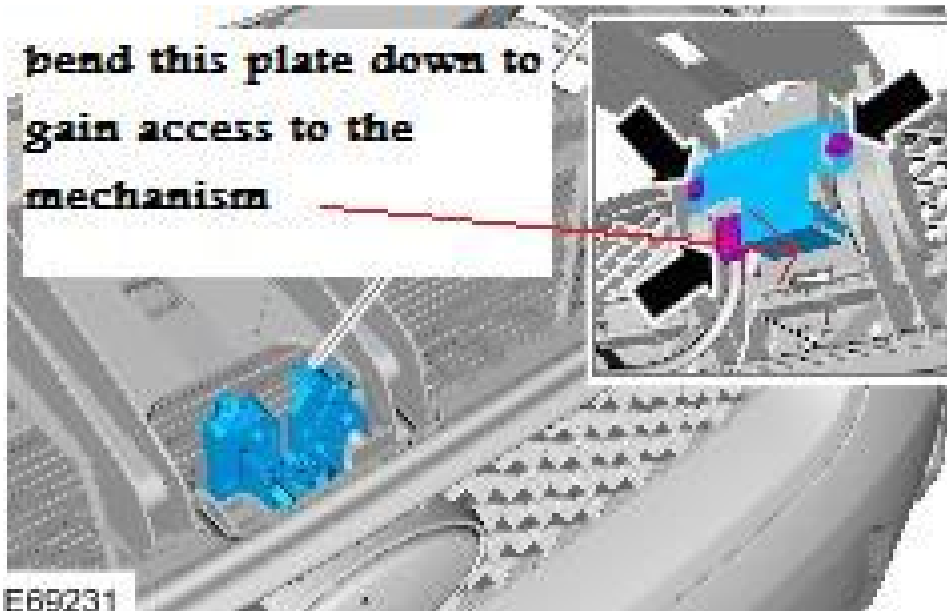
Step 1: Releasing Bonnet If Cable Has Snapped.

Unbolt and remove the front under-tray, some vehicles have two covers a large one covering the sump and a smaller cover over the lower part of radiator, in this instance both need to be removed.

Position yourself under the radiator and look upward, using a torch in front of the main radiator you will see the bonnet catch mechanism.

There is a metal plate covering the bottom of the mechanism. Bend this back with a screwdriver.

You can then access the release lever (shown in purple on illustration) push the release lever towards the passenger side to release the bonnet.

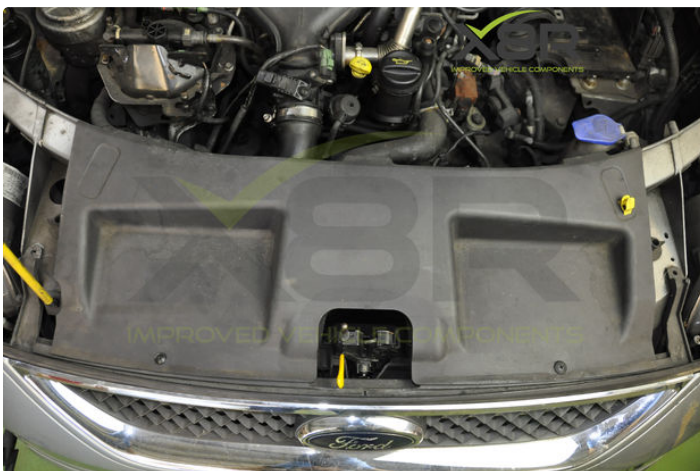
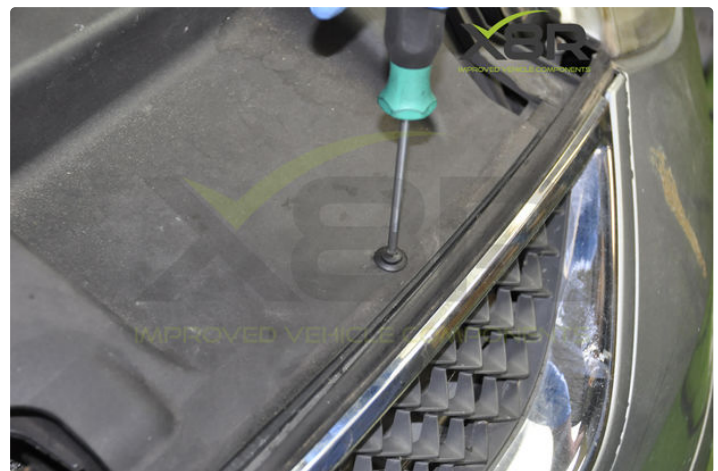
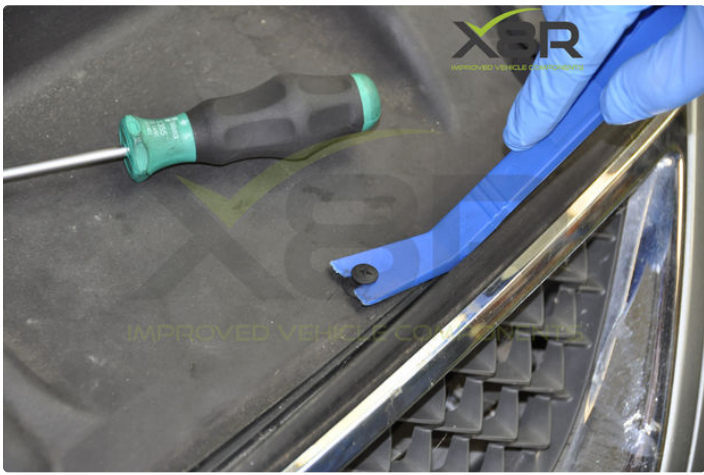
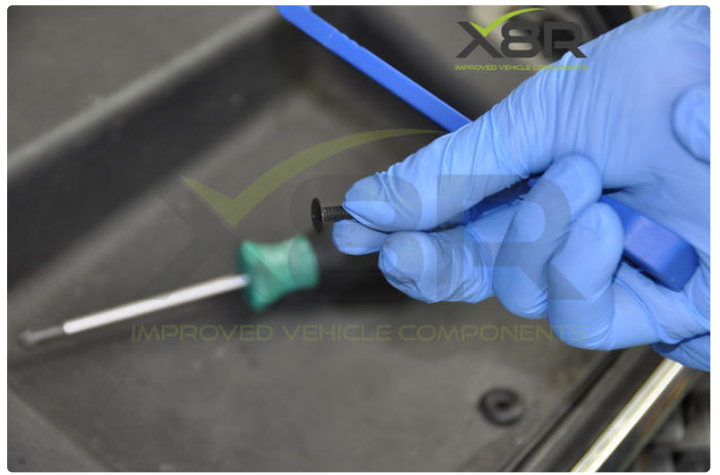
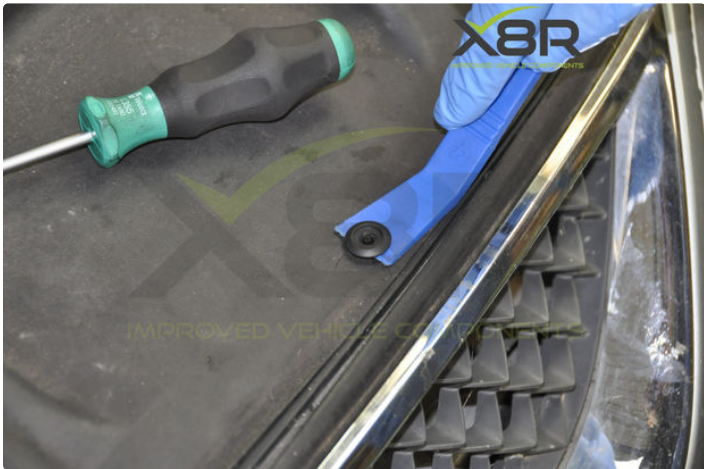
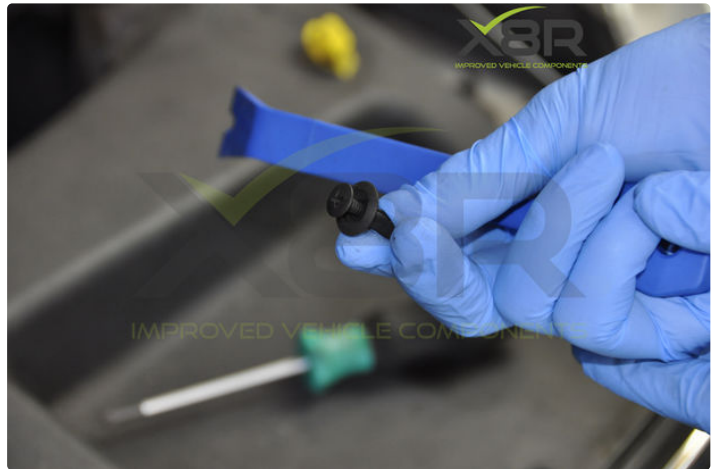
Step 2: Remove Plastic Trim

Locate the two grommets on the front of the trim.

Using a Philips screw driver release the top part of the grommet.

Slide a pry tool or flat bladed screwdriver under the top section of the grommet and lever out of position.

Slide the pry tool under the lower section of the grommet and lever out of position.

Locate top section in to lower section and retain for reinstall.

Repeat this for the second grommet.

Lift to release the 3 tabs at the back of the trim and lift trim out of position.

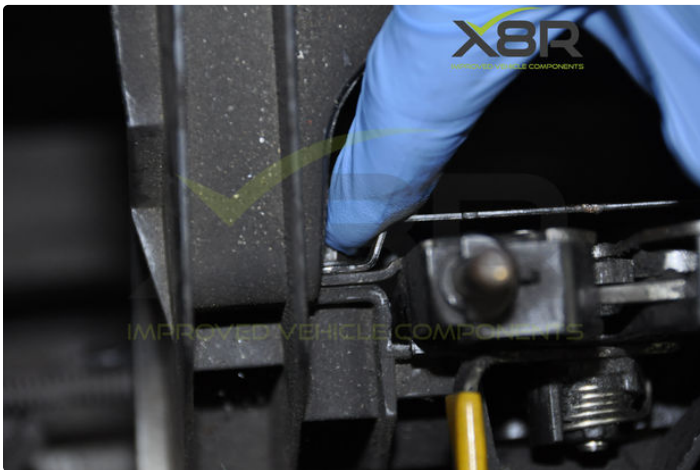
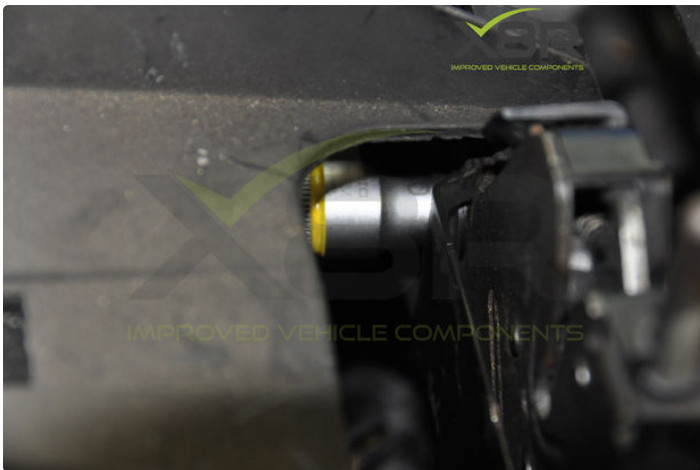
Step 3: Remove Latch Mechanism Bracket

Look down behind the latch mechanism and you will see a black bracket which holds the mechanism, this is retained by two bolts.

Using a 10mm socket remove the left hand bolt.

Locate the wiring clips and remove to allow access to the right hand bolt.

Remove right hand bolt.

Remove bracket, note orientation here, this is important for reinstall.

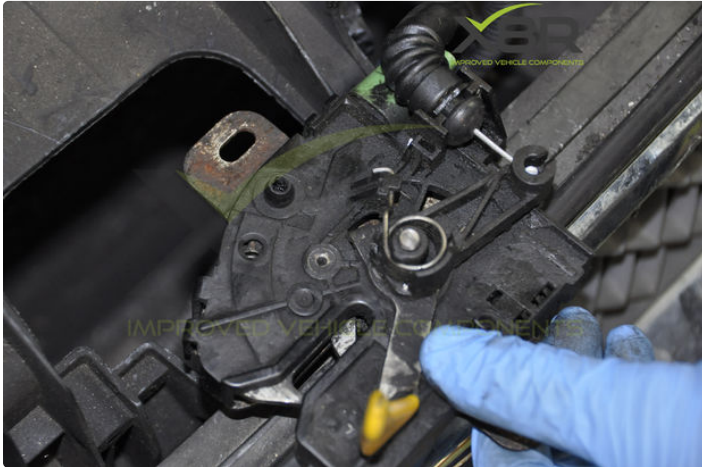
Step 4: Remove Latch

Move the latch out of position to reveal the end of the bonnet release cable.

Remove the stop end from the release lever and lift the cable end out of position.

If cable has already snapped pull on stop end to remove metal cable from the cable sheath.

If cable hasn't snapped cut cable with wire cutters.

Retain the black rubber part shown, note orientation this needs to be slide on to the new cable later on.

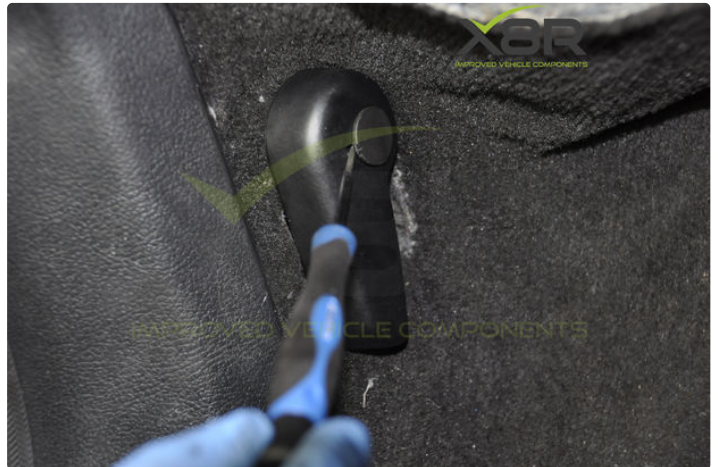
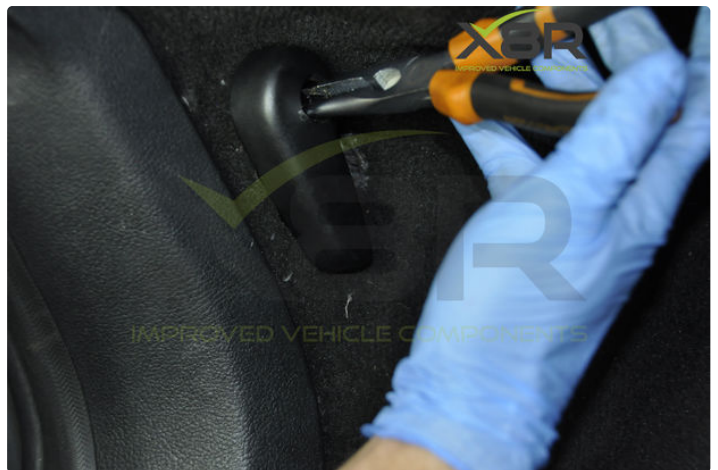
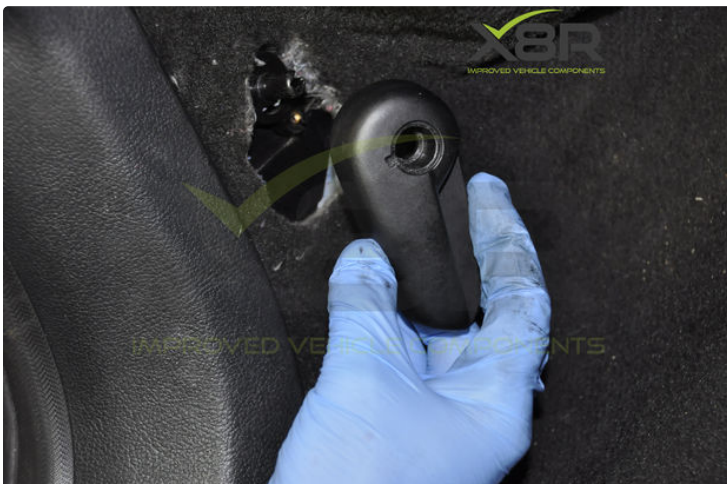
Step 5: Remove Release Lever

Pry off plastic grommet, locate square section of grommet and lever out using a small flat bladed screwdriver.

Using long nose pliers compress the two tabs within the lever to release the lever, pull lever away.

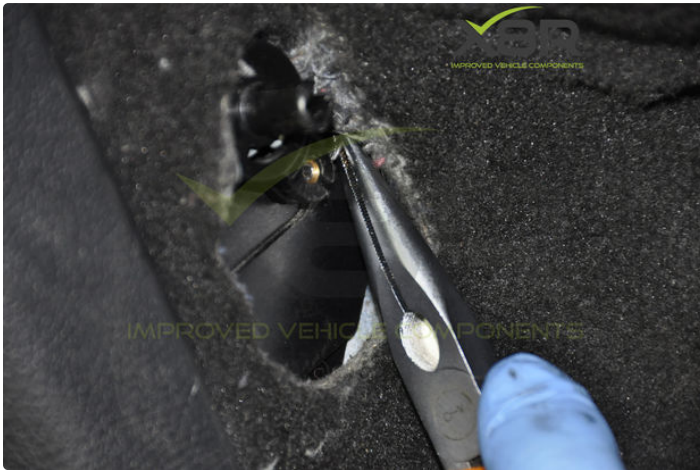
Step 6: Remove Cable

Remove stop end from lever mechanism this will twist and lift out.

Pull through and remove remnants of old cable.

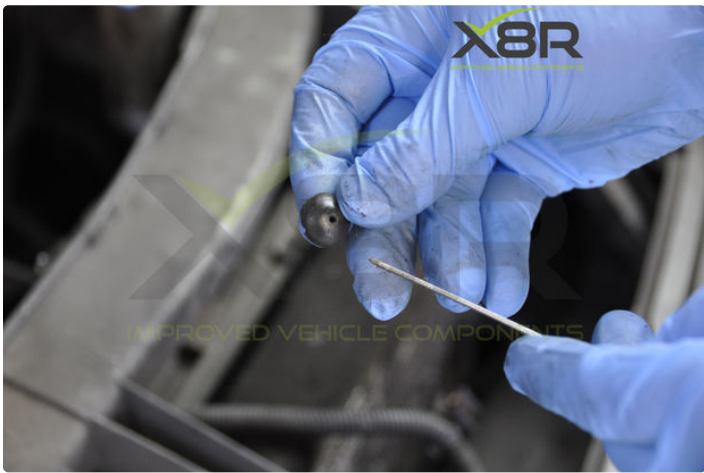
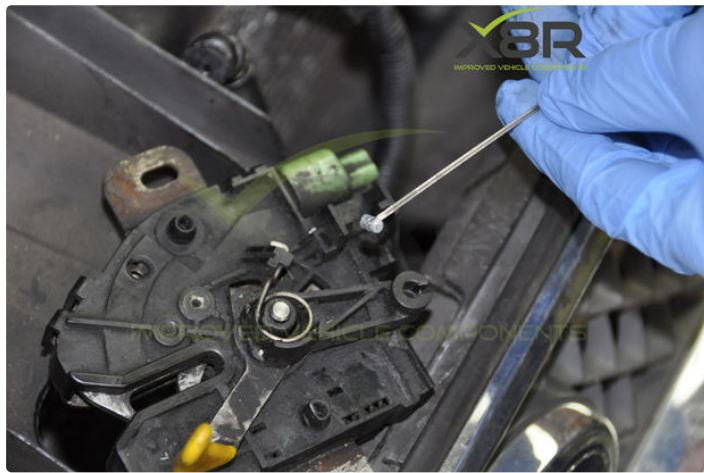
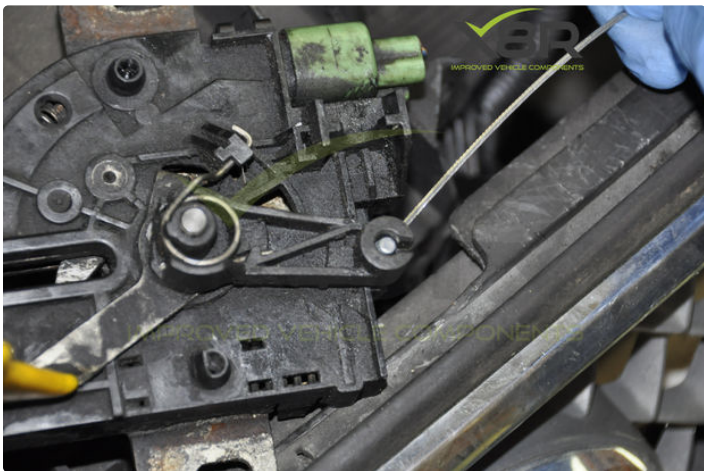
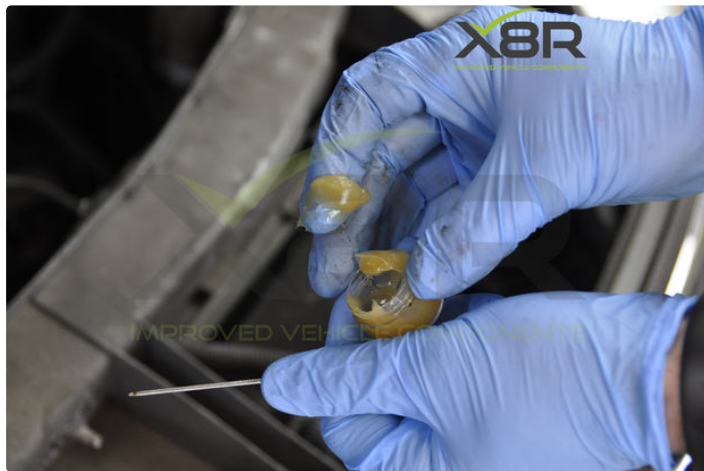
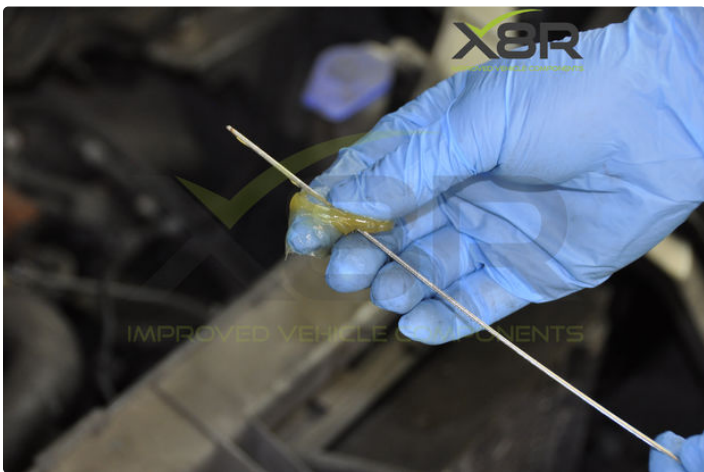
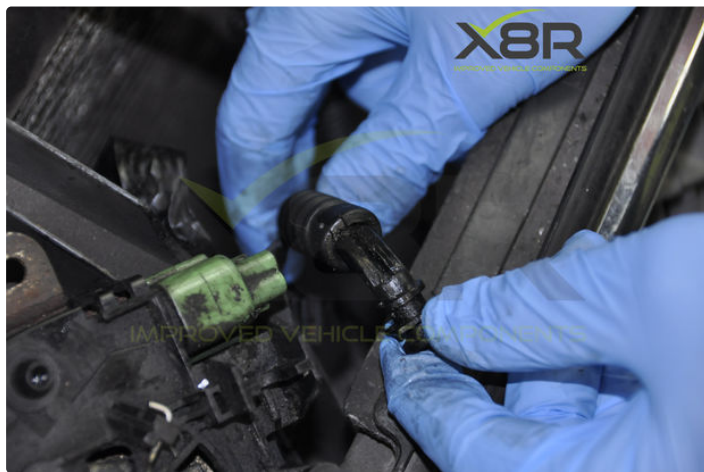
Step 7: Fit New Cable From Latch End

Take our new cable and fit the rubber grommet as orientated, push this down cable to stop end.

Install stop end in to release lever, push in and twist to locate.

Take the grease and lubricate the complete length of the cable.

Pull back the flexi black rubber sheath on the sharp

bend at the start of the cable outer.

Push the cable through the hole (before the sharp bend) and pull through full length of cable.

Push the cable through the hole after the sharp bend. Feed the cable through from a high position as shown to push the cable through the plastic outer in to the vehicles cabin.

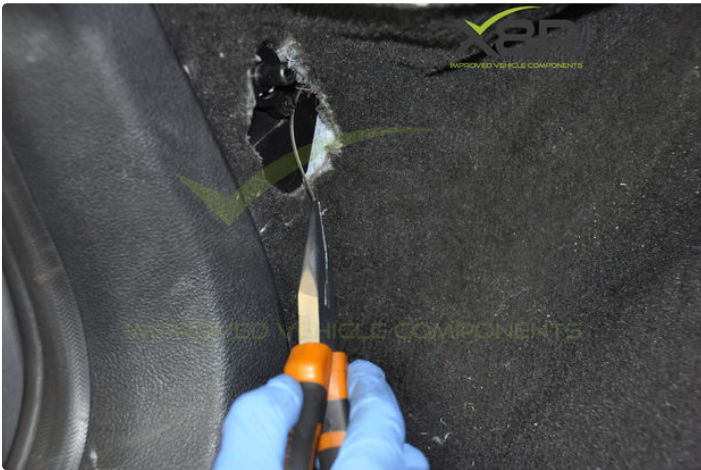
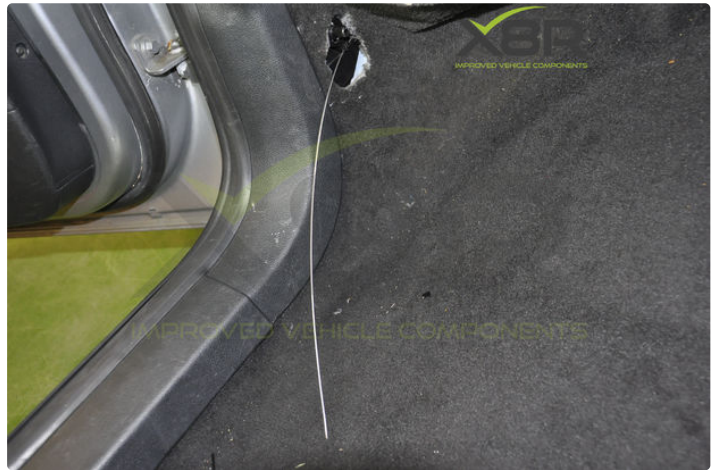
Step 8: Pull Cable Through From Interior

Using long nose pliers pull the cable through.

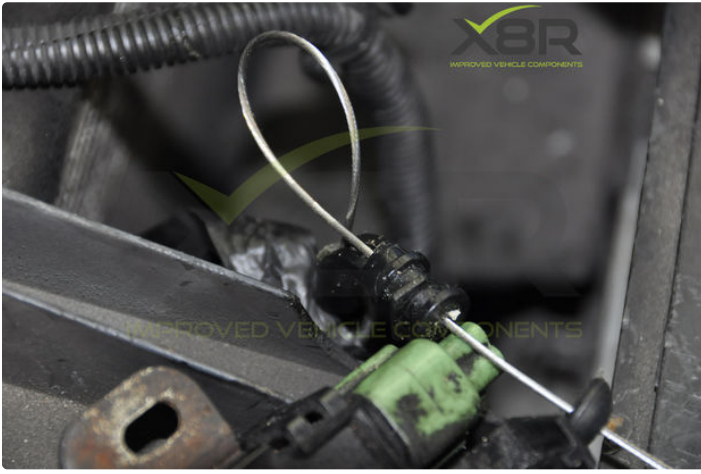
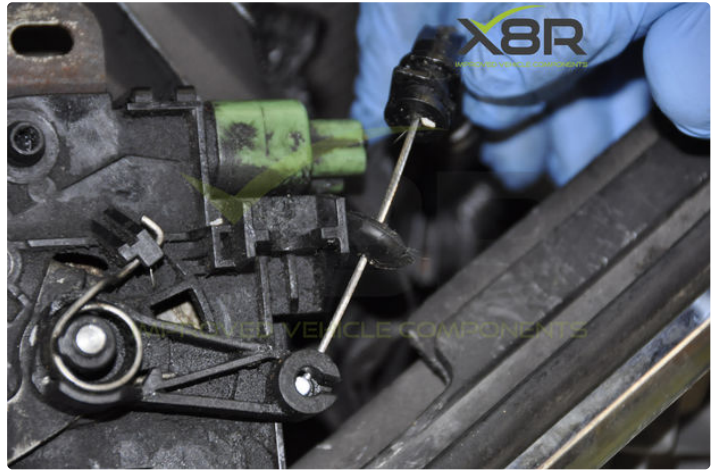
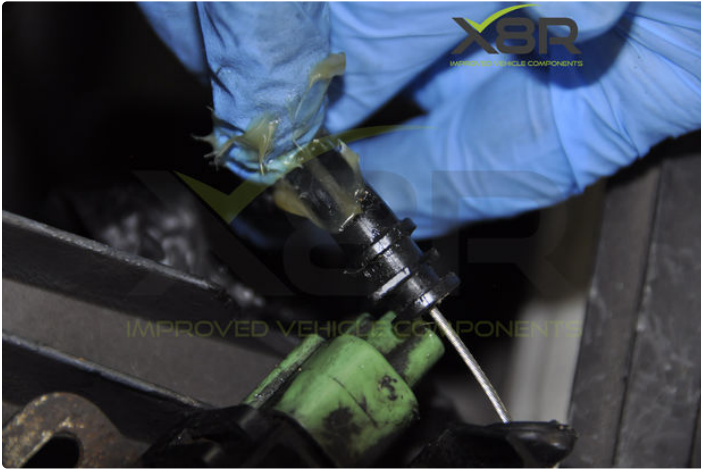
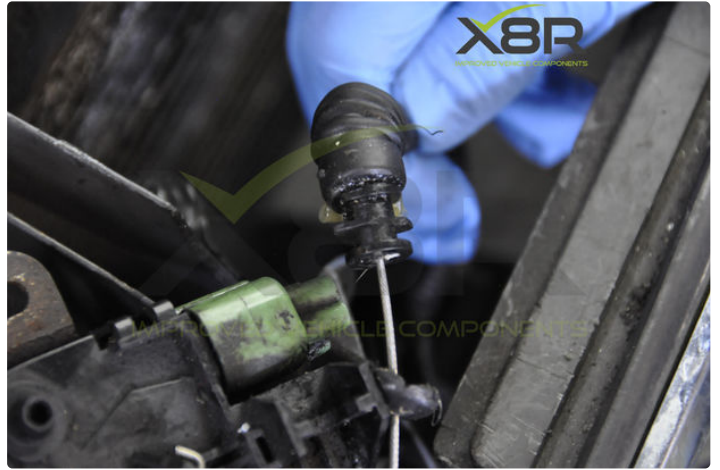
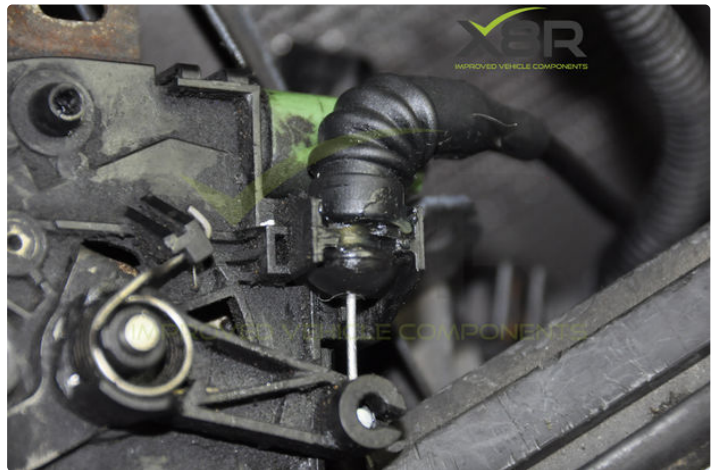
Step 9: Refit Cable End to Latch

Push through the remaining length of the cable.

Lubricate the sharp bend with the grease.

Push flexi rubber sheath over sharp bend and back in to position.

Push rubber end grommet back in to position.

Refit cable end to latch mechanism.

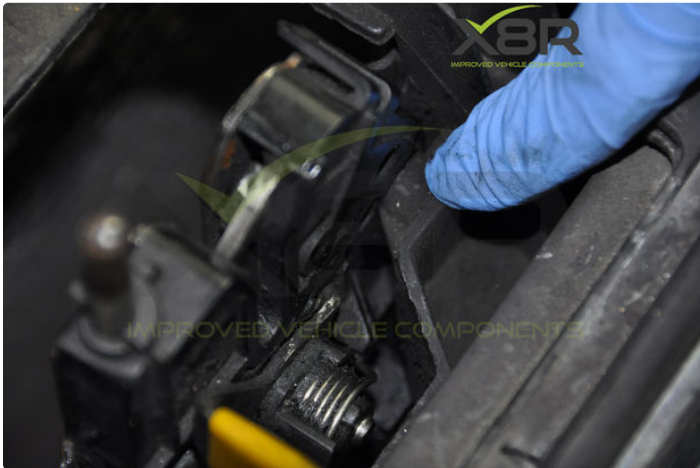
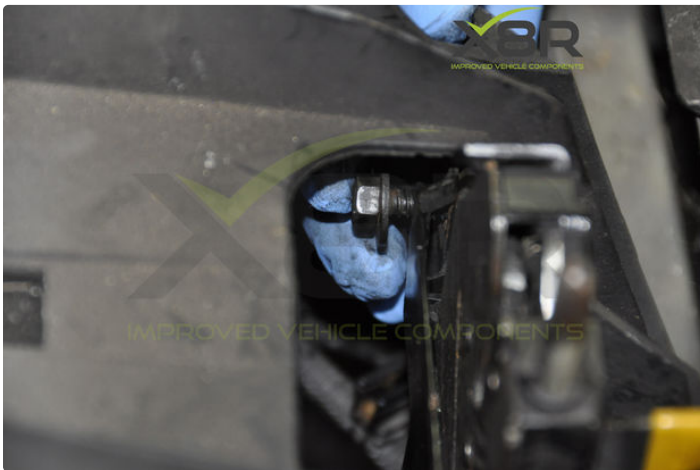
Step 10: Refit Latch Mechanism.

Refit latch mechanism.

Push back in to position, the latch has a stud that will locate on the front of the mechanism so it will hold in position before bracket is fitted.

Refit the bracket as orientated and fasten the two bolts.

Refit the electric wire clips to secure.

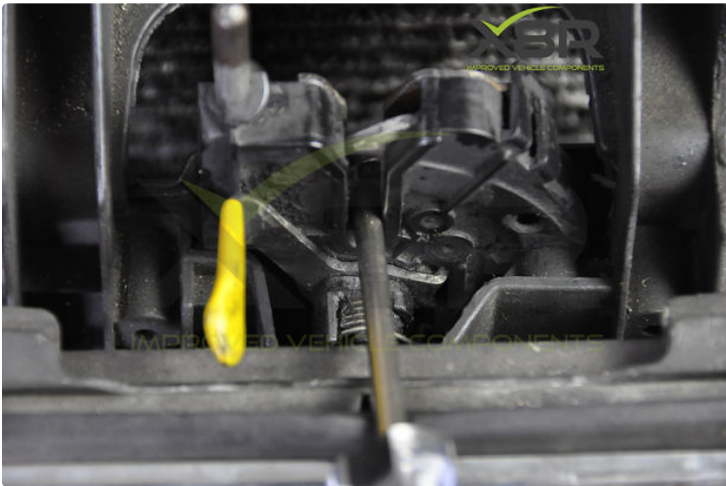
Step 11: Lock Latch

Insert screw driver in to latch to simulate locked bonnet. Push past first latch and down on second latch. Screwdriver should stay locked in position and should not be able to be pulled upwards.

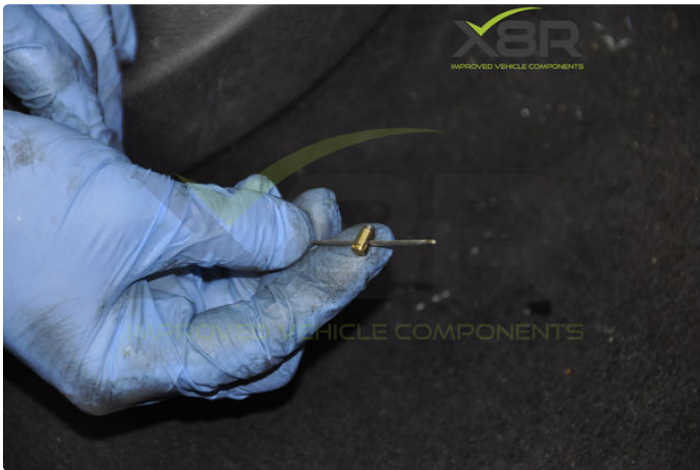
Step 12: Fit Stop End

Push our stop end on to the end of the cable.

Slide up the cable length.

Pull on the cable length not so as to release the bonnet but just so it is taut.

Locate the stop end in to its locator on the release lever and fasten the grub screw not fully tight but so as it wont slide.

Once cut there will be some cable that protrudes from the stop end. Release the grub screw lightly and slide the stop end a tiny amount so that there is no cable protruding from the stop end.

Fully tighten the grub screw. Using the pliers grasp the stop end and fully tighten the grub screw as tight as possible.

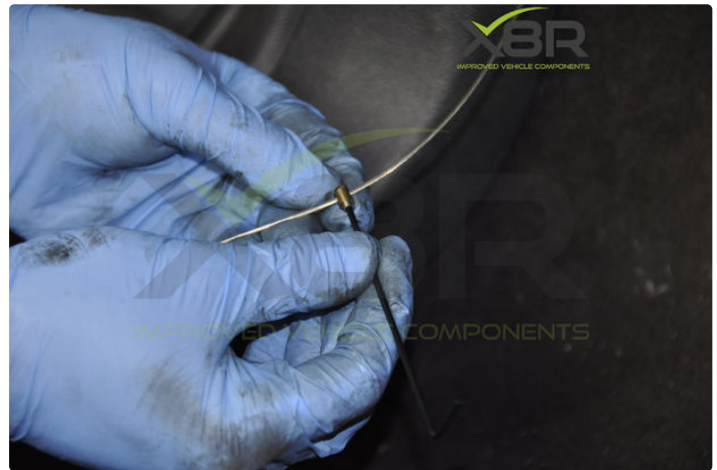
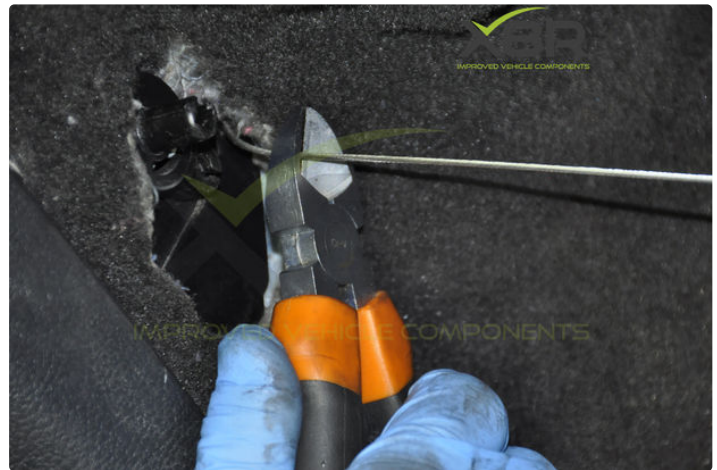
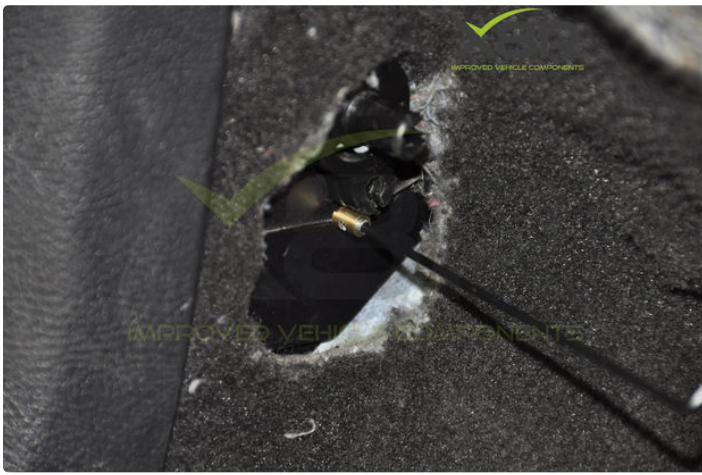
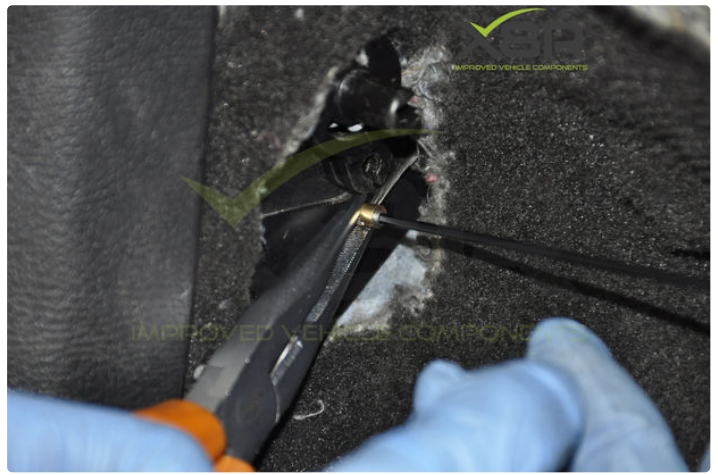
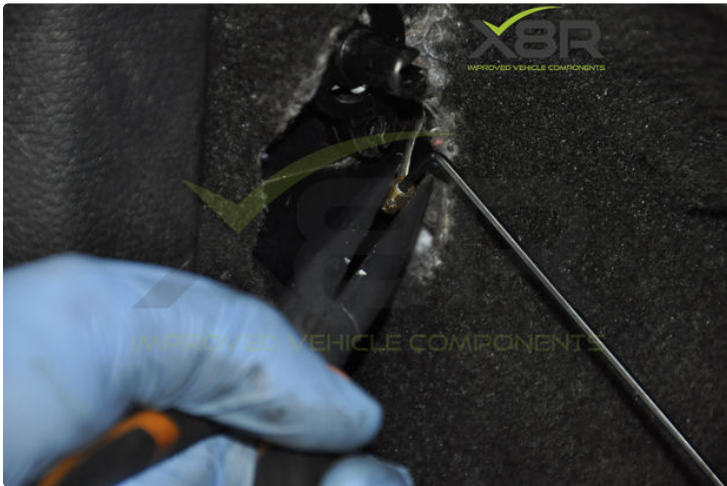
Using wire cutters cut the wire as close as possible to

the cable end.

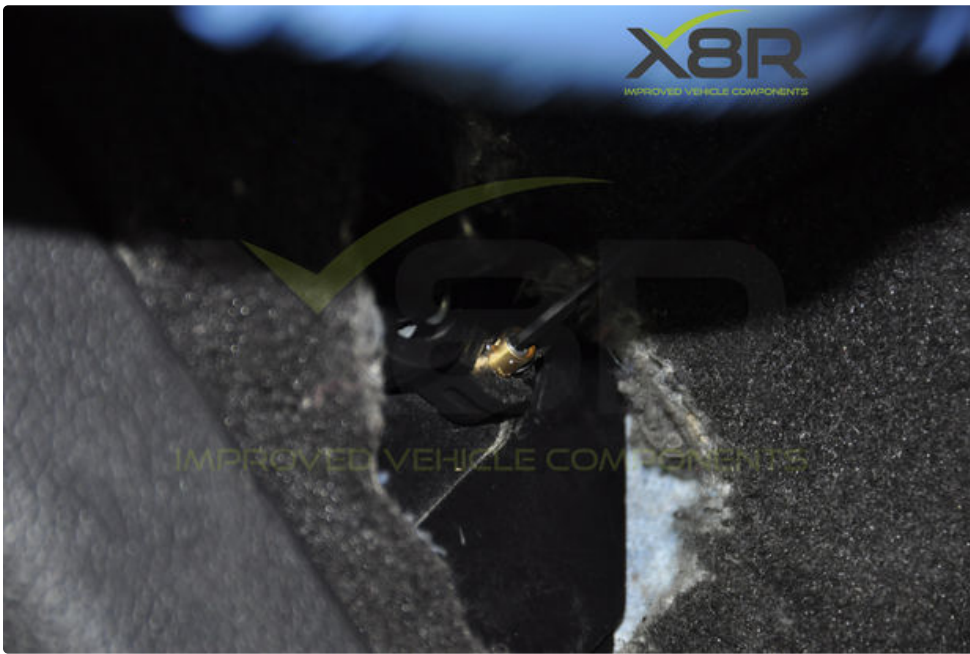
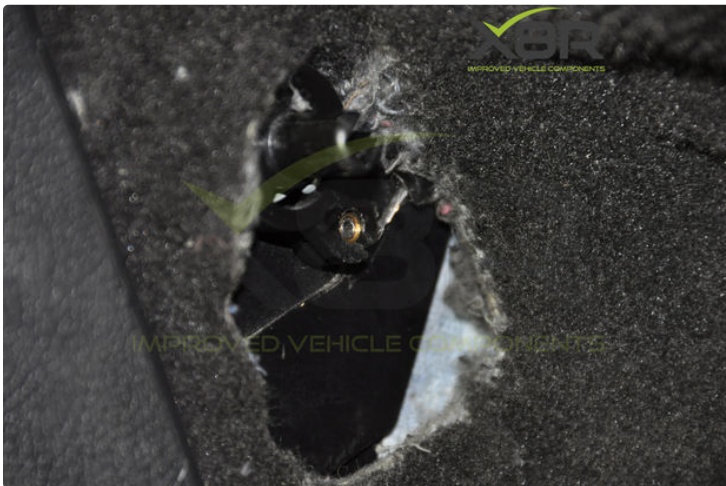
Step 13: Fit Stop End to Release Lever Mechanism

Push the stop end in to the recess on the lever mechanism.

Push in with the Allen key in the grub screw and pull the cable in to position using the long nose pliers.

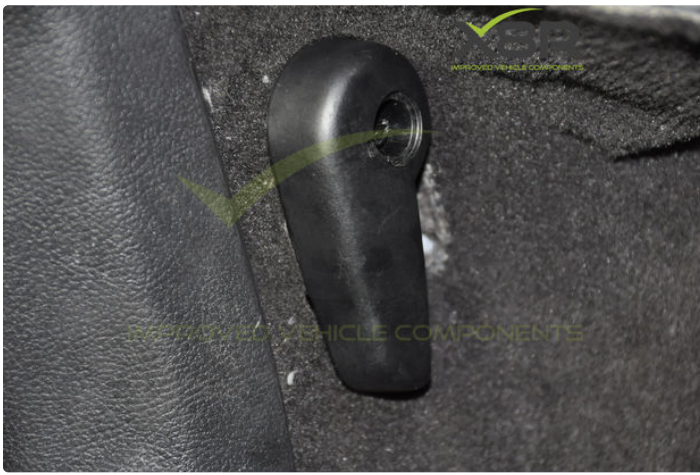
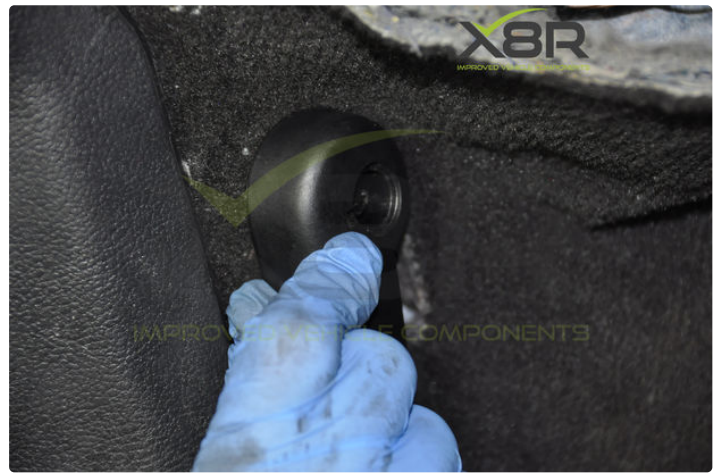
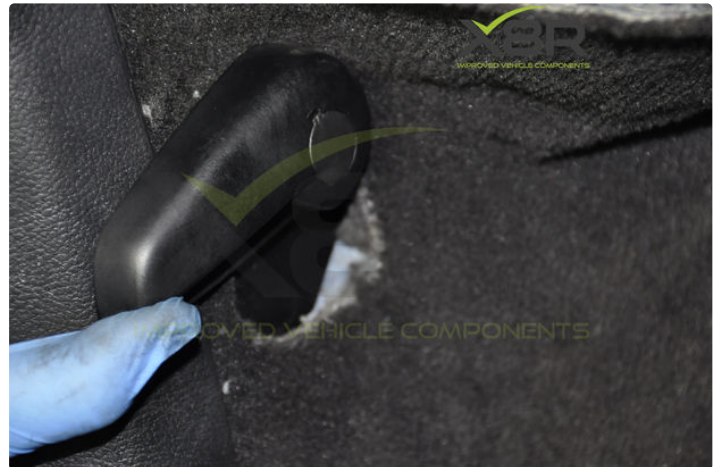
Step 14: Refit Release Lever

Push the release lever on to the release mechanism.

Refit the plastic grommet locating the square section in to the square recess.

Pull on the lever to release the bonnet latch and the screwdriver!

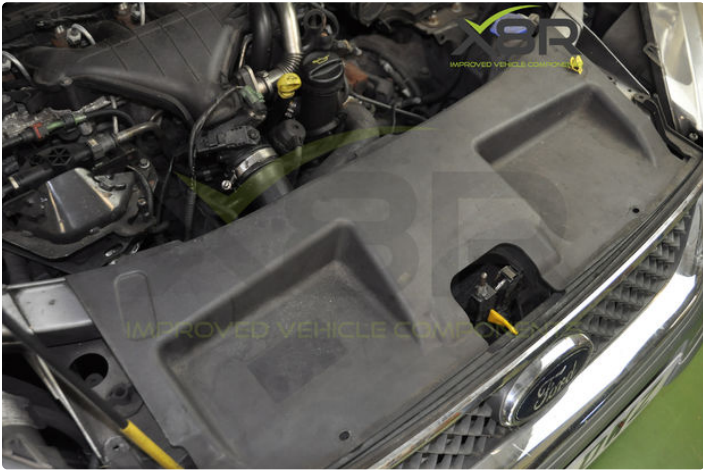
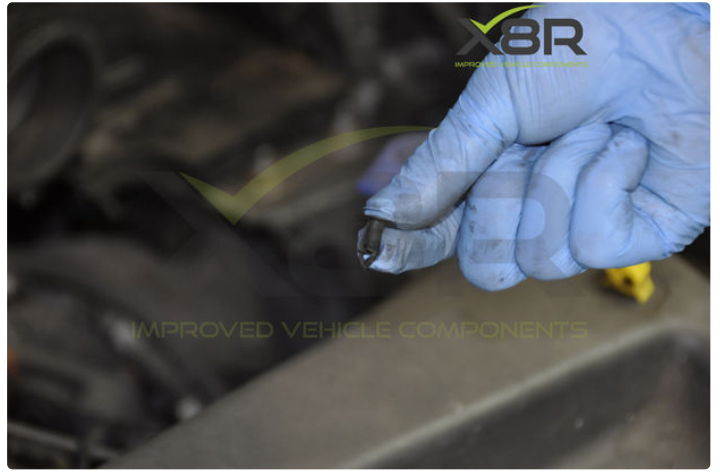
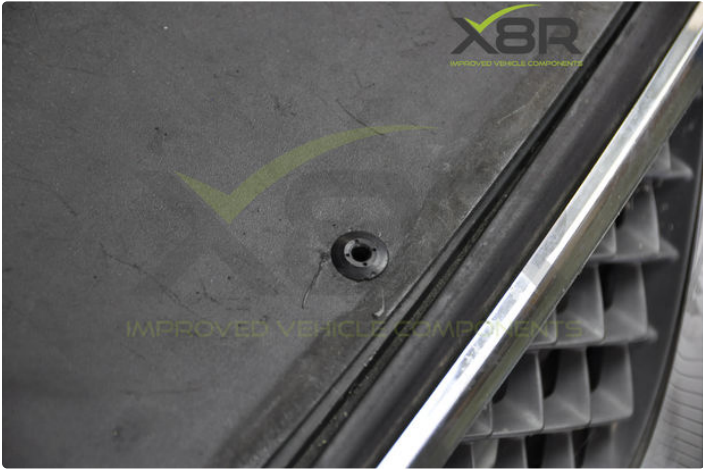
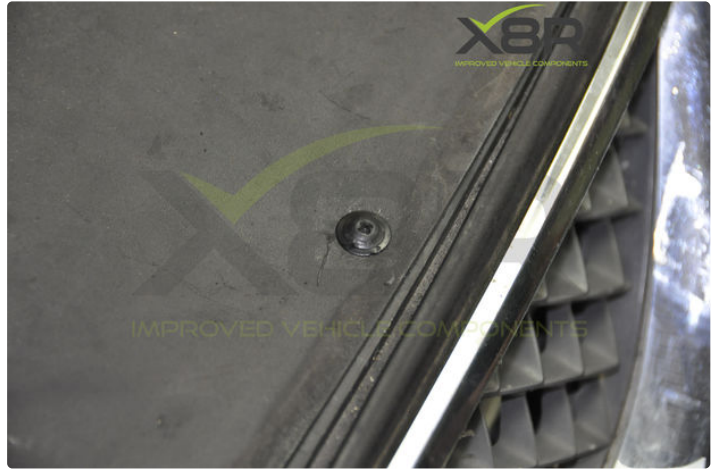
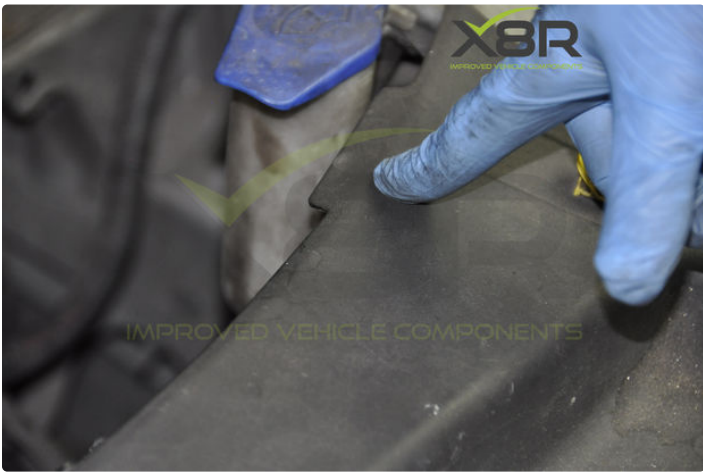
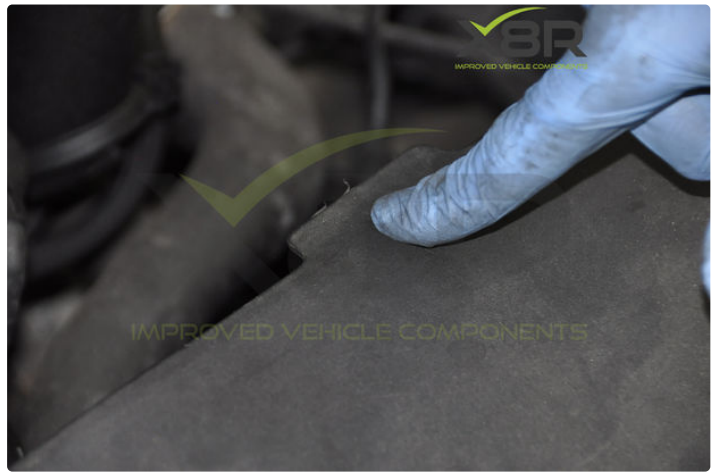
Step 15: Refit Plastic Trim

Refit plastic trim.

Refit 2x grommets remembering the two sections.

Push down on the three top tabs to secure.
