Mercedes Benz W639 Vito Viano Gear Selector Shift Stick Lever Bush Repair Fix Kit Manual Install Instructions Guide

by x8rltd

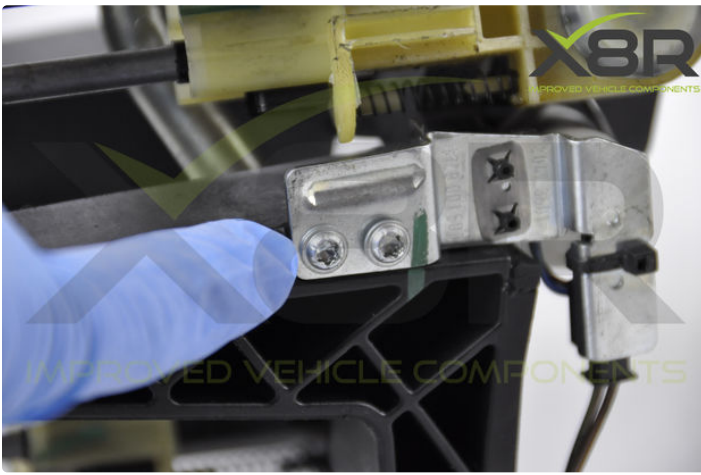
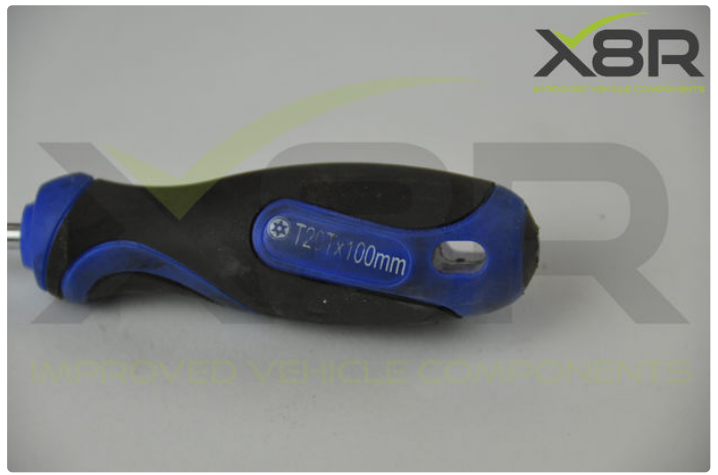
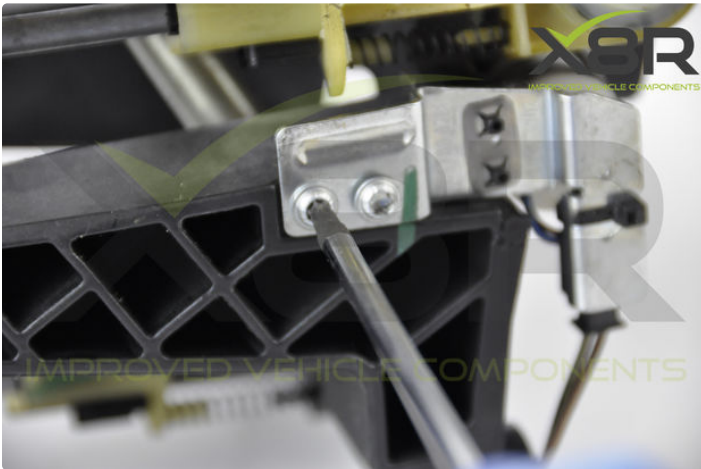
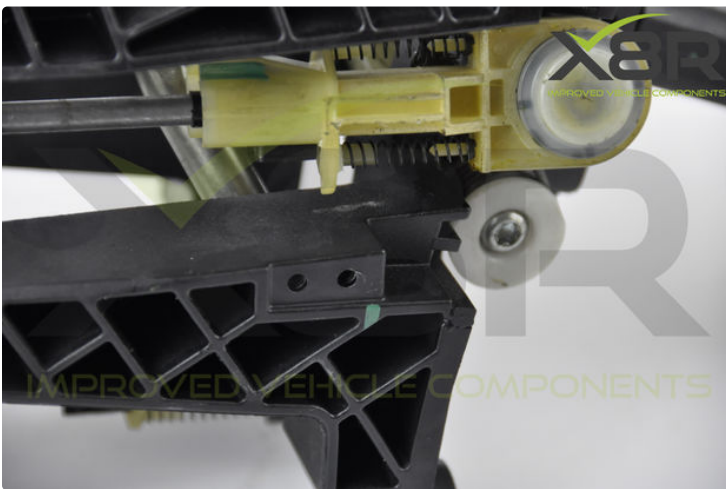
Step 1: Remove Electrical Connector

Remove the electrical connector. This is held in place by two T20 Torx screws. This needs to be removed to access other parts later on.

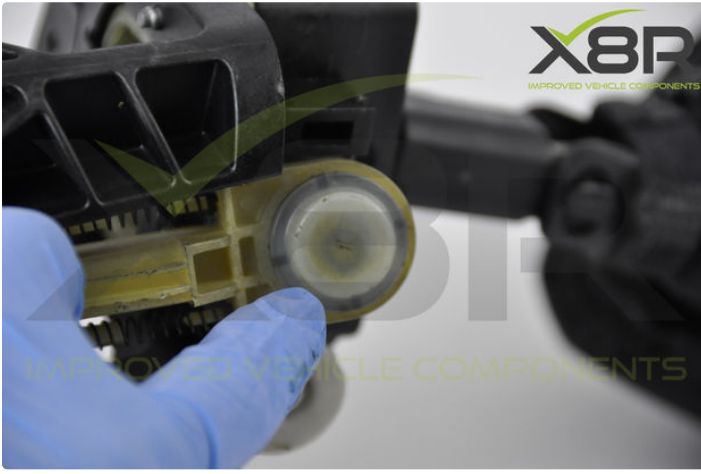
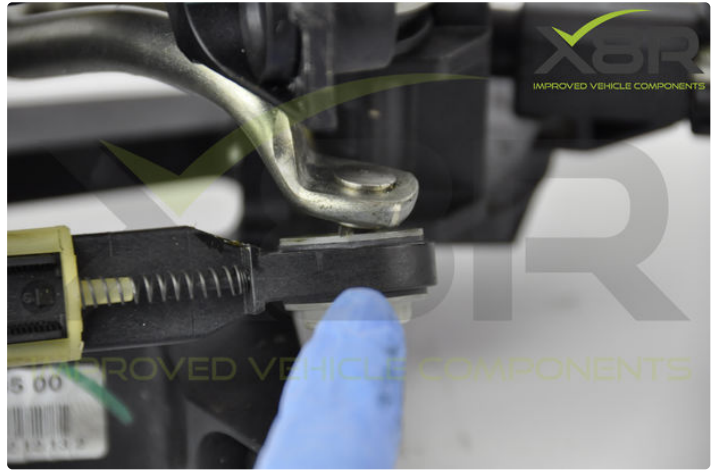
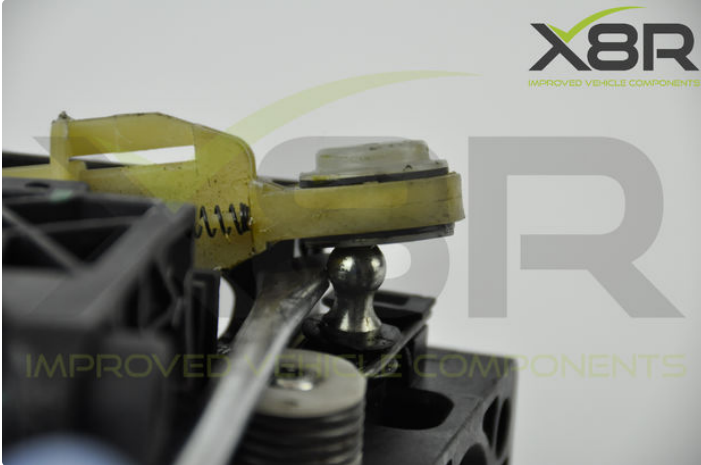
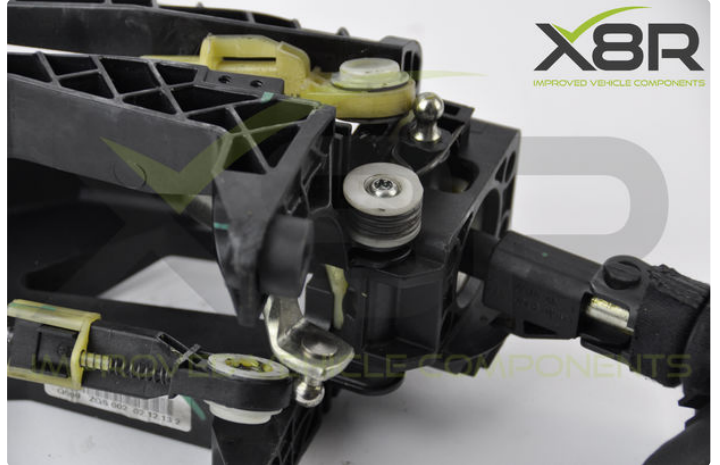
Step 2: Remove Gear Shift Cables

Remove the gear shift cables from their ball sockets.

Use a large flat head screwdriver or suitable size spanner to gently ease the head of the cable upwards and away from the ball socket.

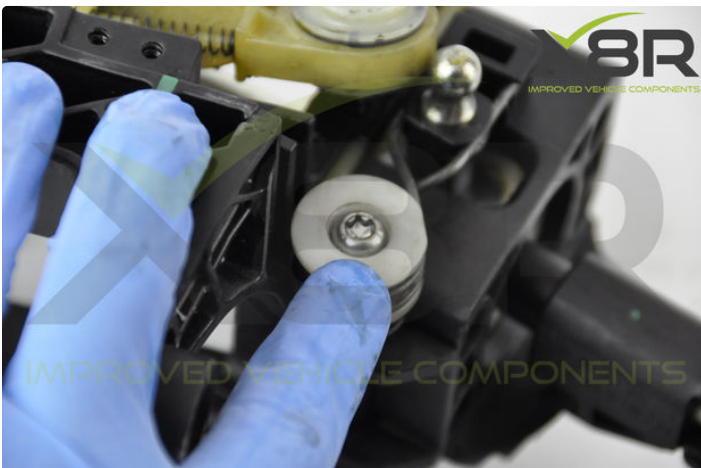
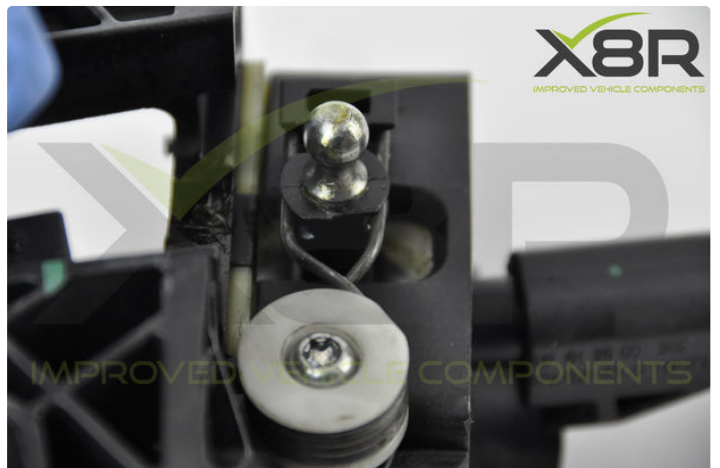
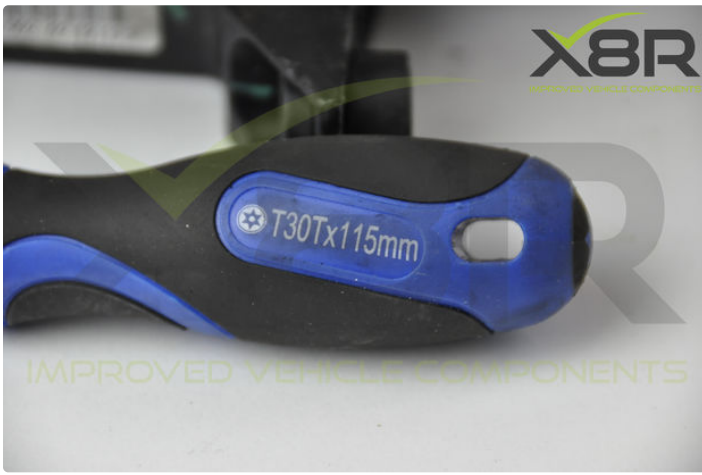
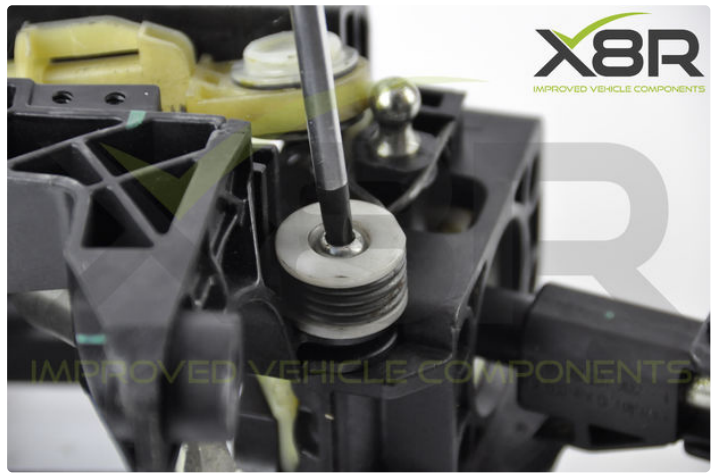
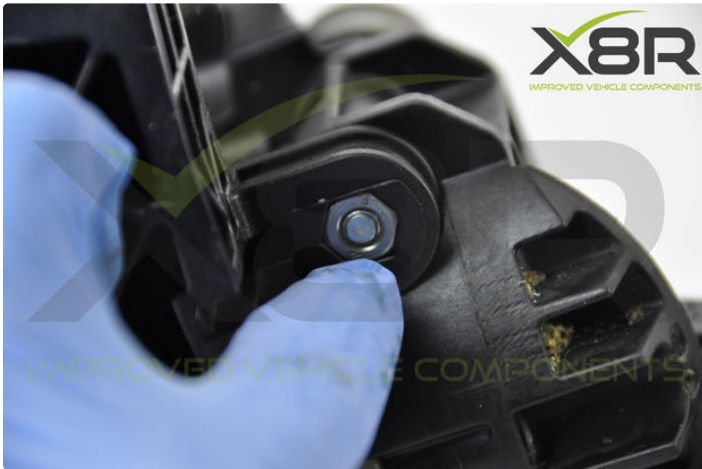
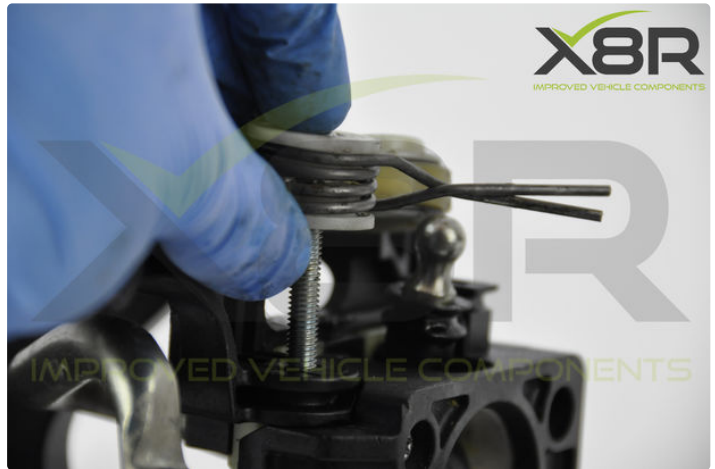
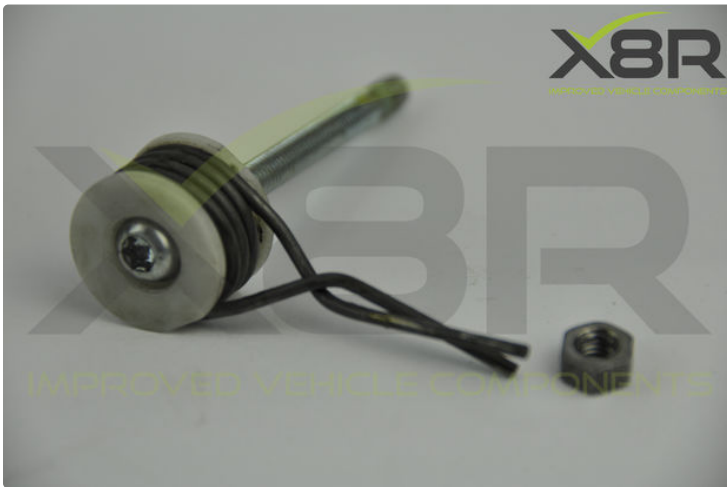
Step 3: Remove Spring Loaded Retaining Clamp

Remove the screw using a T30 Torx. There is a nut at the other end of the screw which is located in a hole the size of the nut. When you undo the screw take care to locate and keep the nut safe.

When the screw is loosened, the spring clamp loses tension and the prongs can be pried out of position. Remove this item completely from the assembly.

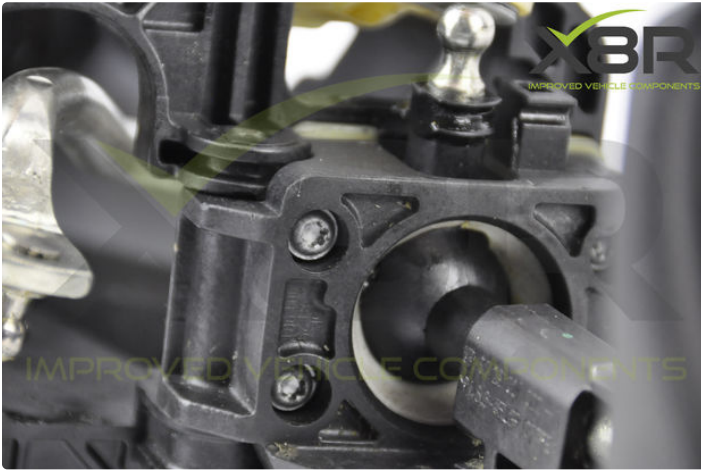
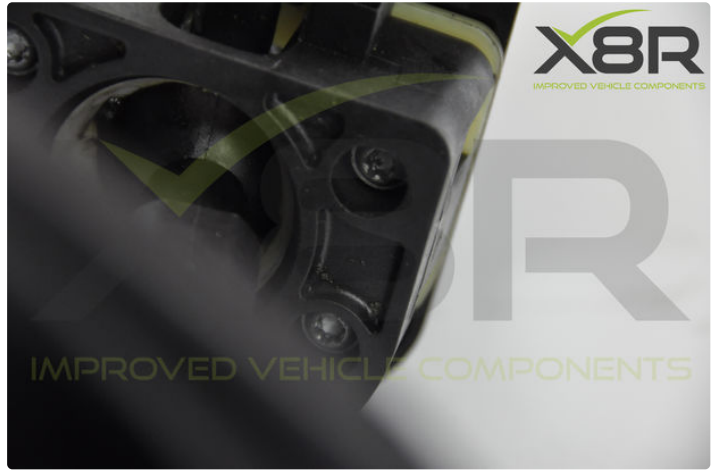
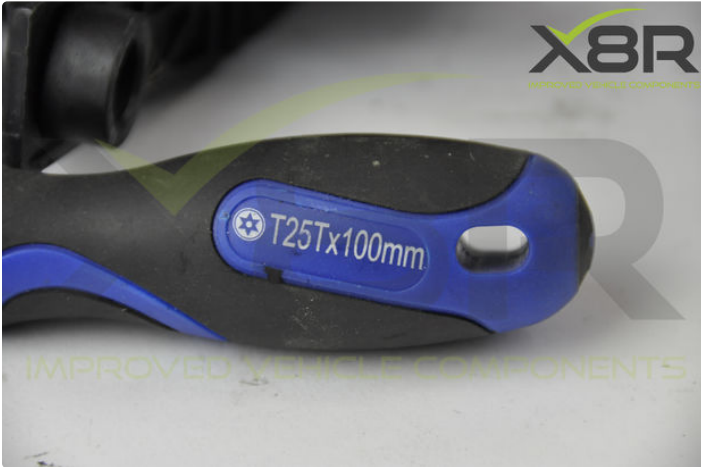
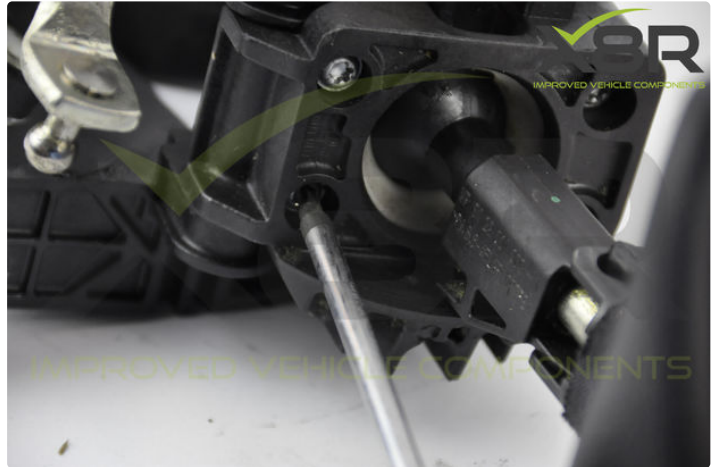
Step 4: Remove the 5 Screws

Remove the five T25 Torx screws holding the upper gear stick assembly to the lower section.

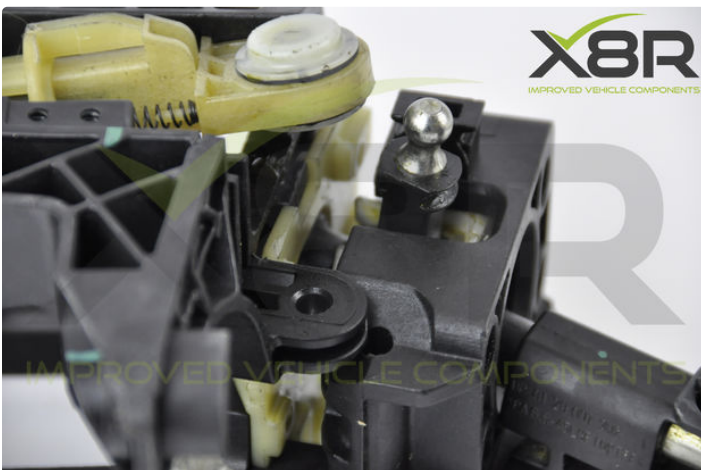
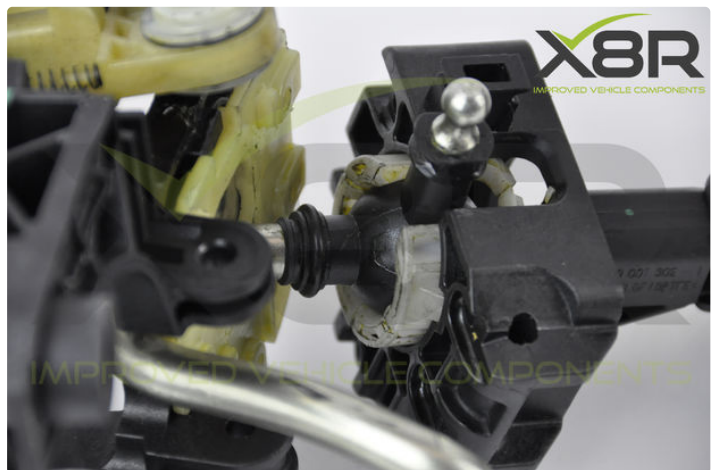
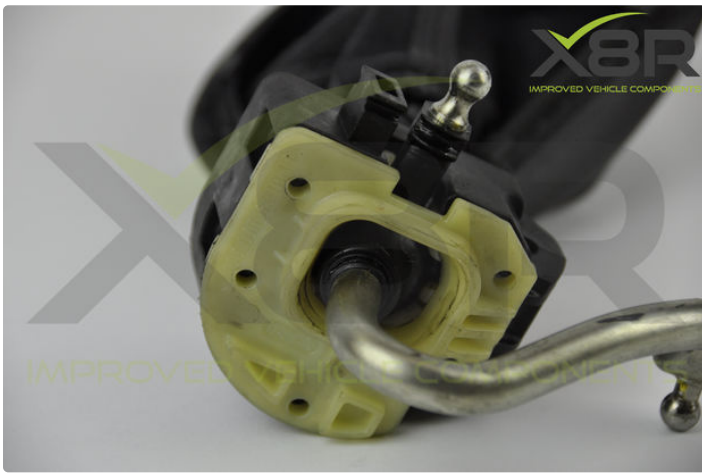
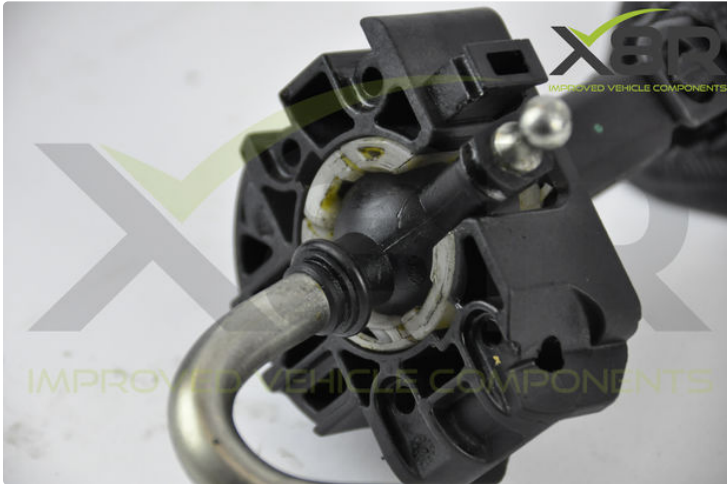
Step 5: Remove Upper Assembly

The whole upper assembly can be pulled gently upwards.

Remove the base plate (yellow-ish colour), which should just come away easily, slide it along the metal shaft and off of the end over the ball socket. This will expose the location of the gear bush that we need to change.

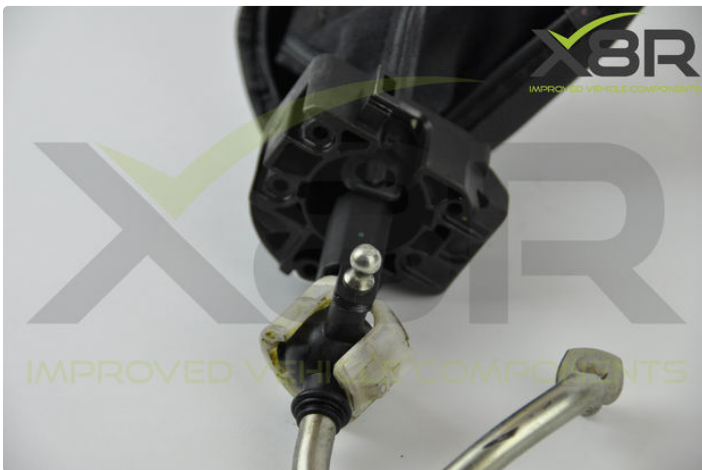
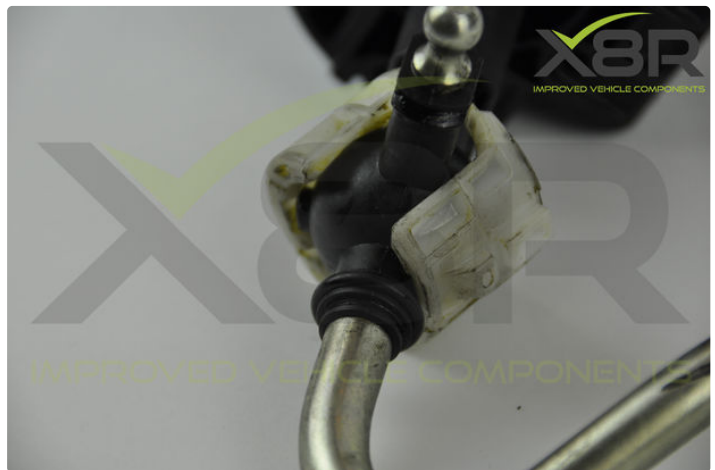
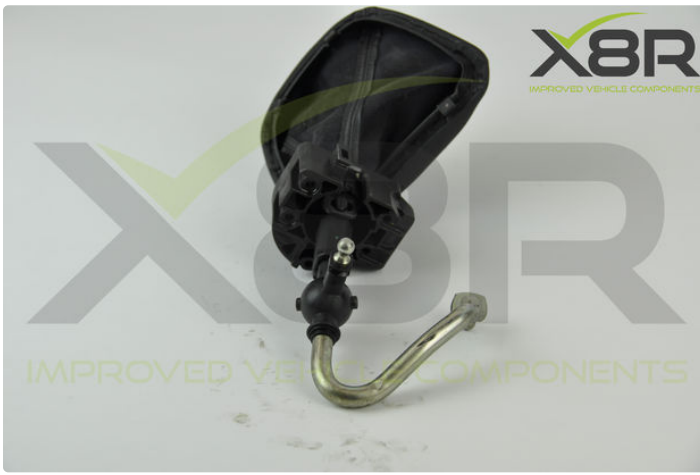
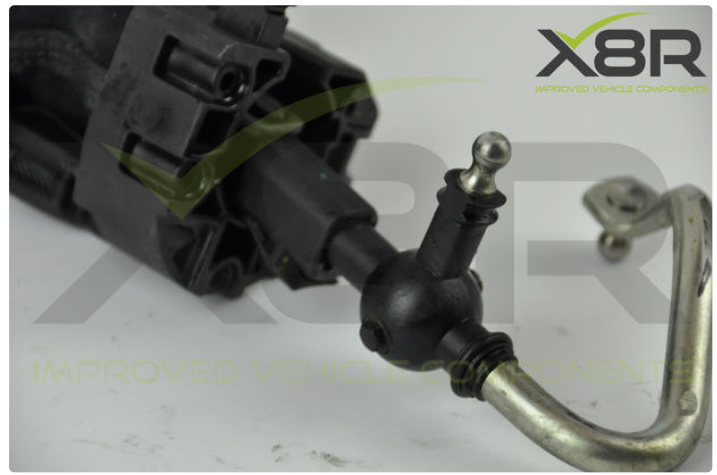
Step 6: Remove Old Bush

The bush is located in the Black housing. Slide this Black housing upwards to expose the gear bush.

Quite often the gear bush will be broken and could well just fall away, but as shown here, it could just be worn. In this instance cut away the thin section of the bush above the groove for the ball joint, this will allow you to snap out of position.

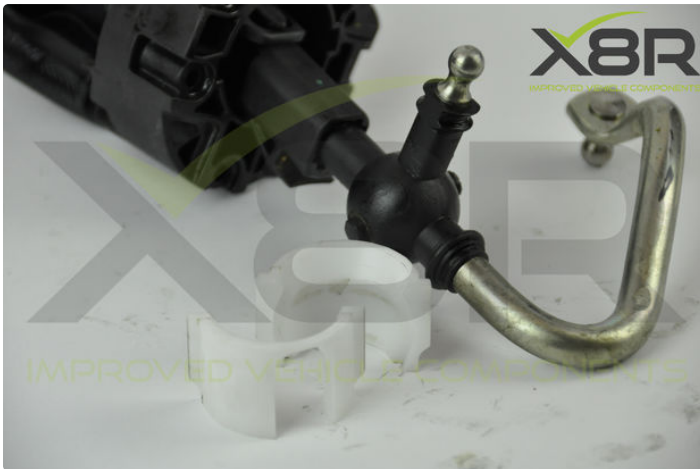
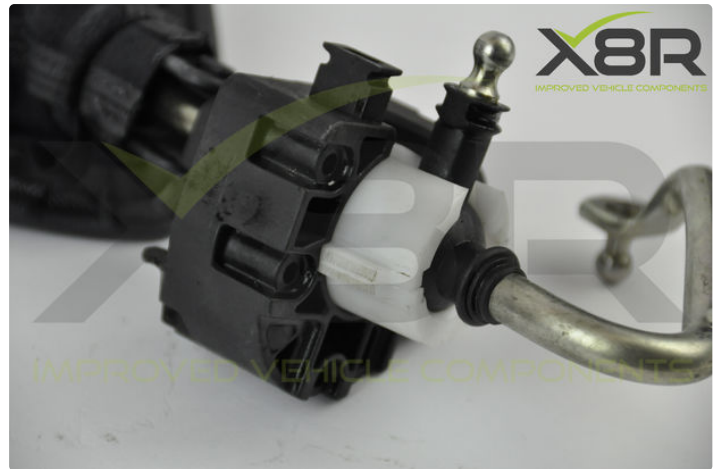
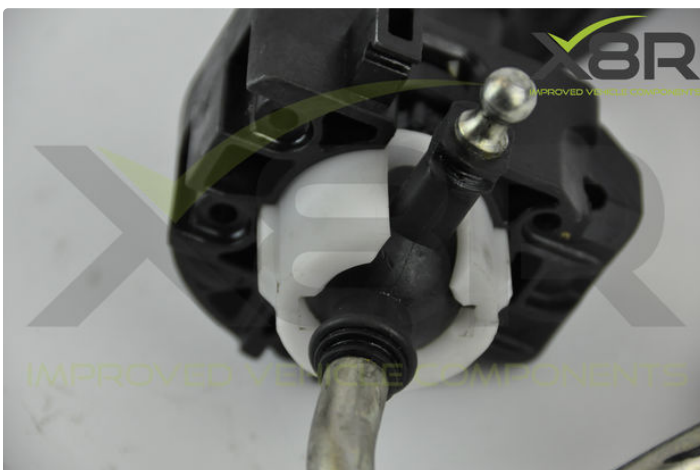
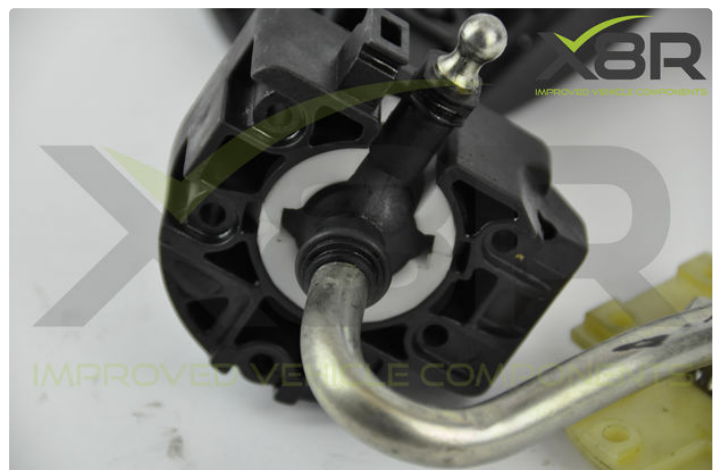
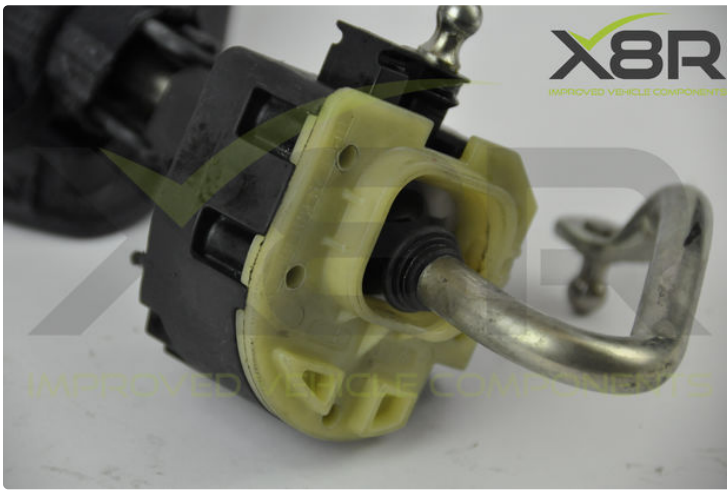
Step 7: Fit New Gear Bush

Our bush comes in two halves so that it is easier to install. When lined up, the two halves will have two protruding notches which will need to be lined up with the corresponding notches on the bush housing.

Once lined up, just slide the housing down over the bush and you should already be able to feel the new

stiffness and solidness of the gear stick.

Slide the base plate of the housing back into position so that the screw holes line up on the housing and the base plate.

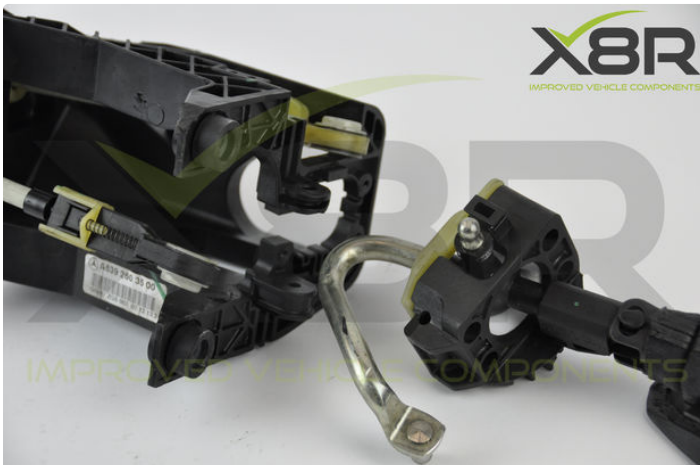
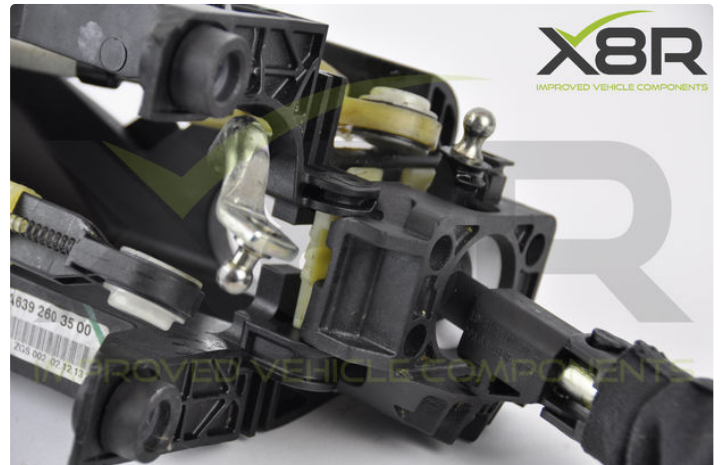
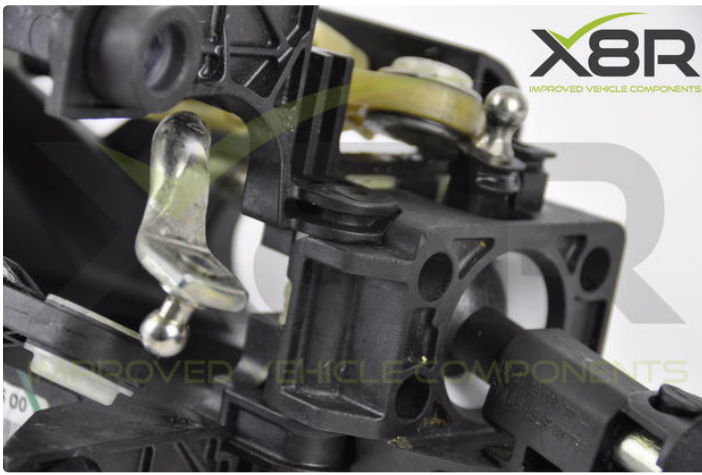
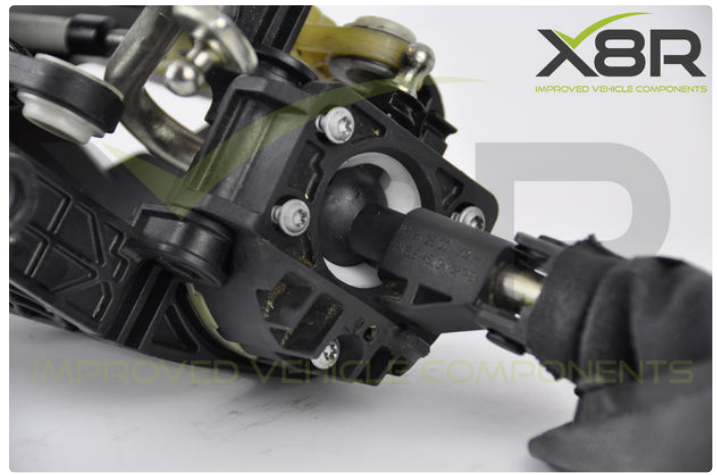
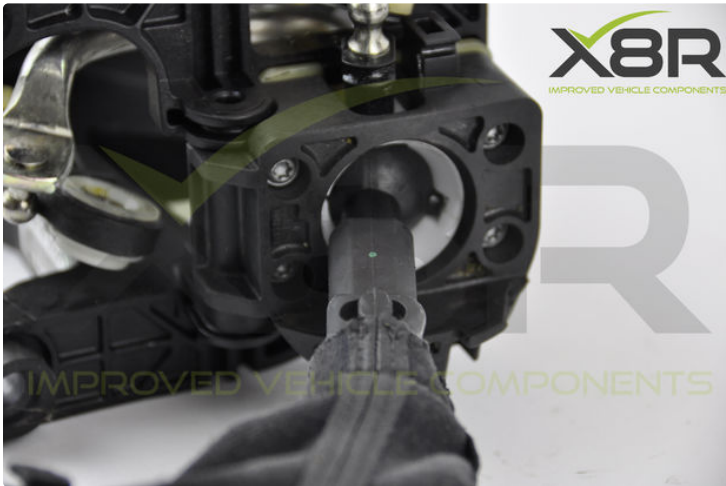
Step 8: Refit Upper Assembly to Lower Section

Refit the upper assembly to the lower section by sliding it into position.

Line up the holes left by the long T30 Torx screw.

Refit the five T25 Torx screws which hold the upper and lower sections together.

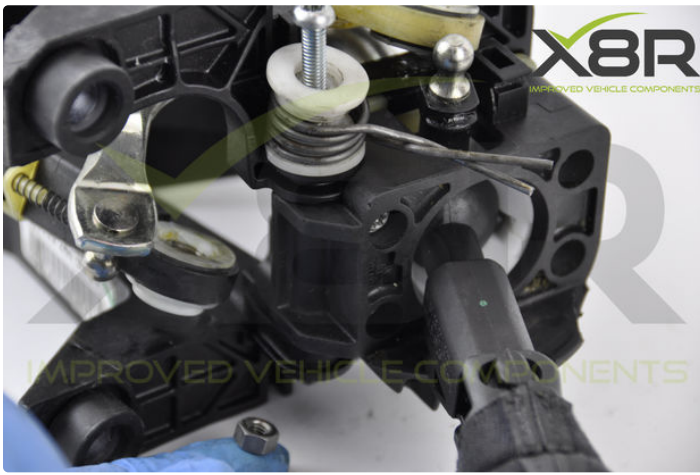
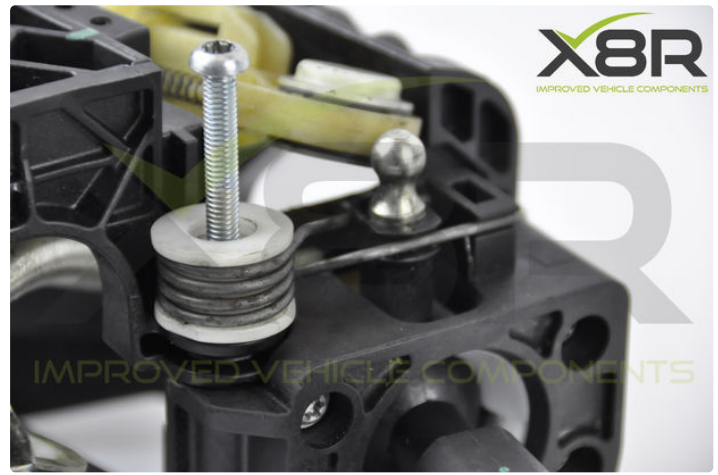
Step 9: Refit Spring Retaining Clamp

Put the nut in place first and hold with your finger while you put the screw and spring clamp into position. Lightly tighten the screw until the nut holds in position by itself.

You will then need to put the spring clamp retaining prongs in position in the grooves on the protruding

piece of plastic with the ball socket on the end. Once these are in place, fully tighten the screw. At this point test function to ensure that when shifter is pushed left or right it springs back to the central position. If it doesn't, recheck the spring is orientated as shown.

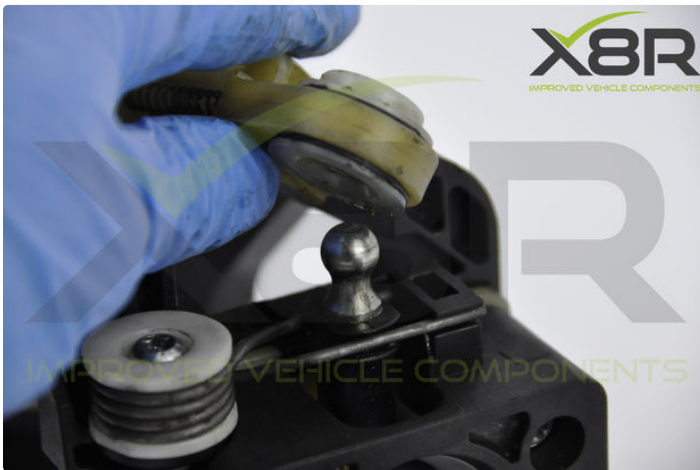
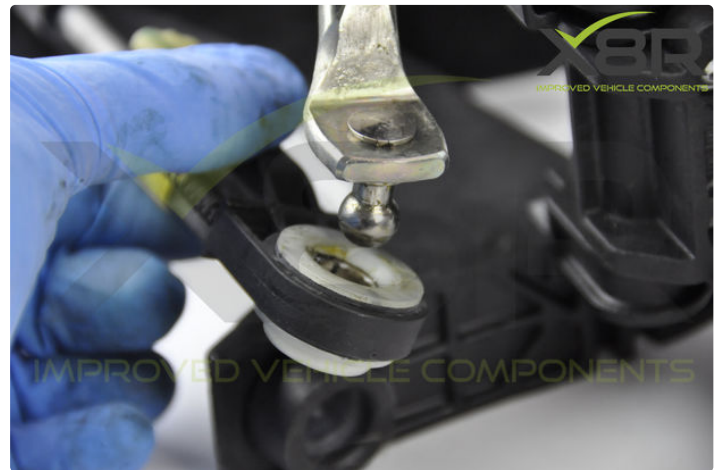
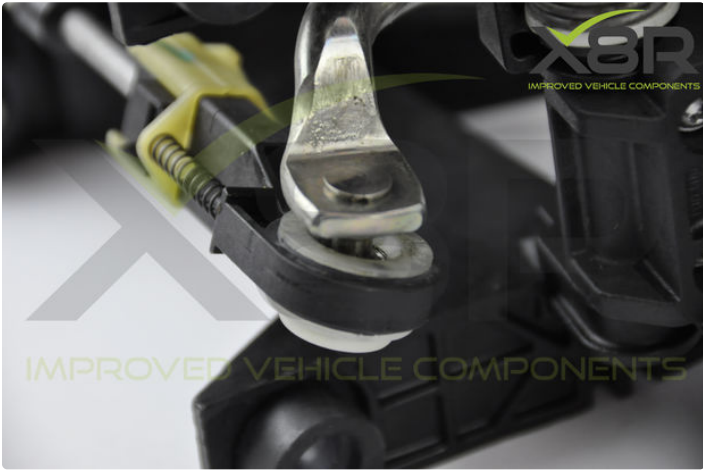
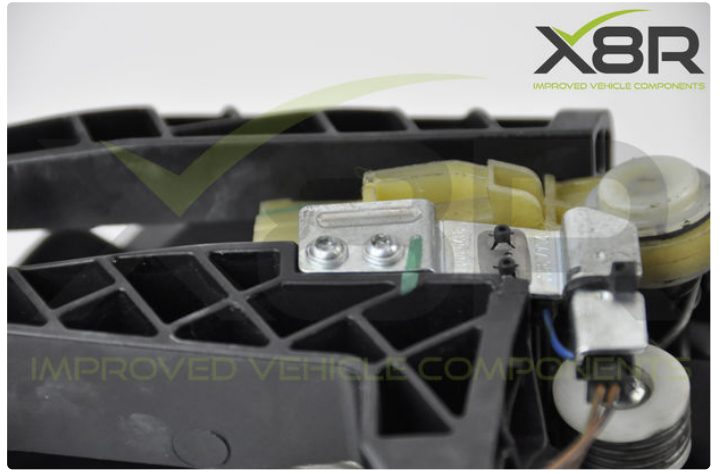
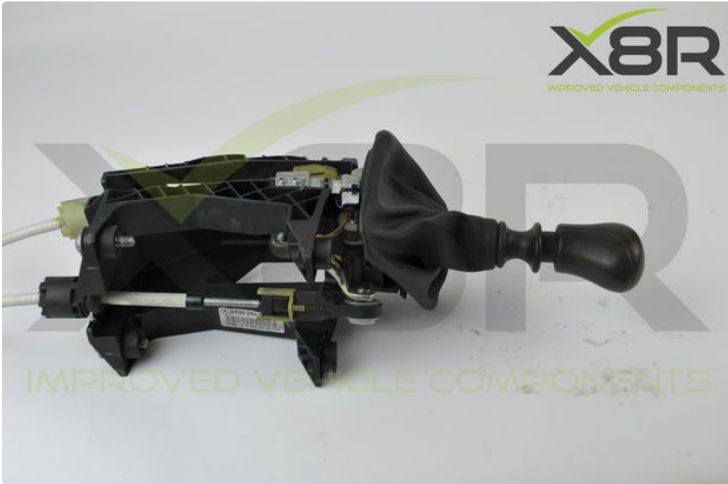
Step 10: Refit Gear Shift Cables and Electrical Connector

You can now refit the gear shift cables on to their appropriate ball sockets.

They are a simple push fit.

The final step is to refit the electrical connector with the previously removed T20 Torx screws.

Once this is done, the gear bush repair is complete.
