New VW Beetle Interior Door Grab Pull Metal Handles Replacement Repair Fix Kit Install Instructions Guide

by x8rltd

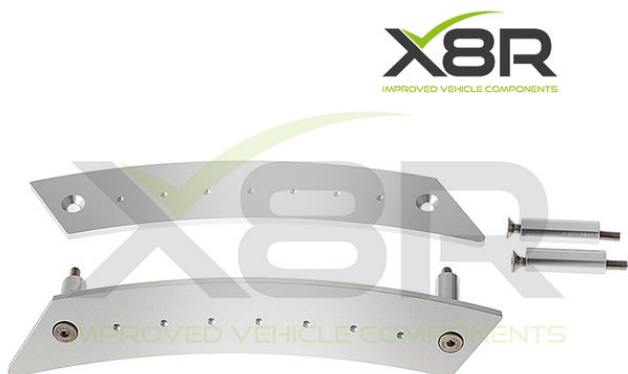
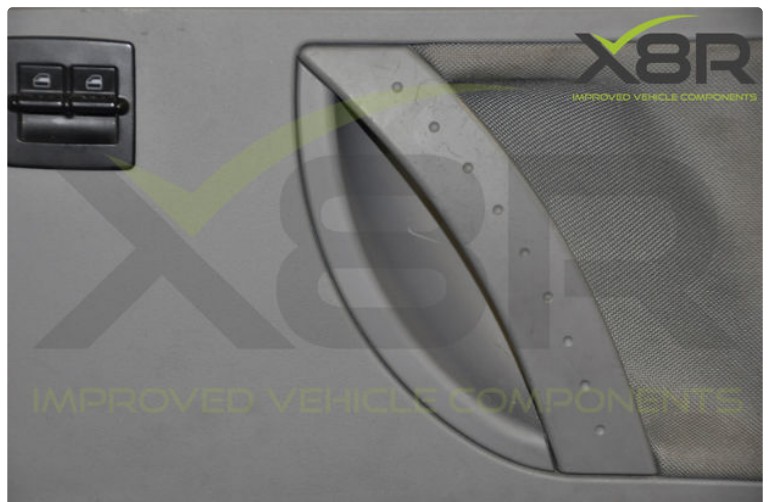
2x CNC machined billet aluminium anodised handles.
Left and Right sides.

4x Anodised aluminium spacers.

4x Countersunk stainless steel screws.

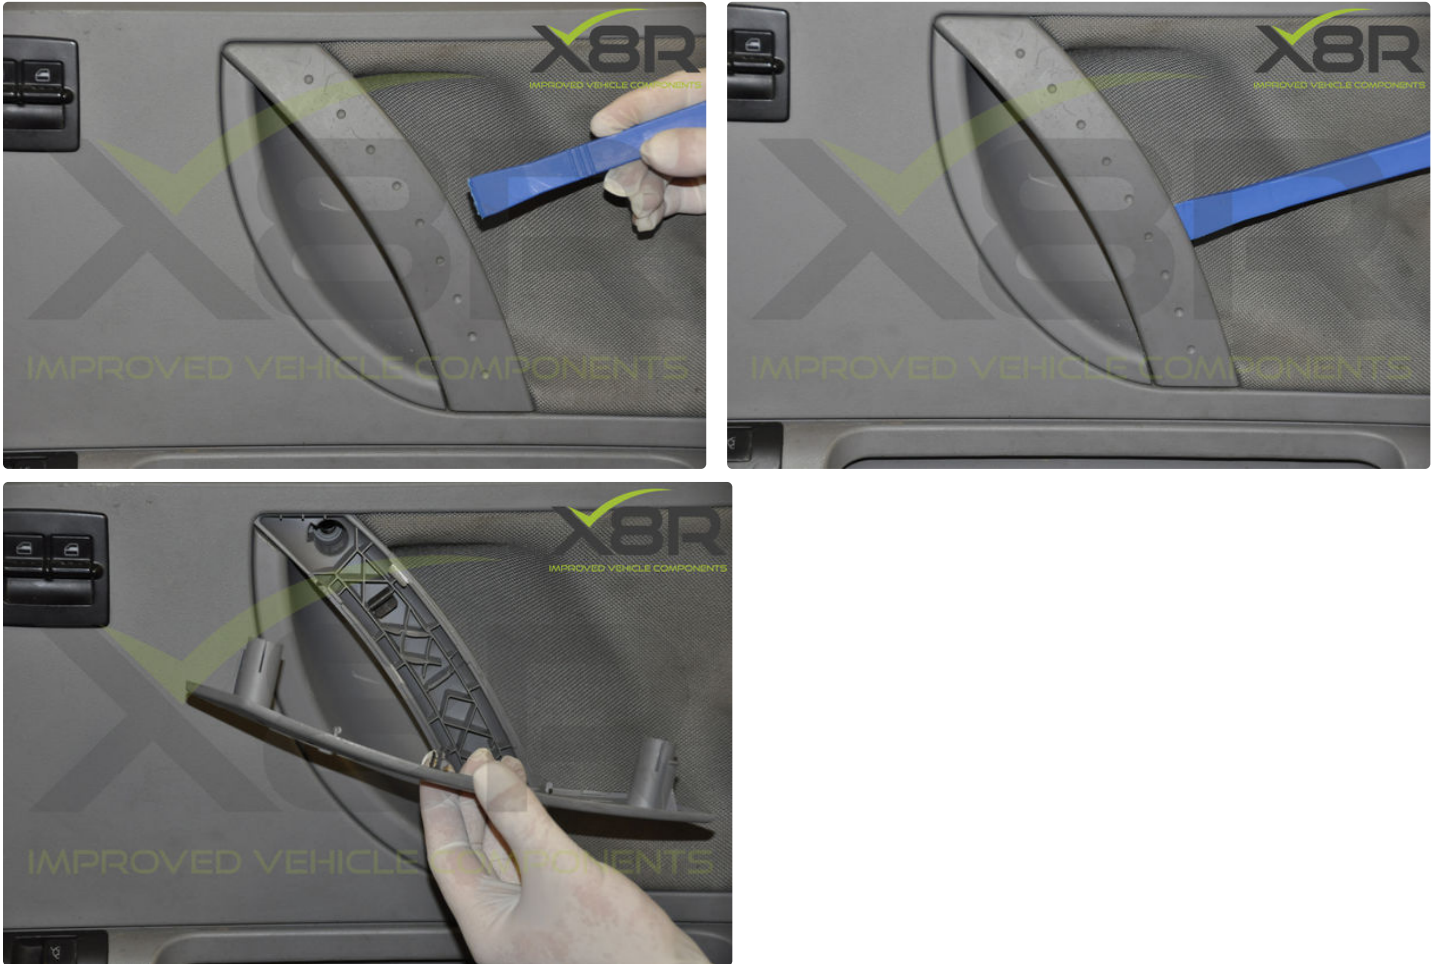
Step 1: Remove Top Section of the Handle

Using a plastic lever tool or screw driver lever off the top section of the handle.

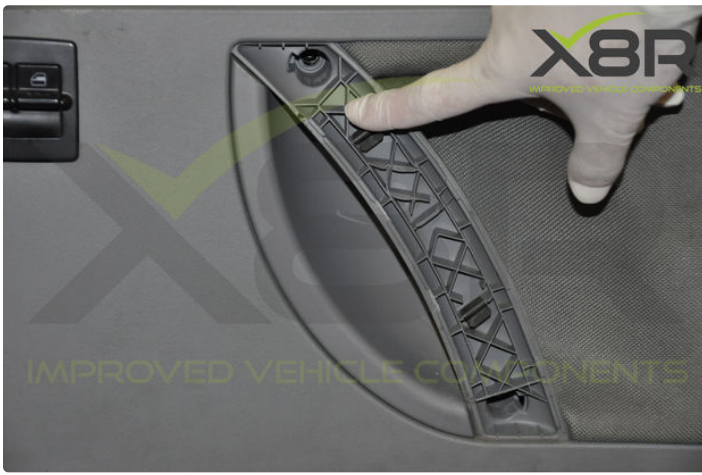
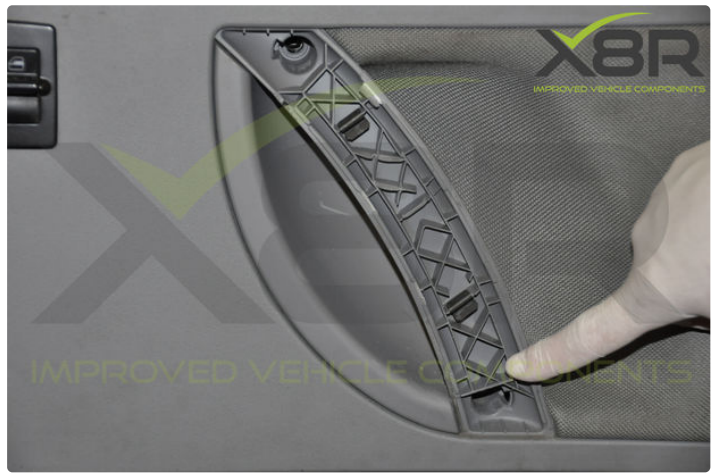
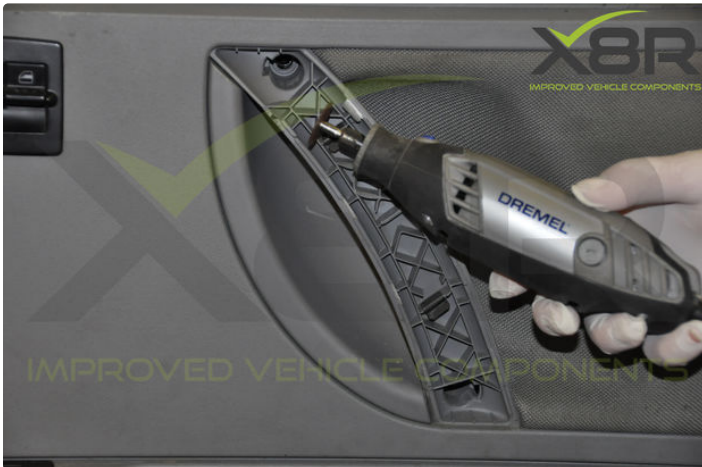
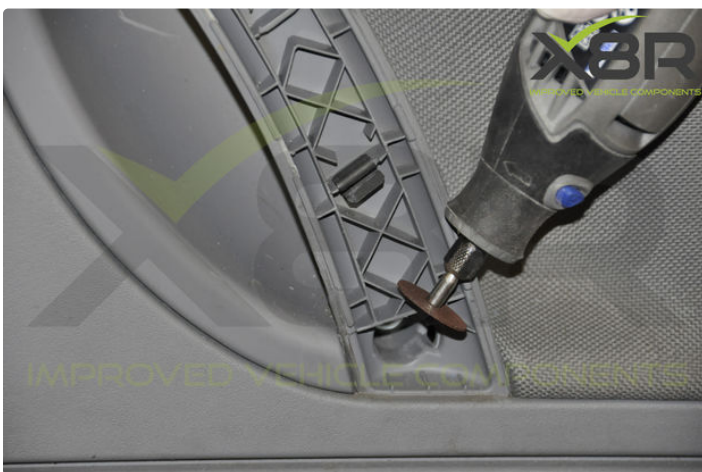
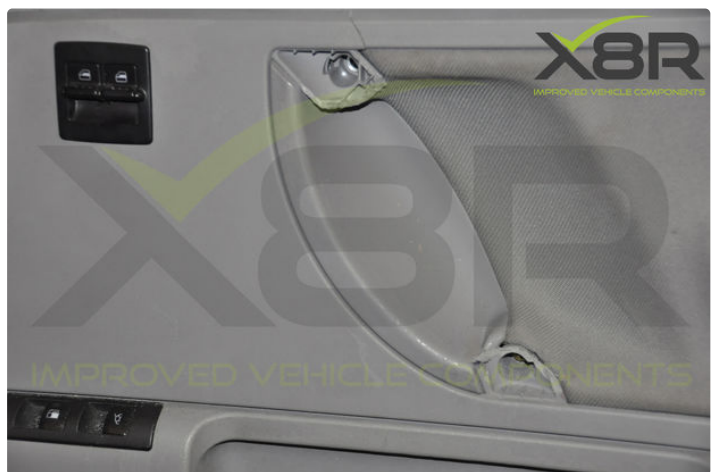
Step 2: Cut Away the Lower Section of the Handle

Using a cutting tool such as a Dremmel cut away the lower part of the handle.

Cut as close as you can to the holes at each end of the handle, taking care not to damaged the door trim or upholstery underneath.

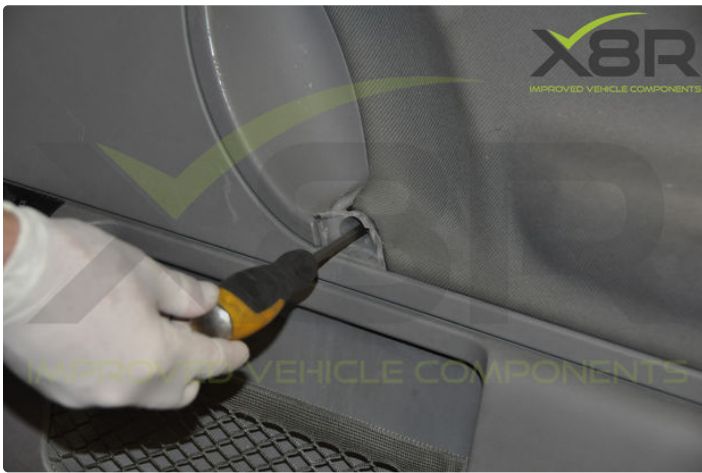
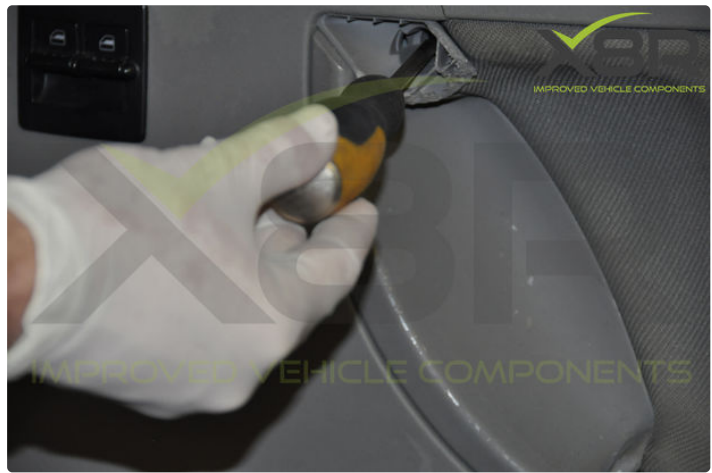
Step 3: Remove Screws From Door Trim

Using a Philips head screwdriver remove the two screws at each end of where the old handle located.

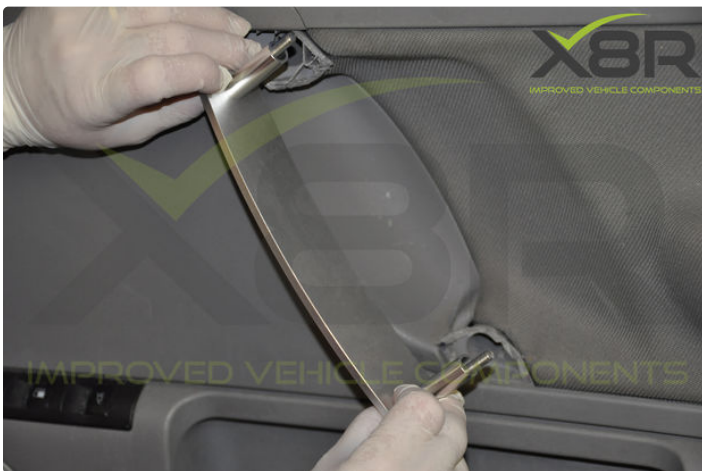
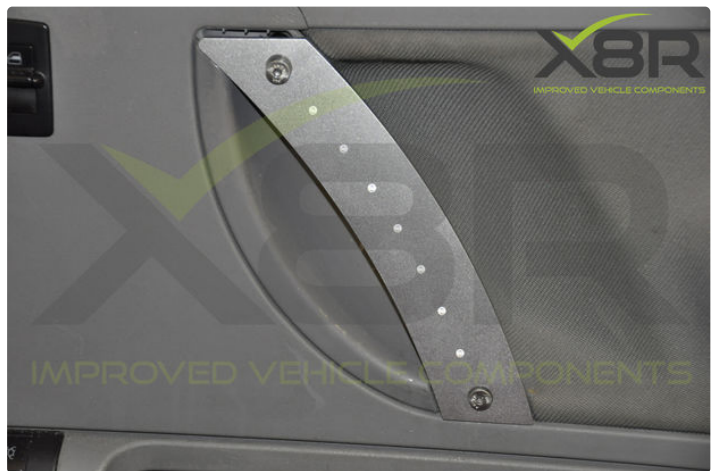
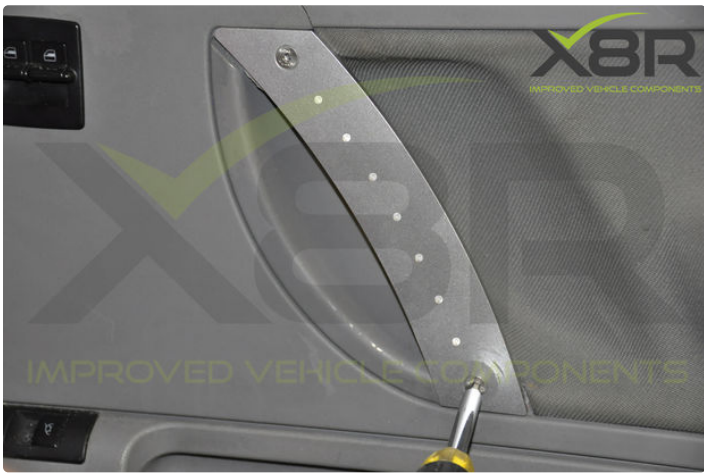
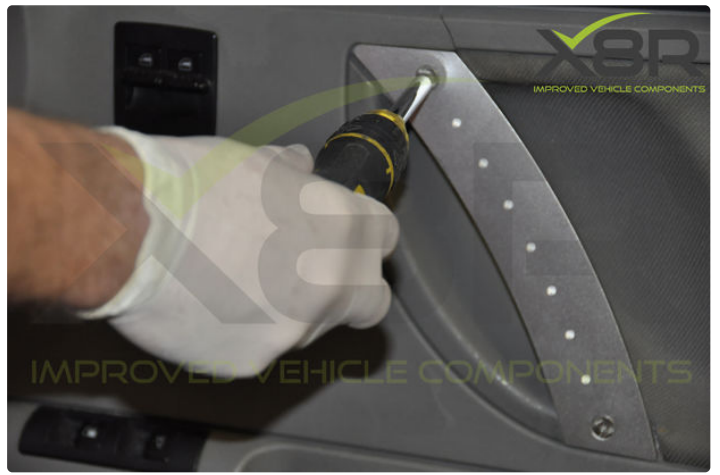
Step 4: Fit Our New Handle

Insert our replacement screws through the handle and through the spacers. Push the handle in to the holes left by the old handle. Tighten the screws ensuring the new handle seats correctly as the screws are tightened.
