Renault Twingo Clio Kangoo Clutch Pedal Link Linkage Ball Joint Ratchet Bar Rod Repair Fix Kit Install Instruction Guide

The Problem

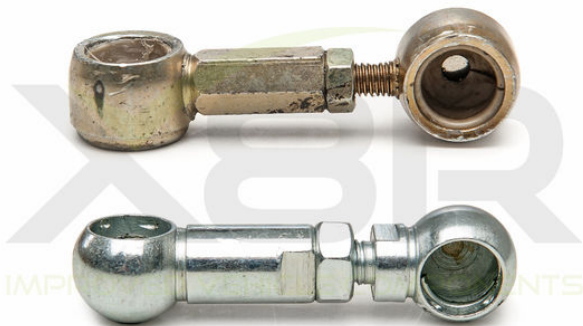
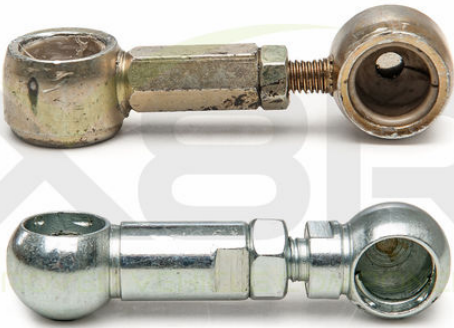
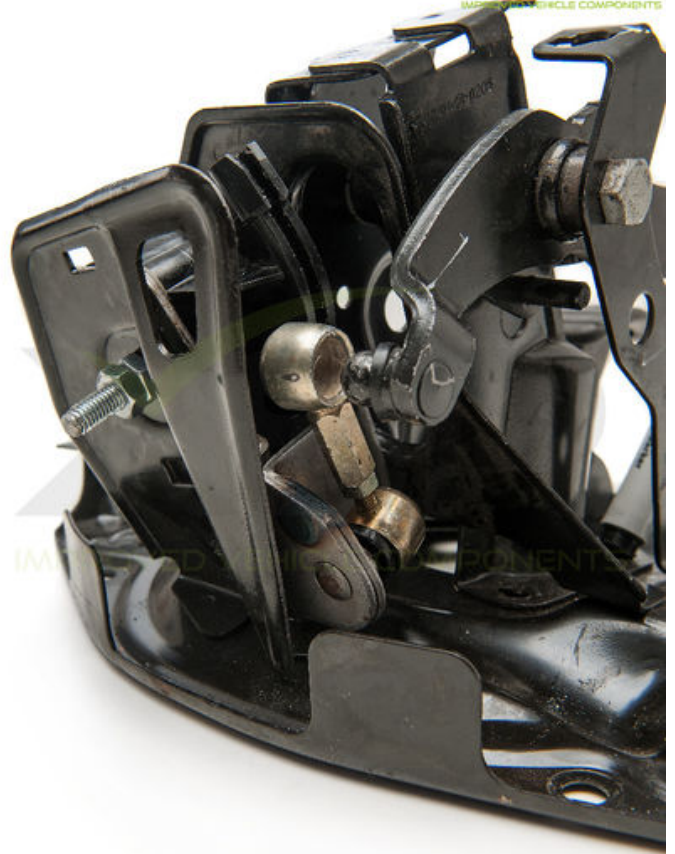
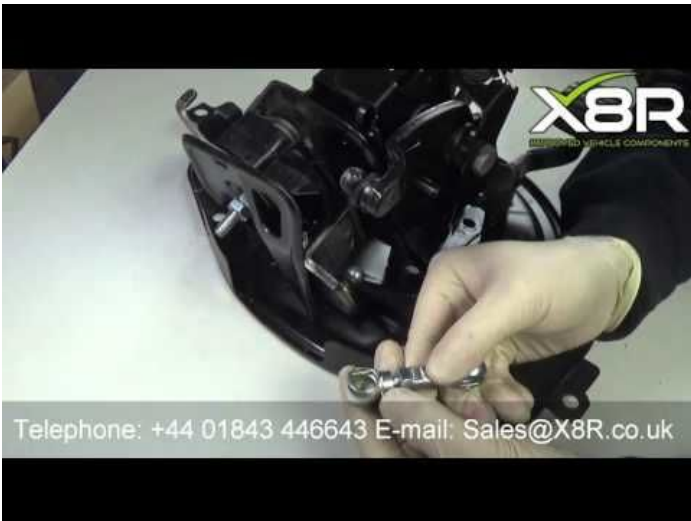
The connecting rod from the clutch pedal wears and pops off of its ball joint causing these symptoms.

It is a common fault on Renault Clio, Twingo and Kangoo models for the clutch pedal linkage rod to wear and pop off of its ball joint. The OEM linkage features a poor quality nylon insert within the rod, this operates on a metal ball joint and inevitably wears and leads to the linkage popping off. Our customers note upon contacting Renault they are presented with a repair bill in the region of £400-500 for a complete pedal unit assembly. Not only is this an extremely expensive solution but also the new assembly would utilise the same linkage rod which would just fail again. Our solution allows you to replace just the component that fails; with an improved design permanent solution to the fault providing a vast saving.

Fit our improved design linkage rod and fix the fault permanently, saving the cost of a complete replacement clutch pedal assembly which would only fail again. Our upgraded linkage rod is improved in design and material and will not pop off again. Our ball joint link rod is made from metal and features a dual retaining feature including retaining clips to prevent the linkage from ever detaching from the ball joints. Our heavy duty metal linkage with locking clips is a direct replacement for the original and can be installed very simply using our instructions and video guide. Our unique repair kit also comes with grease seals, allowing you to lubricate the linkage, the seals retain the grease to allow smooth lifelong operation.

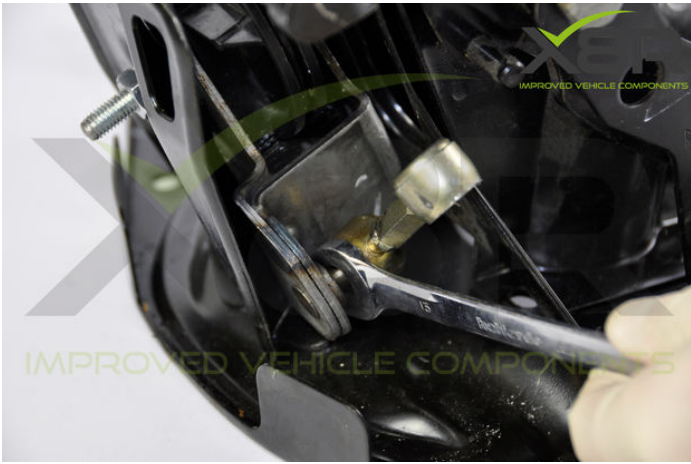
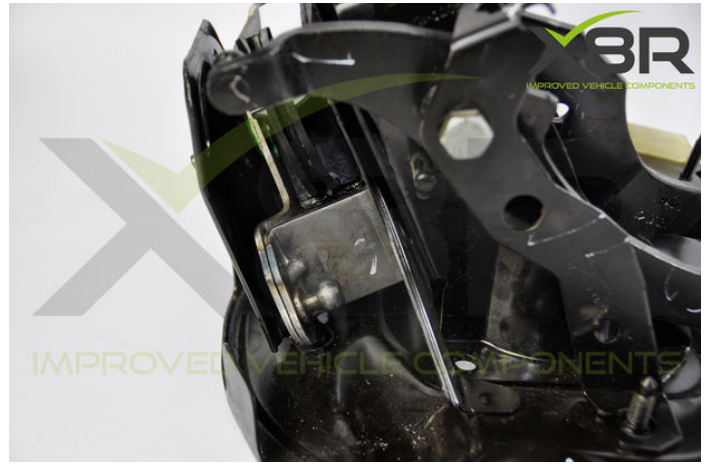
Step 1: Remove the old linkage rod

- Using a 13mm spanner pry off the old rod from both ball joints.

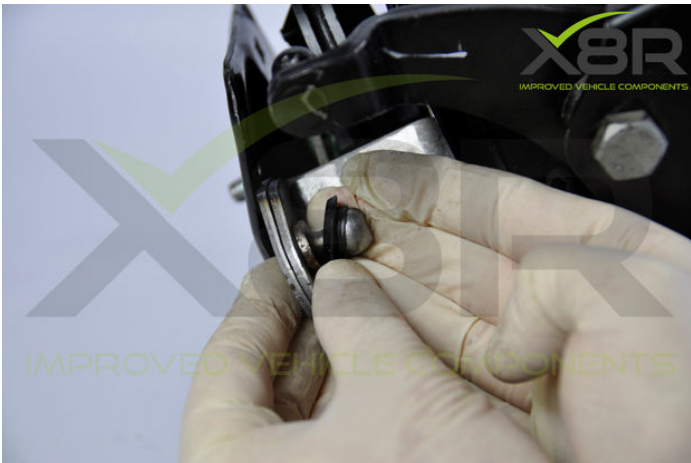
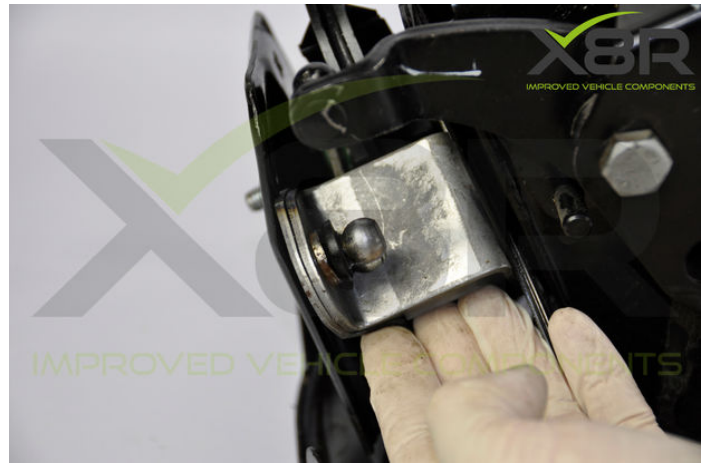
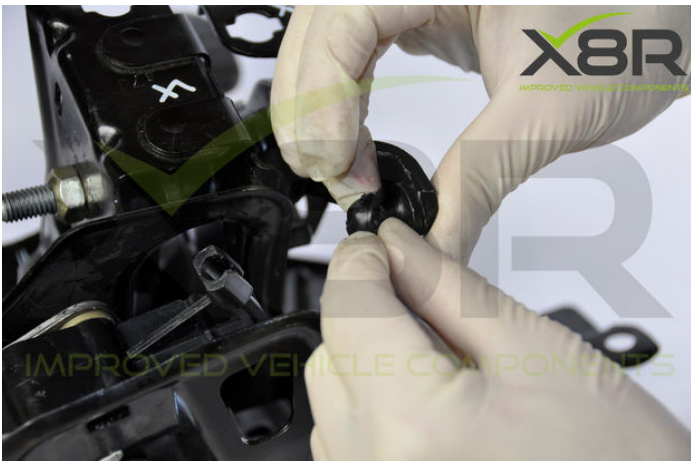
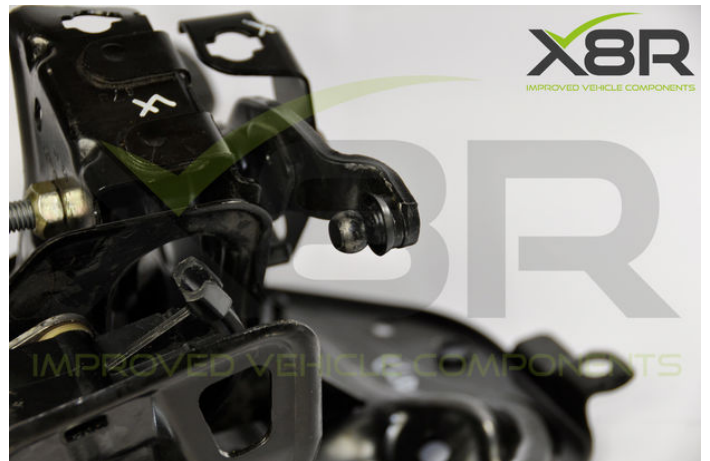
Step 2: Fit the grease seals

- Before fitting the new rod fit the grease seals to the ball joints.

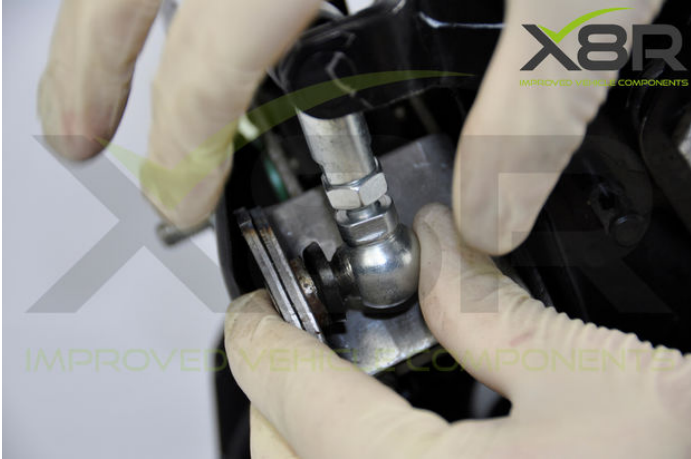
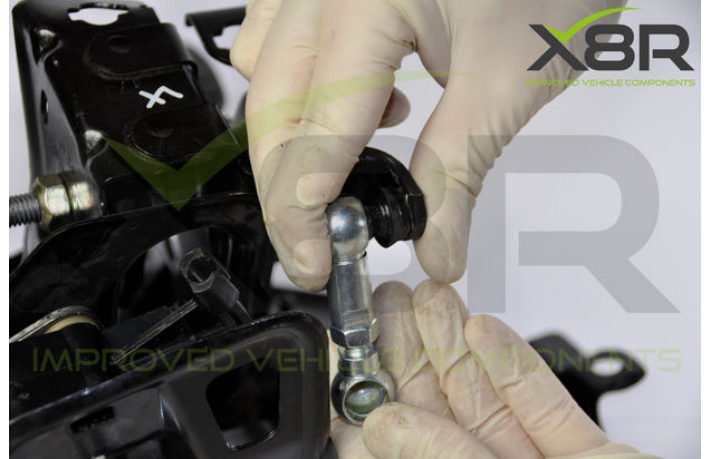
Step 3: Fit the new rod

- Before fitting the new rod apply a small amount of grease on the inside of the joints on the new rod.
- With both joints greased the rod will push on to the ball joints.

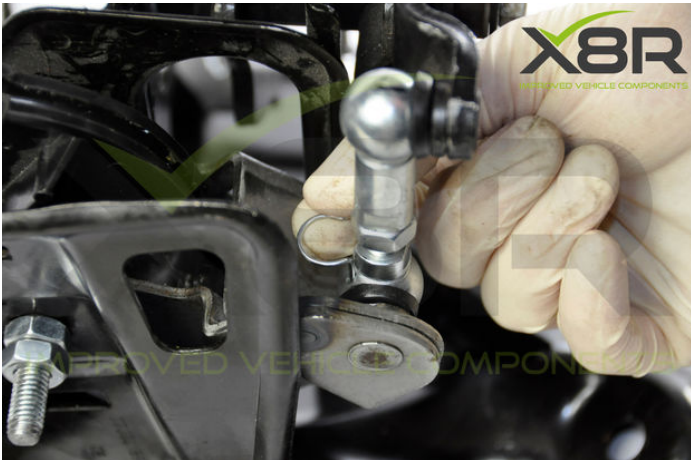
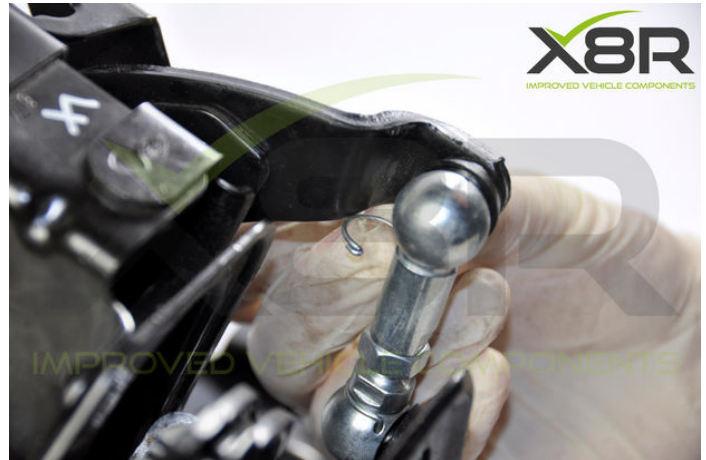
Step 4: Fit the retaining clips

- Fit the retaining clips making sure these are located correctly through the base, then twisted around to lock in to position.
