Toyota Lexus Scion Boot Trunk Lift Lid Hatch Tailgate Liftgate Switch Latch Release Button Rubber Cover Replacement Fix Repair Kit Install Instruction Guide

by x8rltd

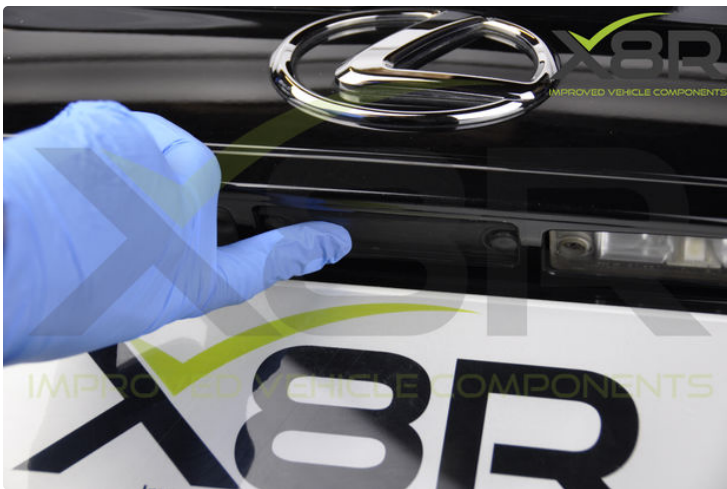
You will receive

1X Brand new improved rubber button

2X Black flange screws

1X Offset screwdriver

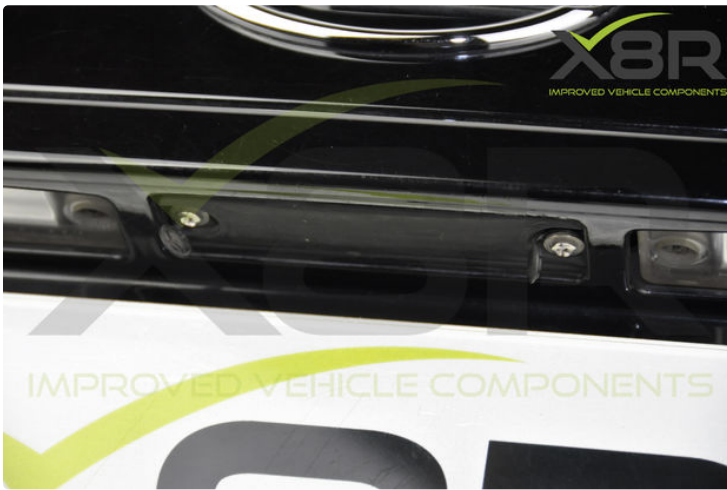
Step 1: Release Screw Covers

Release x2 black plastic screw covers; this can be done with your finger nail or a small screwdriver.

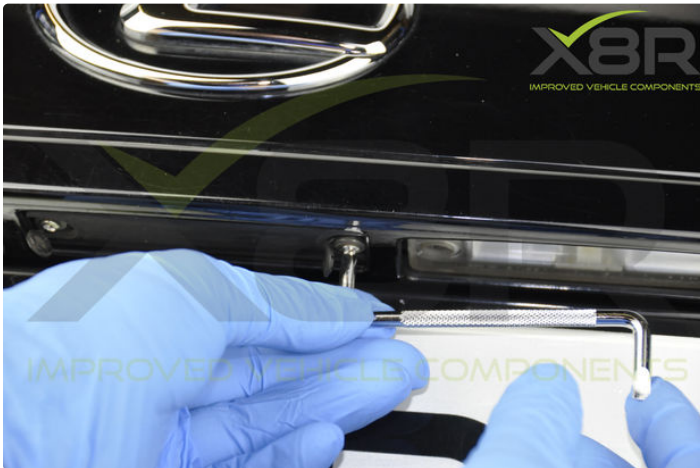
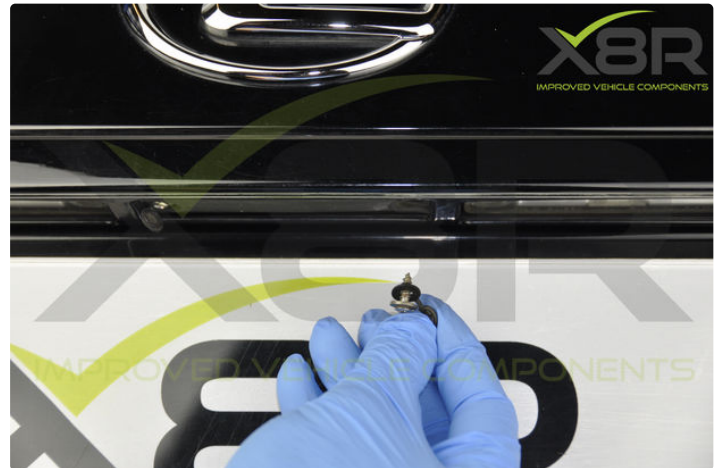
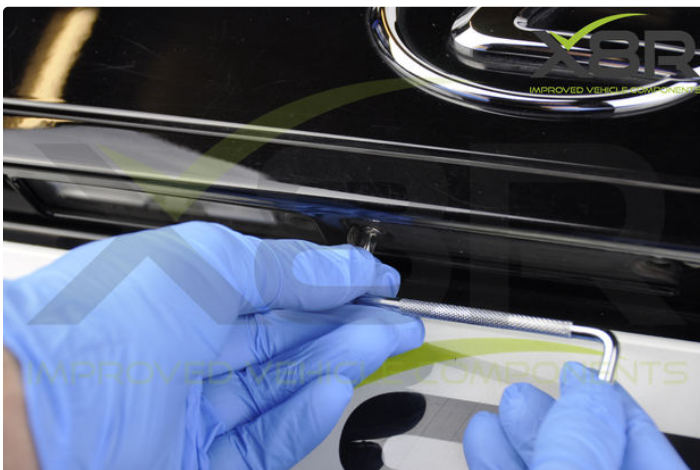
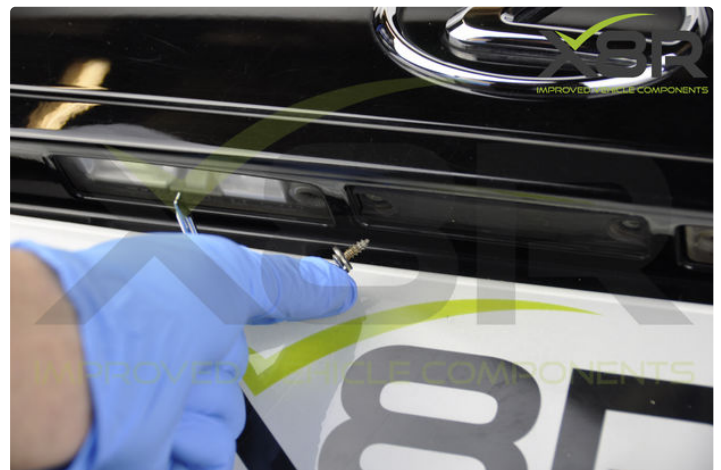
Step 2: Remove Retaining Screws

Remove x2 retaining screws.

With some vehicles it will be necessary to use our offset screwdriver due to the angle of the screws. When using this put pressure on the base of the screwdriver to avoid slippage when removing the screws.

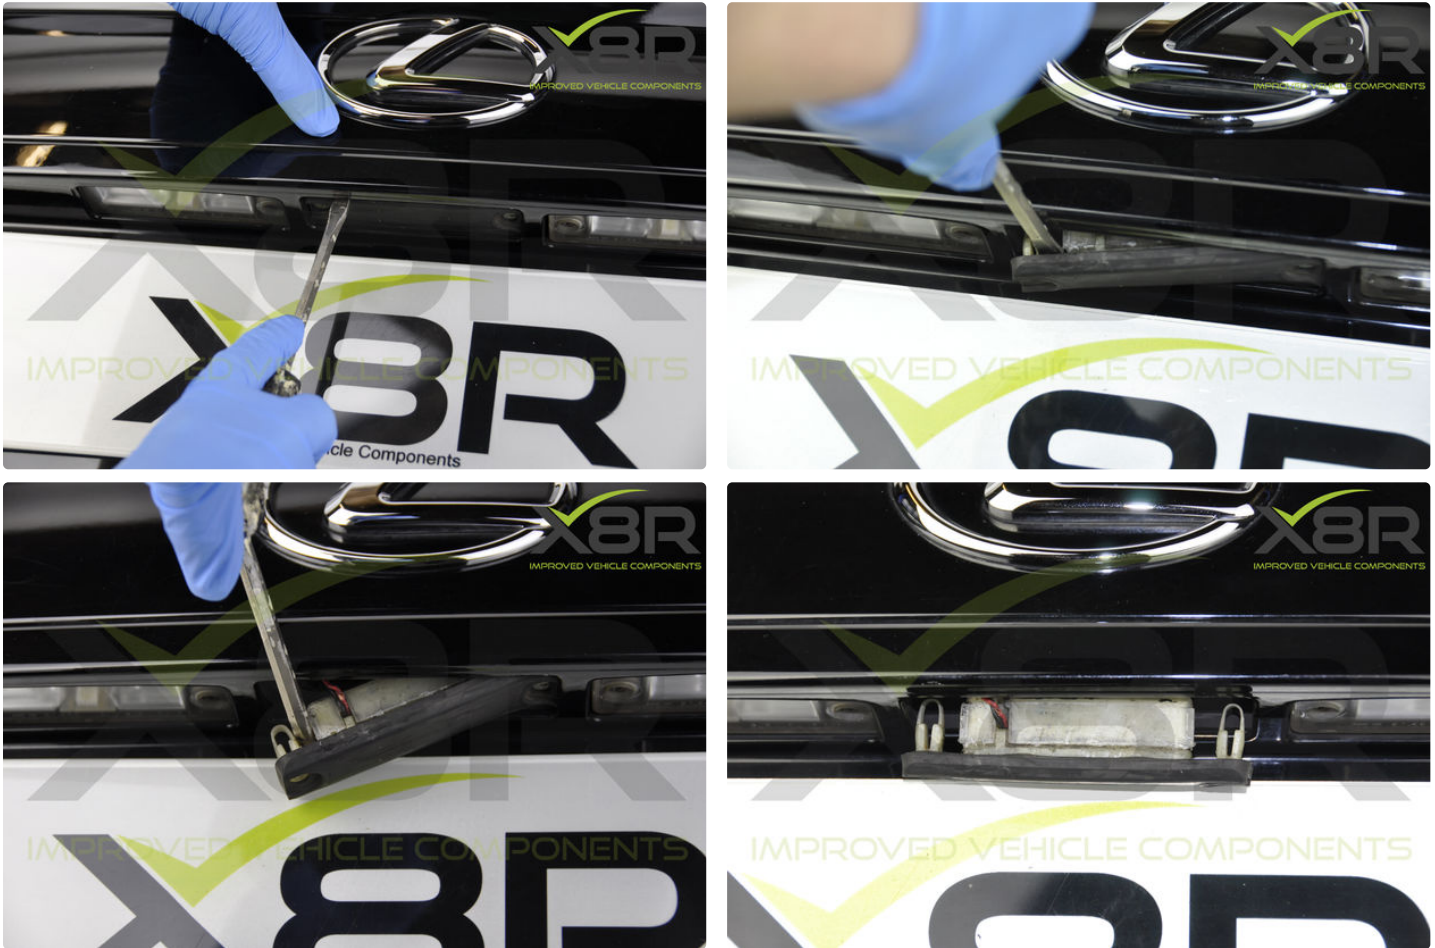
Step 3: Remove Button Unit

Use a plastic pry tool or a screw driver to lever button unit out of position, if using a screw driver we advise masking around the button to avoid any damage to paint work.

Lever from the far left corner and continue levering moving right until the unit is released.

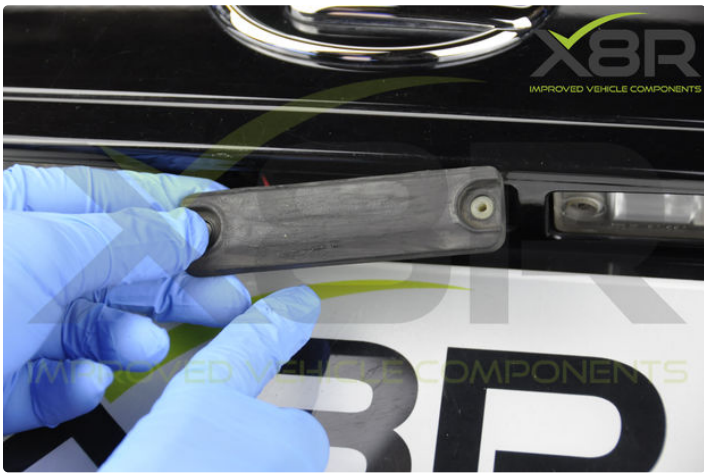
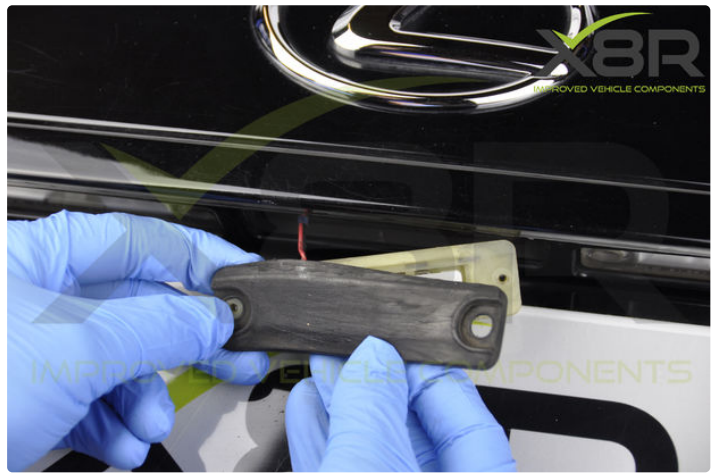
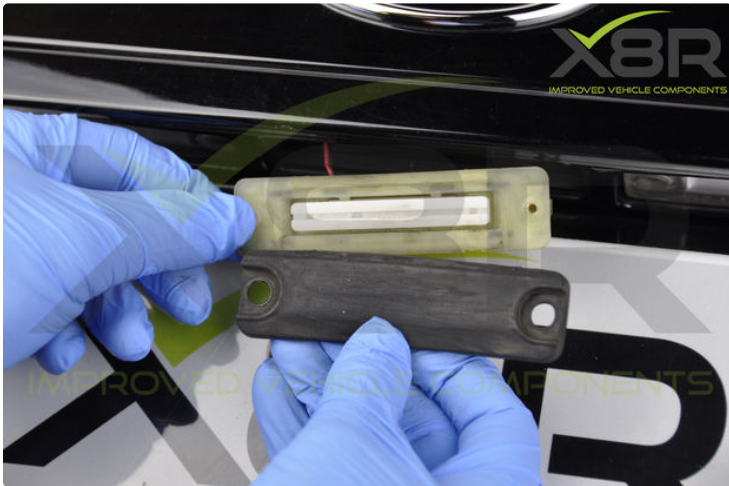
Step 4: Remove Old Rubber

Remove the old rubber button, this can be levered away from the button unit by hand. You will often find the button is very sticky- take care to remove all remnants of the old rubber before installing the new button.

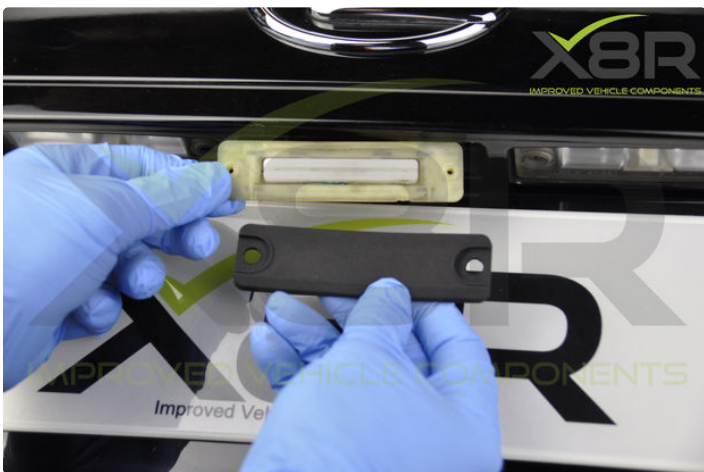
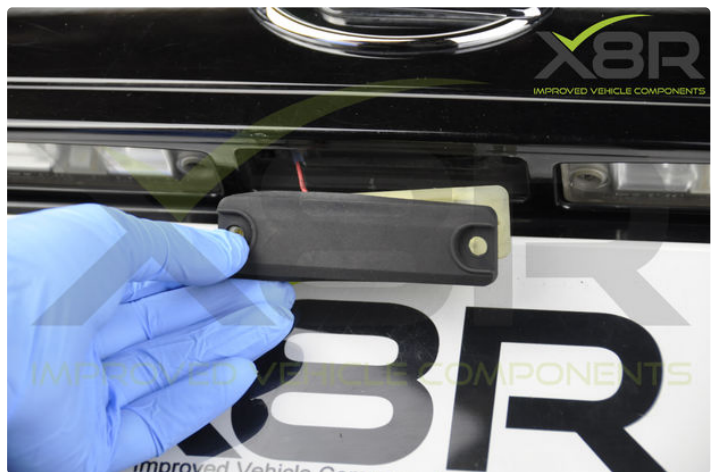
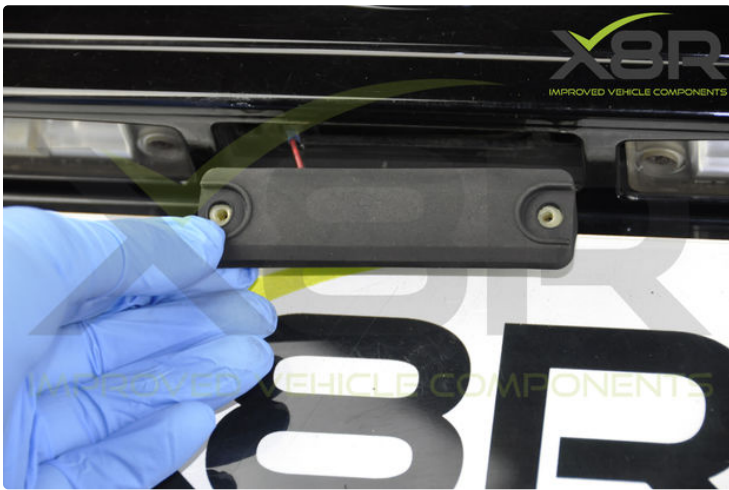
Step 5: Fit New Rubber

Fit our new rubber button. Locate on to the button unit ensuring all 4 sides overlap and don't bind.

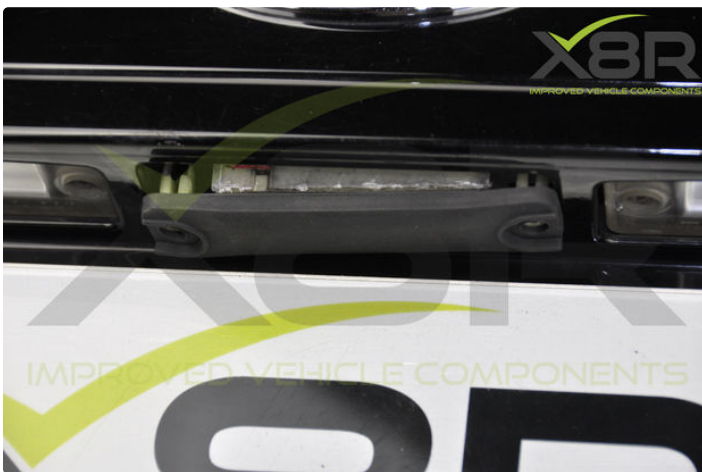
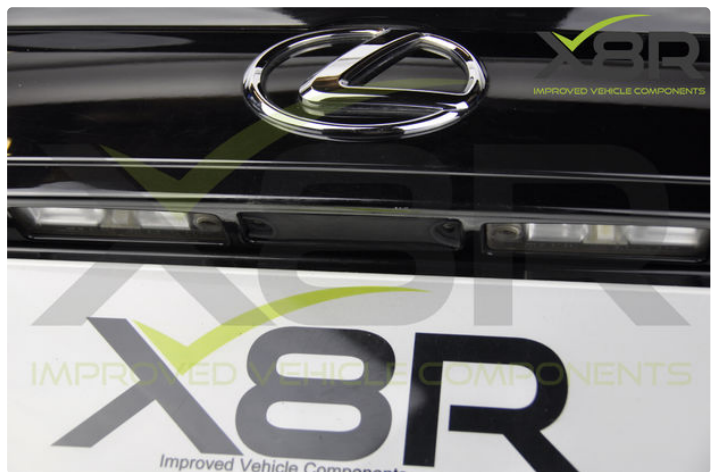
Step 6: Push Back in to Position

Push button unit back in to position.

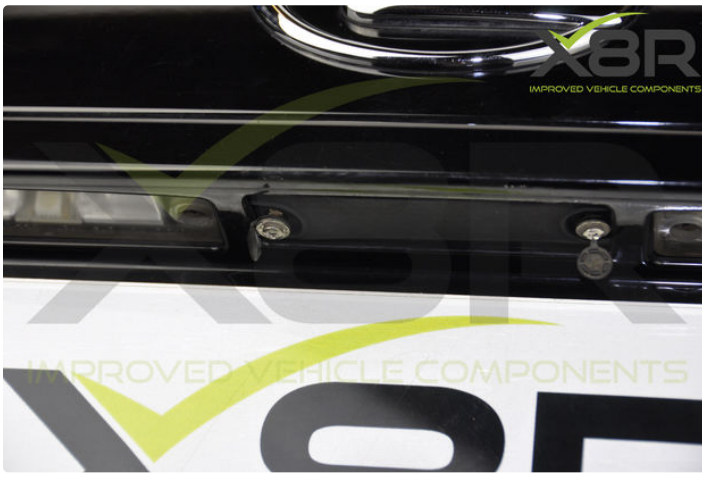
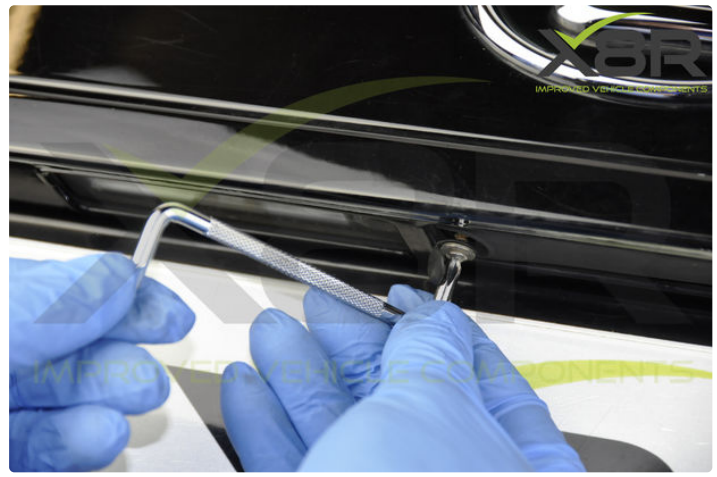
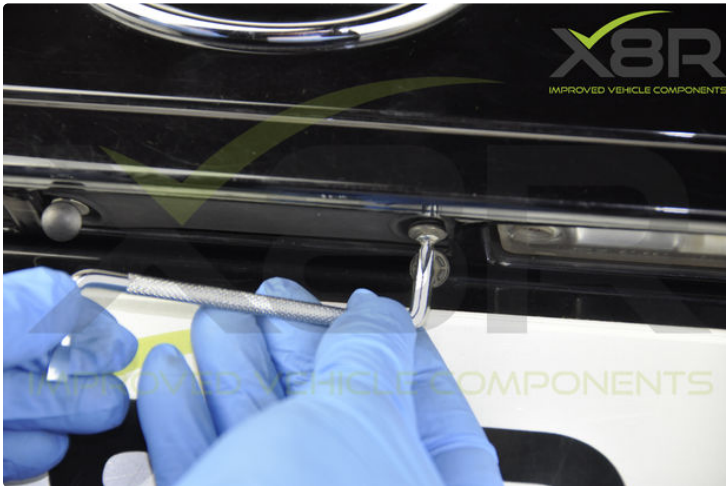
Step 7: Refit Screws

Refit the screws and tighten. If the original screws are damaged replace with our new black screws.
