Vauxhall F23 Gear Stick Lever Shift Selector Unit Anti Play Bush Repair Fix Kit Install Instructions Guide

by **x8rltd** on March 3, 2016

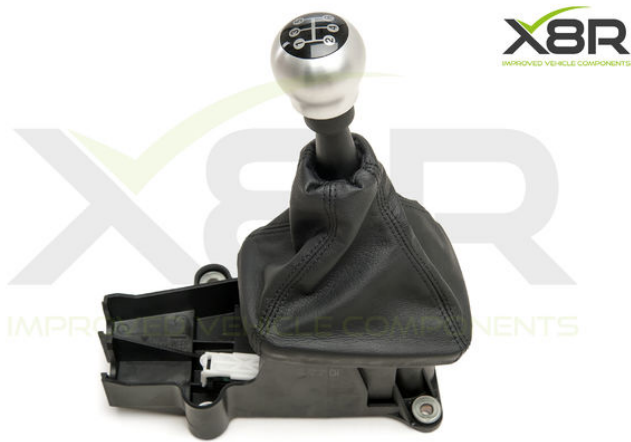
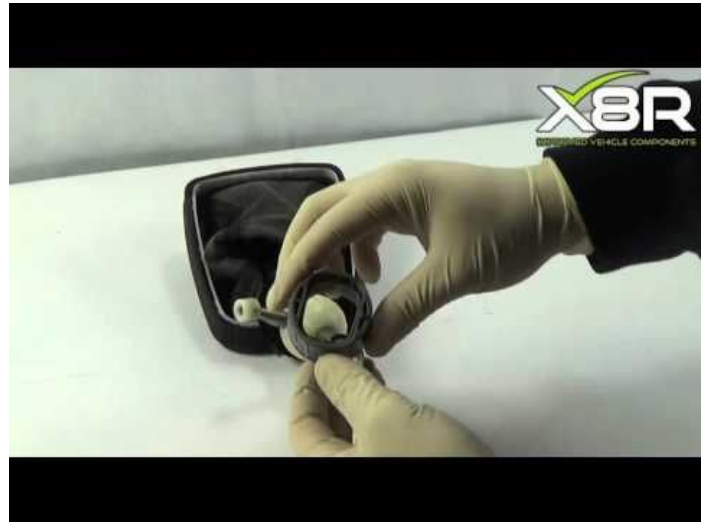
You will receive

1x Gear selector bush

1x Side to side movement rod

3x O-rings

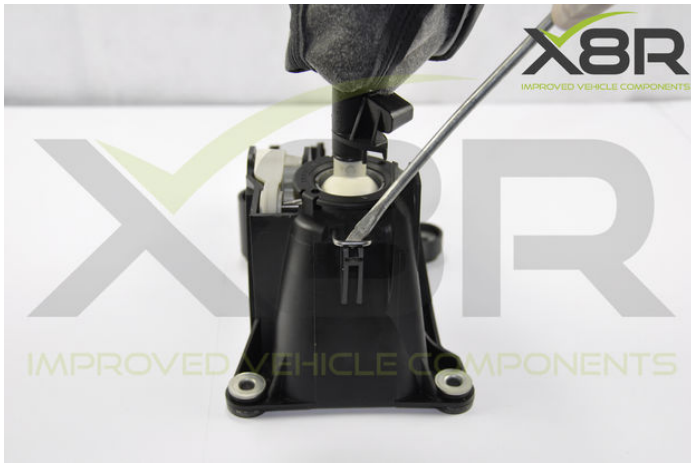
Step 1: Loosen retaining clip

- Using a flat bladed screw driver pry out the clip until it meets the stopper.

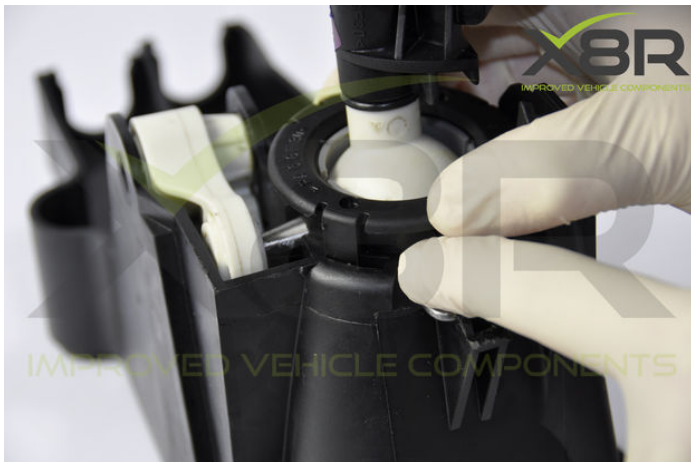
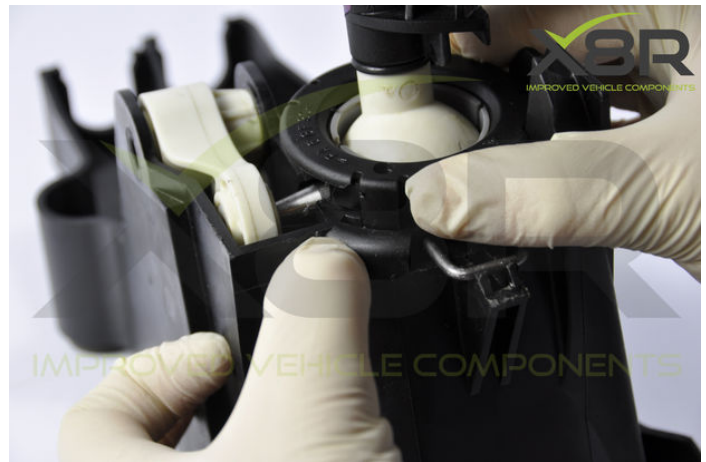
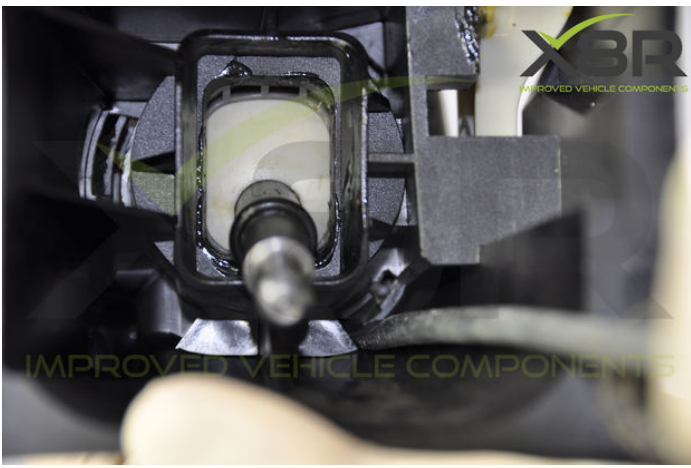
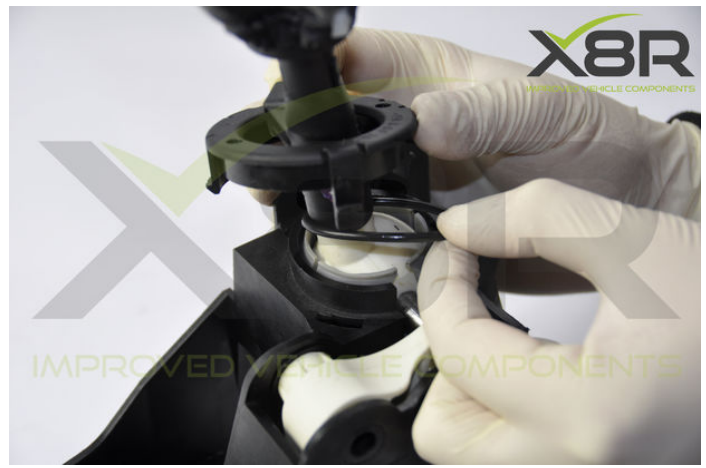
Step 2: Remove the bush retaining plate

- Twist the plate - this is key for it to be removed.
- Flip over the gear unit, exposing the interior, you will now see three tabs which need to be pried back to release the plate.
- This will reveal an o-ring which we'll replace in a later step.

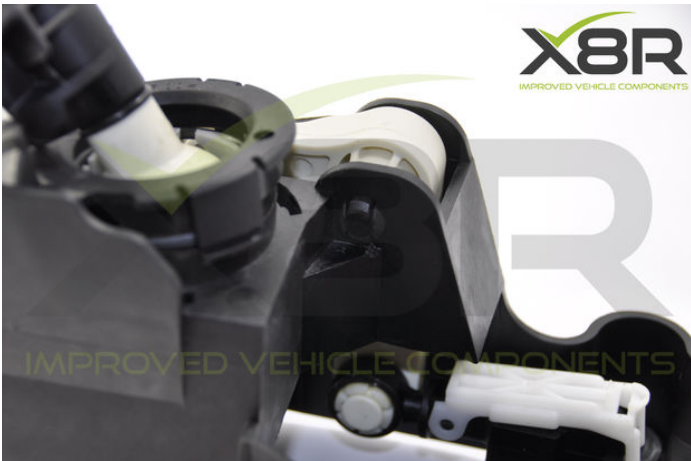
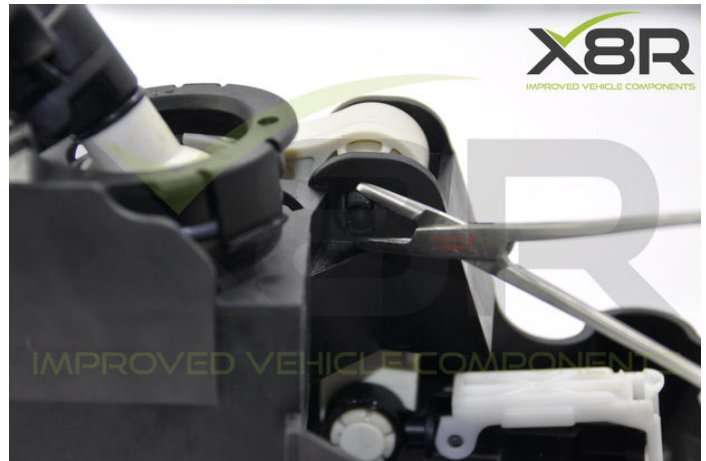
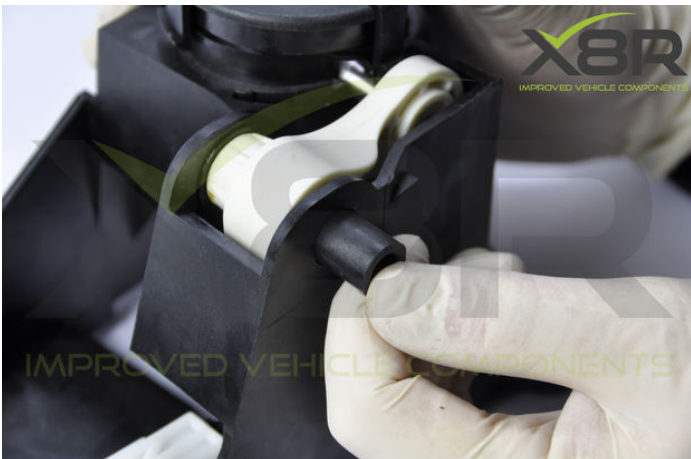
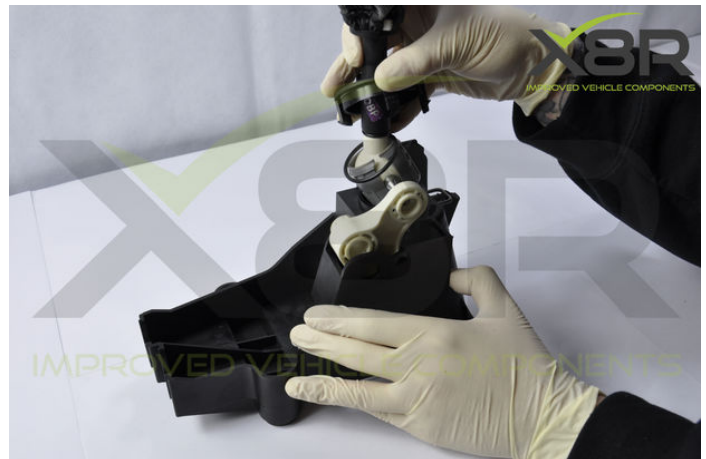
Step 3: Remove the side to side movement rod

- Before lifting out the gear stick you'll need to remove the push fit rod.
- Using a small pair of pliers grip the tabs and press the rod through.
- With the rod removed you will be able to lift the stick out and released it from the cable linkage and its housing.

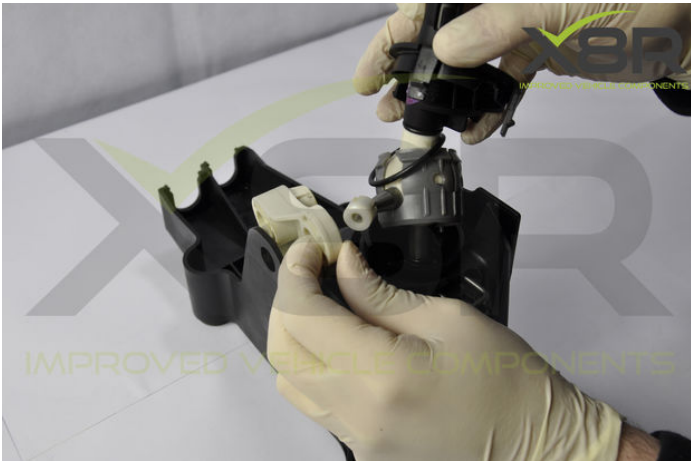
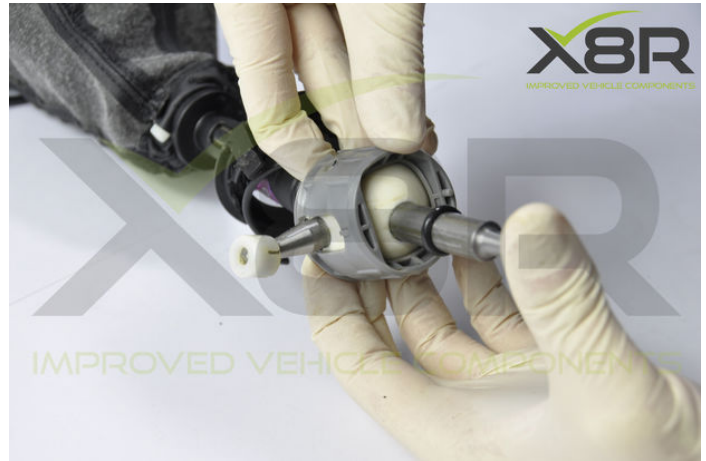
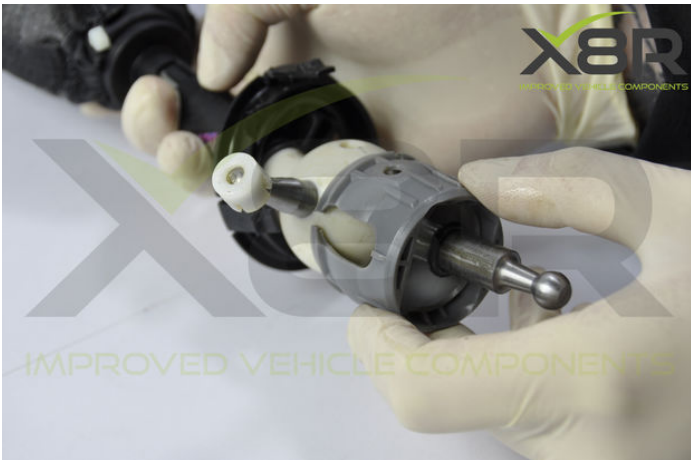
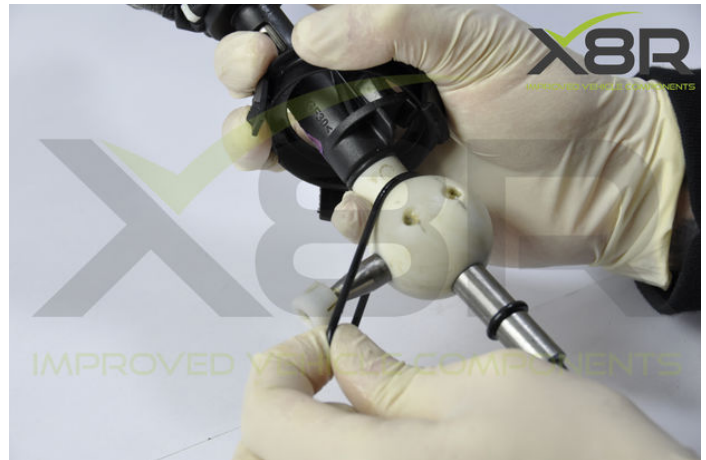
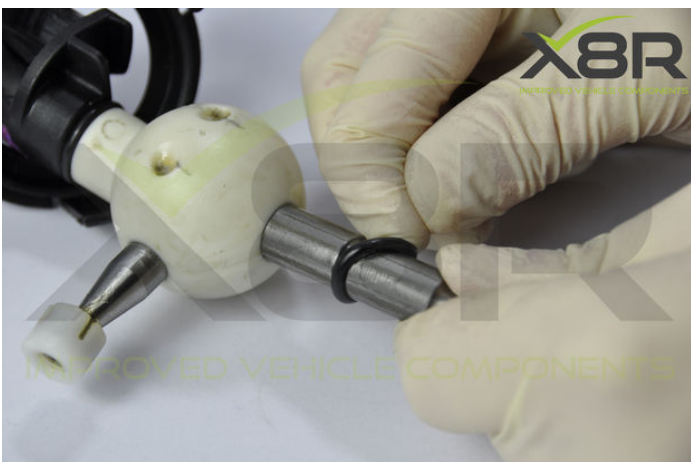
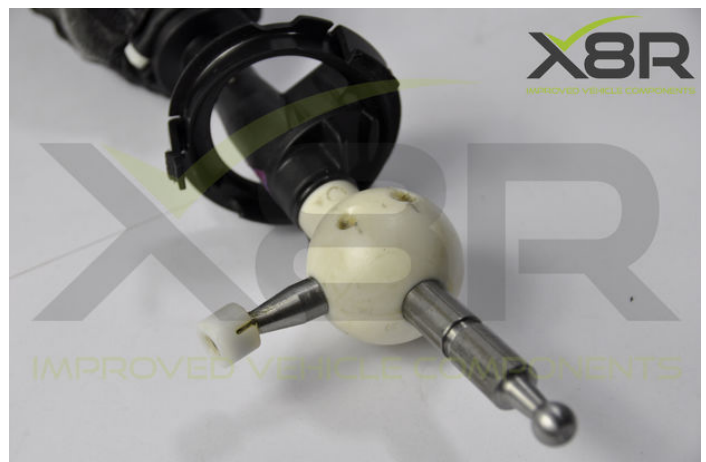
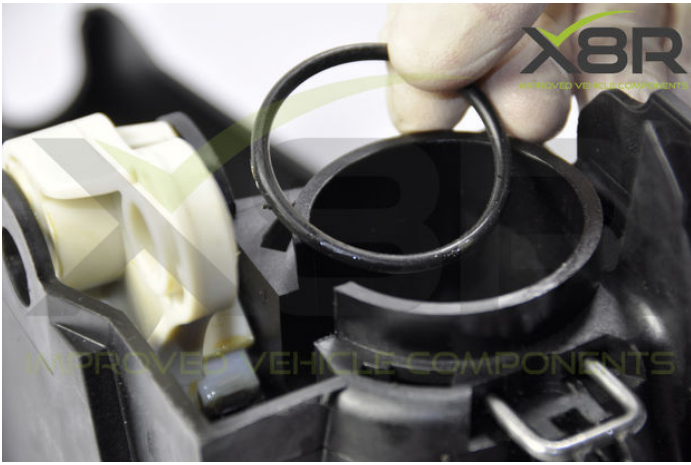
Step 4: Remove the worn parts

- Use both hands to remove the worn bush, pry back on both sides of the bush, lift it over the ball of the gear stick unit (this will feel very tight and some pressure may be required)
- With the worn bush out you can now remove the o-ring that sits above by lifting it over the side part of the stick.
- Remove the smaller o-ring from the stick.
- The third o-ring is located in the gear stick housing which will simply lift out.

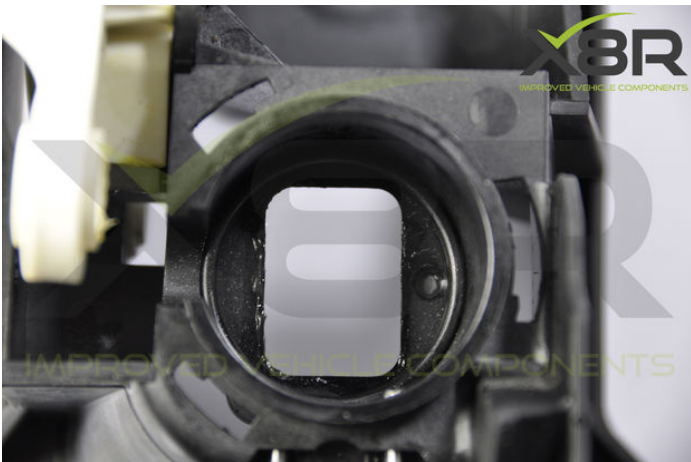
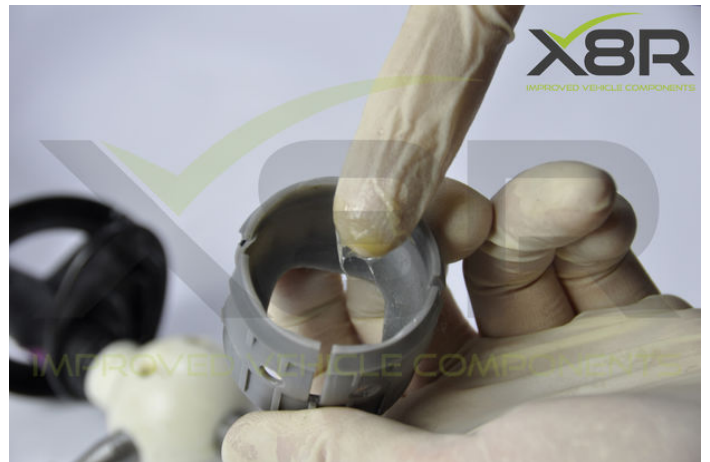
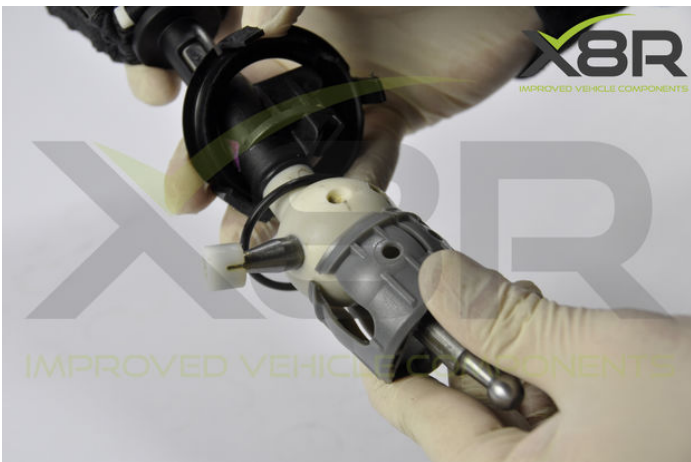
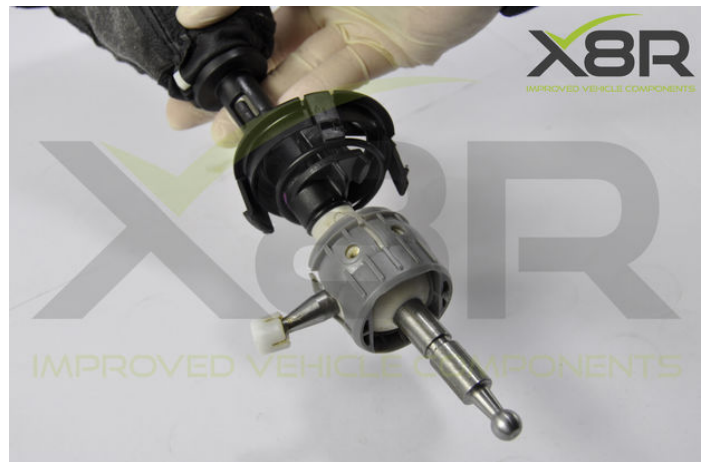
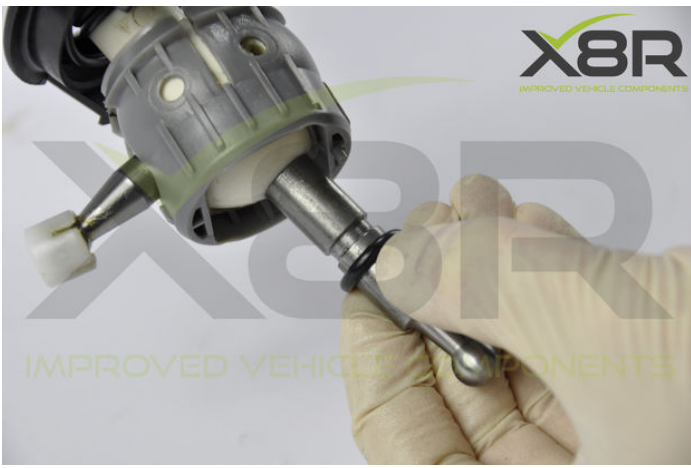
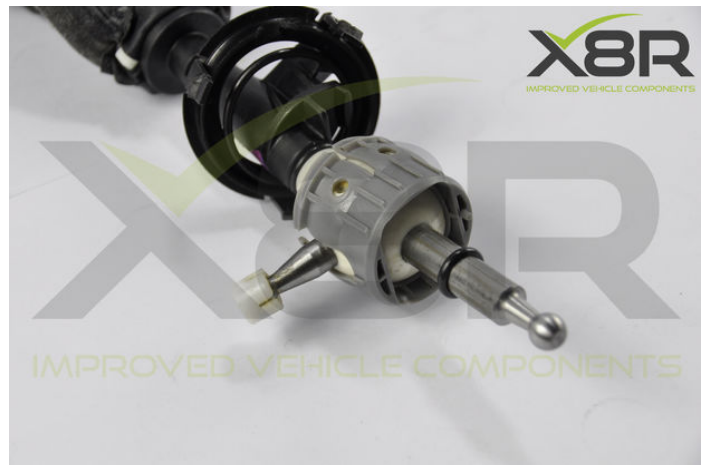
Step 5: Fit the replacement parts

- Fit the new o-ring located within the stick housing, making sure it's seated correctly.
- Fit the upper o-ring on the stick, lift it over the side part.
- Before fitting the new gear selector bush, apply a small amount of grease on the inside - this will help with the fitting which will also make for a smoother stick when fitted back into the car.
- Fit the bush onto the stick - this will clip into place.
- Fit the smaller o-ring as shown in image, this will slide up the stick and sit in its groove naturally.

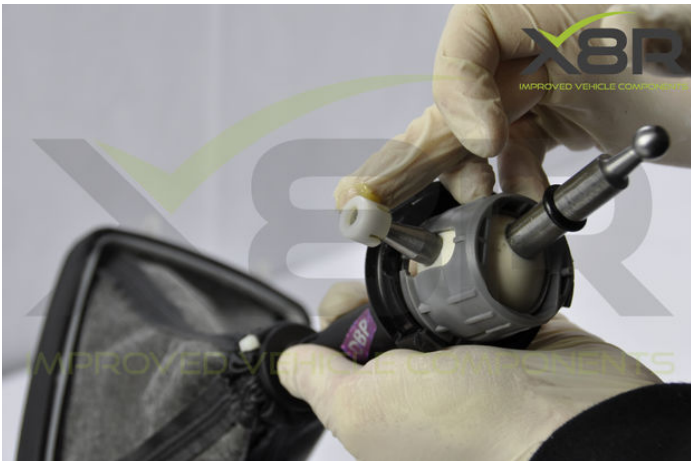
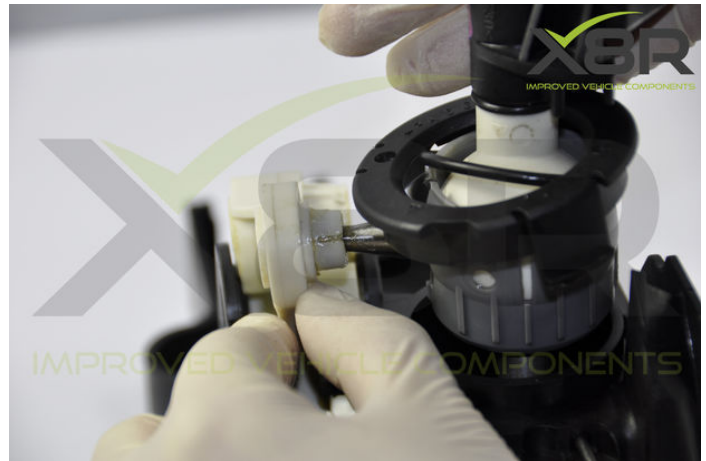
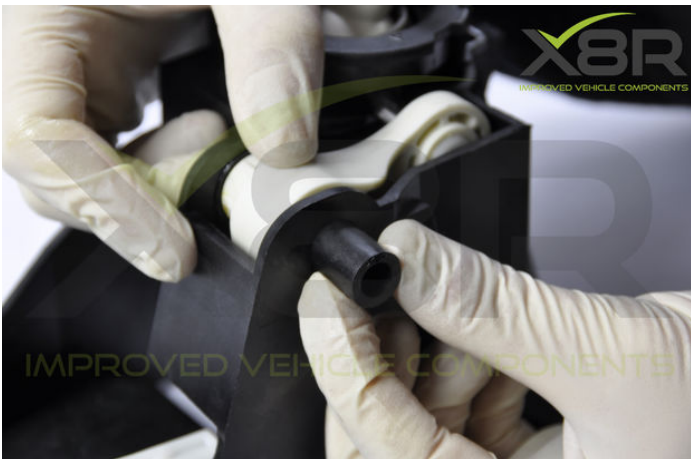
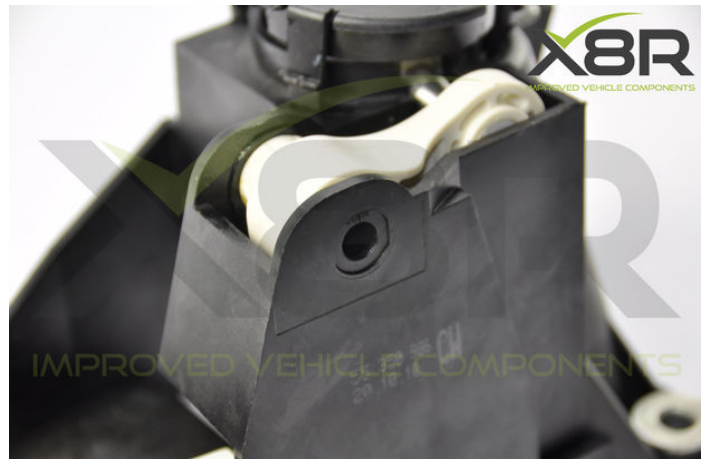
Step 6: Fit stick back into the housing

- Before fitting the stick back into its housing it's worthwhile applying a small amount of grease on the side part of the gear stick.
- Slot the stick into its housing, also slotting the side part of the stick into the linkage part of the unit.
- Slot the new push fit rod in, making sure its correctly aligned.

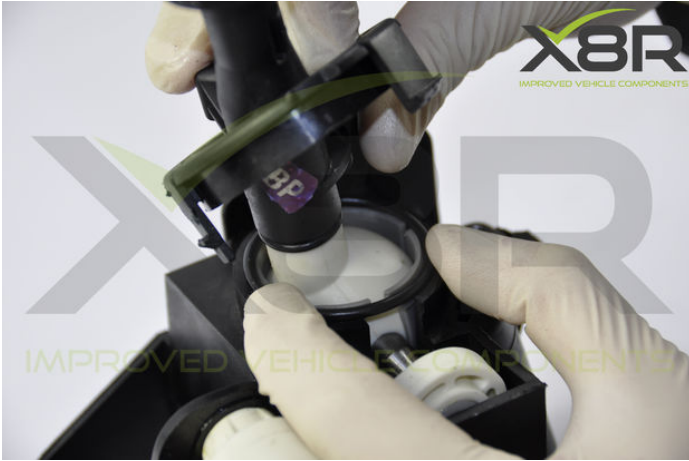
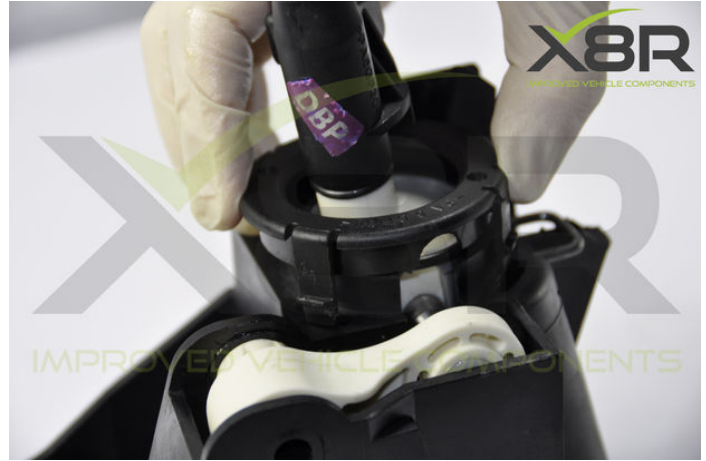
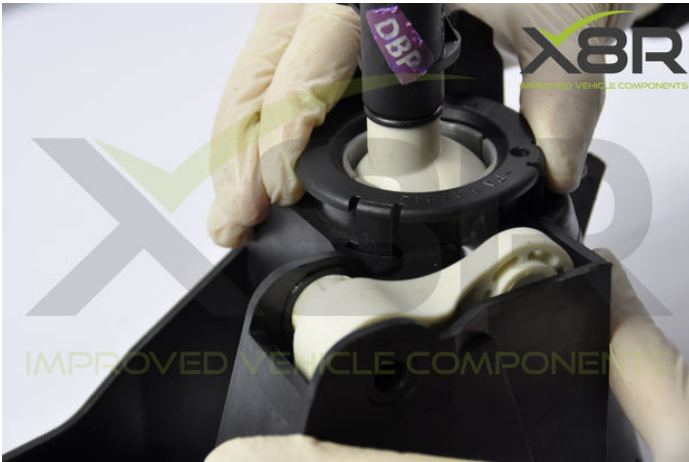
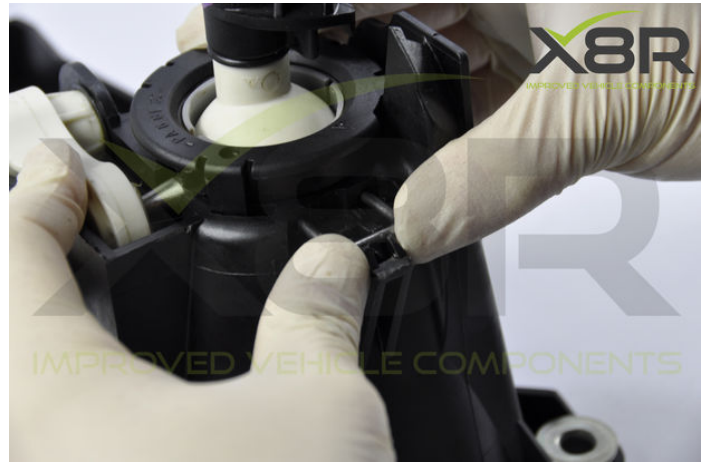
Step 7: Refit cover plate

- Refit the o-ring, seating it around the gear selector bush making sure the tabs of the cover plate are lined up with the correct slots.
- Once aligned press into place and twist to secure.
- Push the metal retaining clip back in.
