Volkswagen VW New Beetle Golf Mk4 Jetta Bora 1J Glove Box Not Latching Dropping Down Lid Repair Fix Kit Instruction Install Guide

Intro: Volkswagen VW New Beetle Golf Mk4 Jetta Bora 1J Glove Box Not Latching Dropping Down Lid Repair Fix Kit Instruction Install Guide

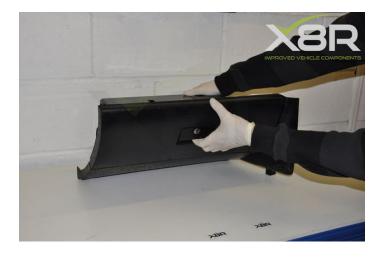
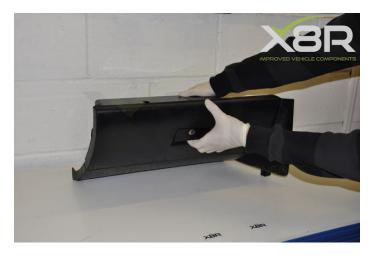
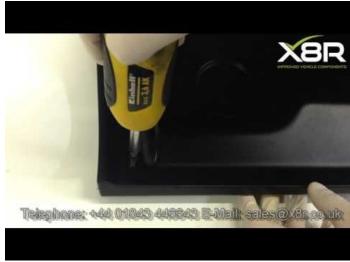
Our kit includes the parts shown 2x high strength magnets, 2x countersunk magnets, 2x magnet fastening screws, 2x Black countersunk washers, 2x Black countersunk screws.

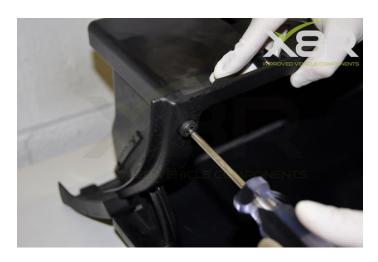
Step 1: Remove the lid stoppers

- Using a T20 Torx screw driver remove both of the glove box lid stoppers.
- The Torx screws are located in the center of the stopper

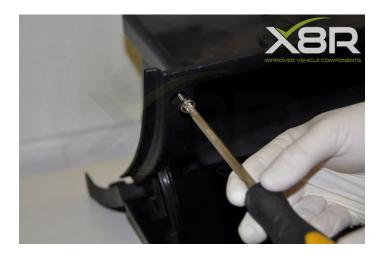
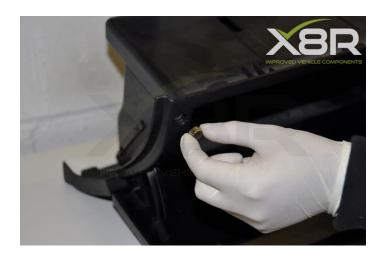
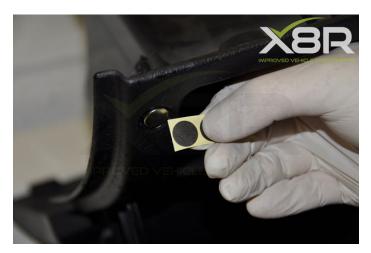
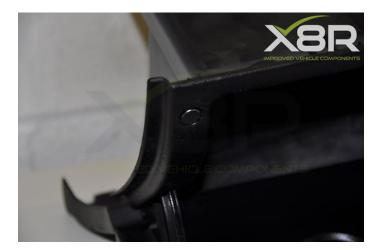
Step 2: Fit the countersunk screw and magnets in place of the stopper

- Replace the parts you just removed with the silver Philips countersunk screw and countersunk magnet supplied in our kit.
- When fitting the countersunk screw it's not necessary to tighten the screws too tight as this will damage the magnet gently nip the screw up.
- With the countersunk screw and magnet in place its time to fit the larger magnet, push in the recess, this will locate its self.
- There are 2 black magnet covers supplied within your kit if you wish to fit these for aesthetics reasons only.

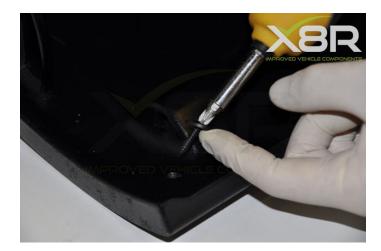
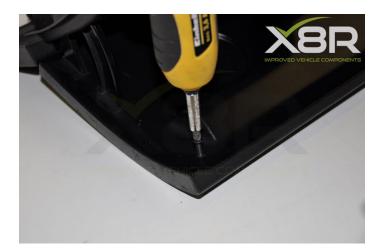
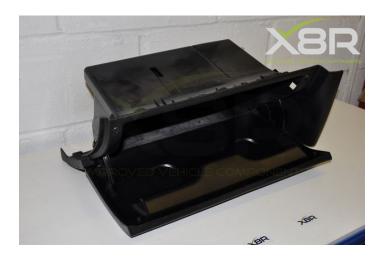
Step 3: Fit the black countersunk screw and washer to the lid

- Located on the inside of the glove box lid, you will see two marks one on either side from the lid rubbing on the stoppers over time.
- Align the screw to the center of that mark and screw in place.
- Try to fit the screw as central as possible.
- Once you have the hole tapped remove the screw and fit it with the washer on both sides.
- You can now test the lid, it will retain tightly on the magnets and restore function to your glove box lid.
