Audi Seat Skoda VW Kia Hyundai TDI CRDI CRTD CDI VDO Siemens Throttle Body Flap Actuator Air Delivery New Gear Repair Kit Fix Overhaul Replacement Install Instructions Guide

by x8rltd

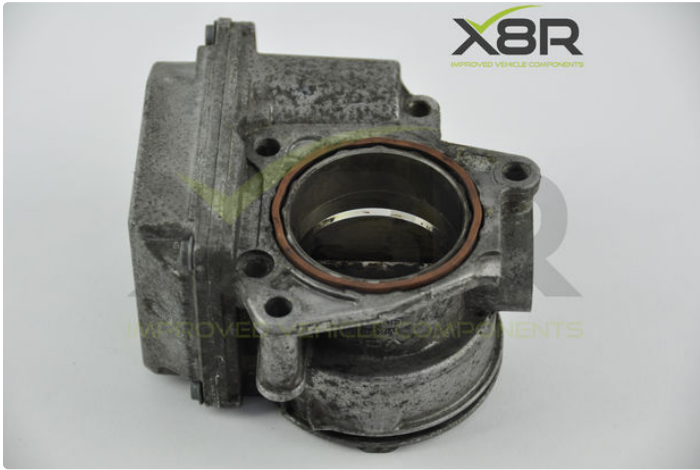
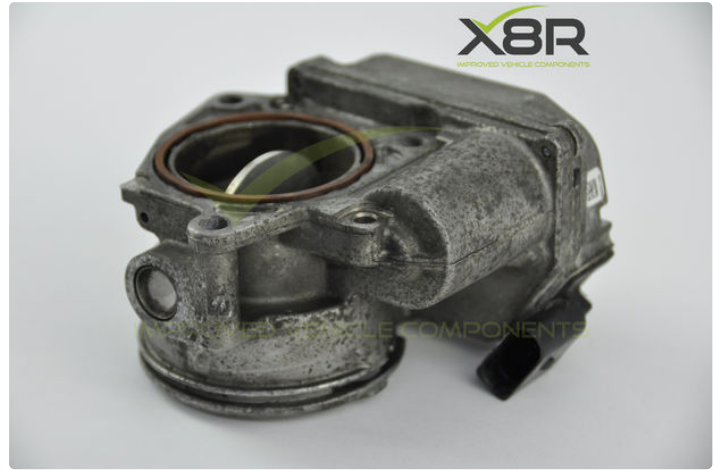
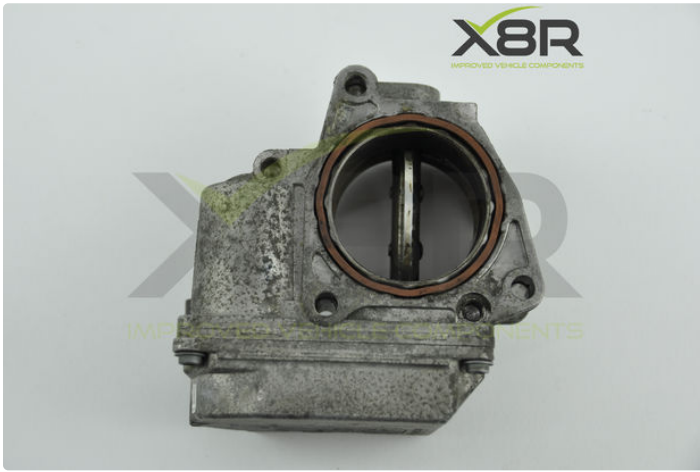
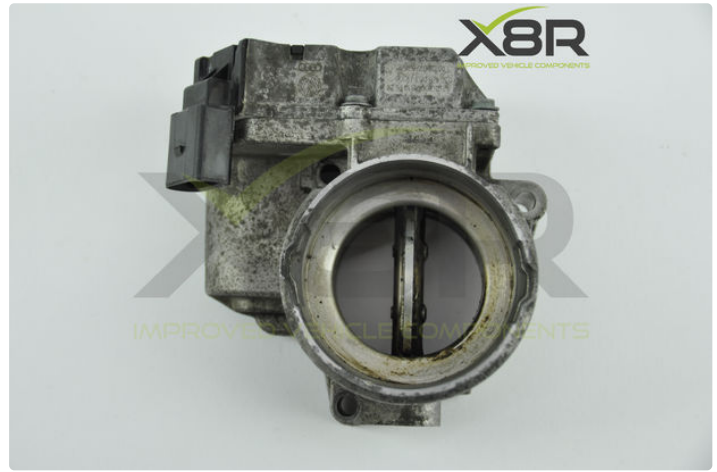
2x Carbon reinforced plastic gears.

1x Throttle body actuator housing gasket

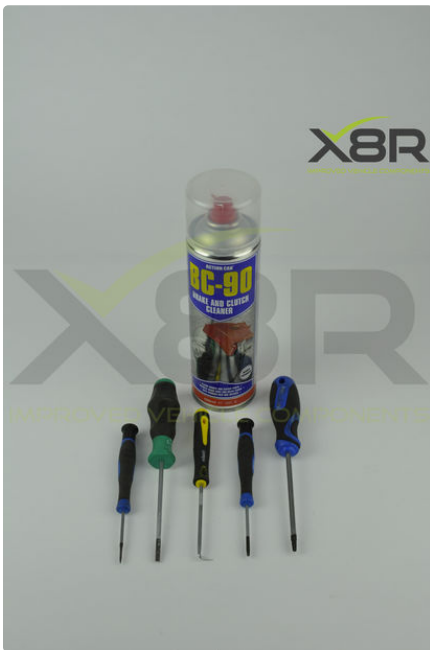
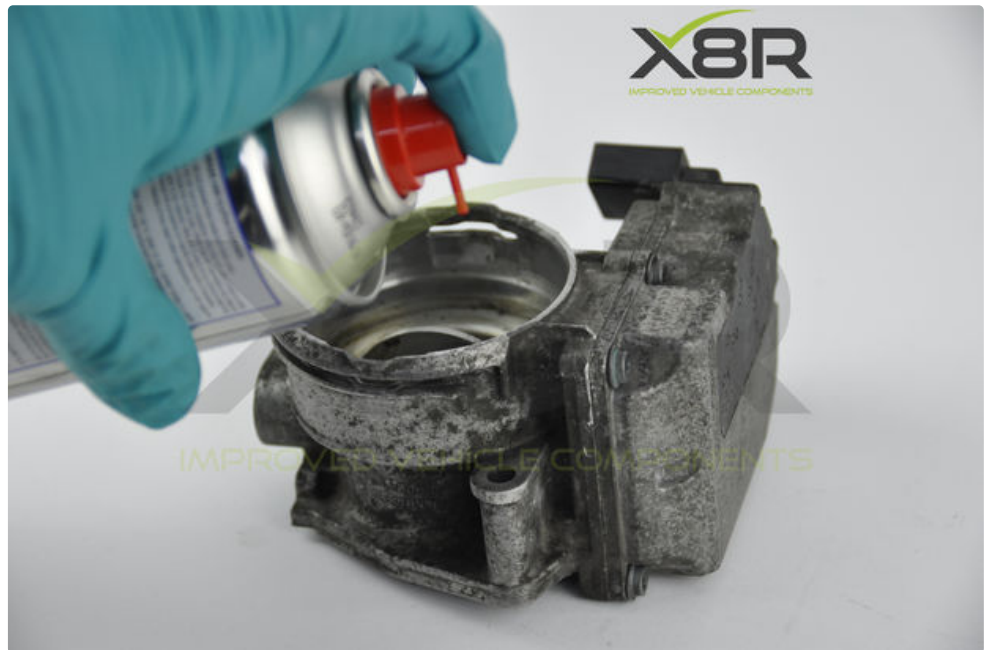
Step 1: Prepare Your Tools and Clean Up the Unit

The unit will more than likely be covered in a layer of carbon deposit from being sat next to the EGR in the vehicle's intake system. This can be cleaned off using brake cleaner and workshop tissue. A soft brush such as an old toothbrush would also be useful for this task.

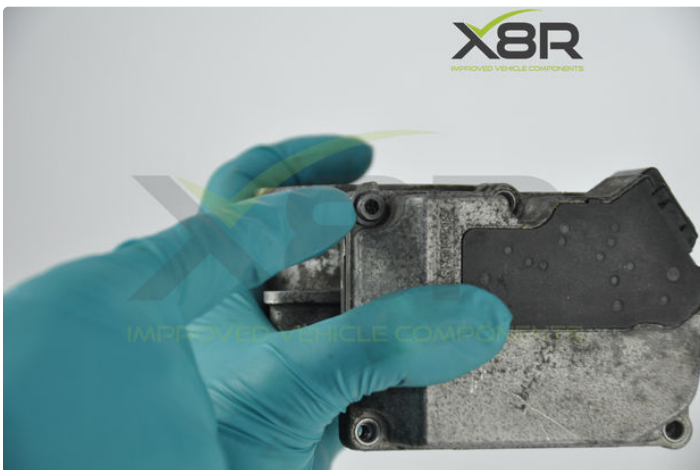
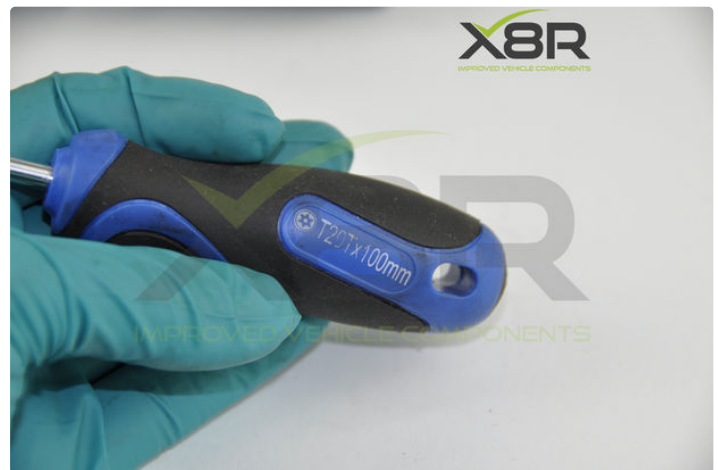
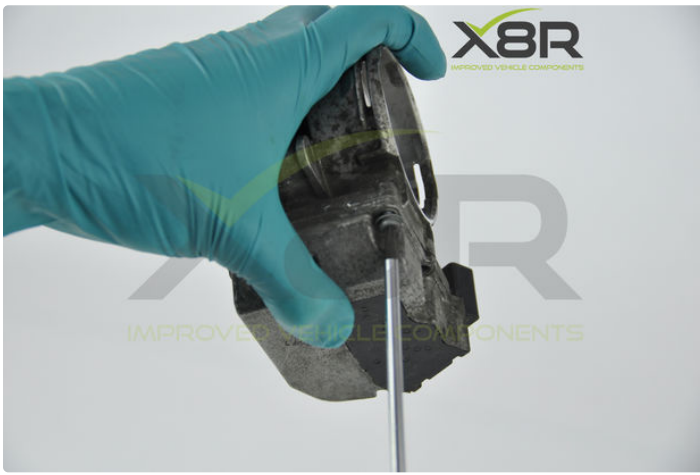
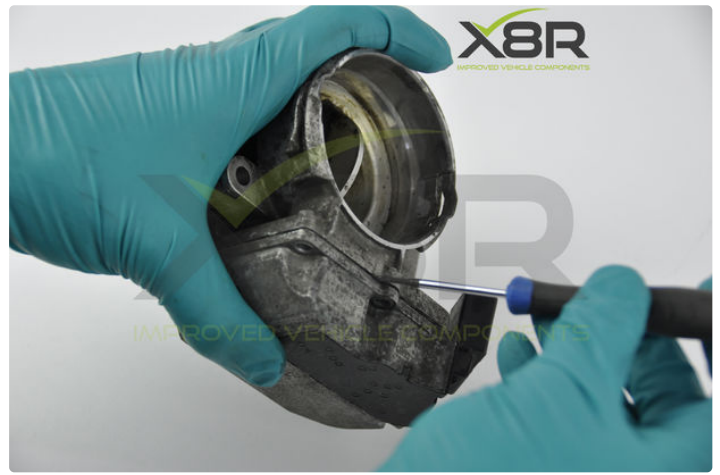
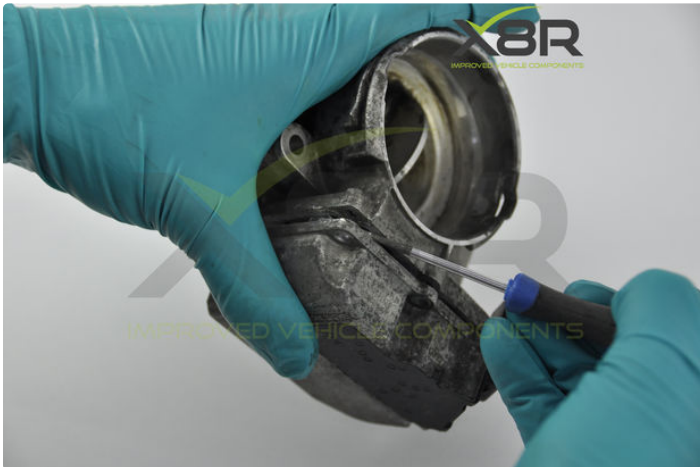
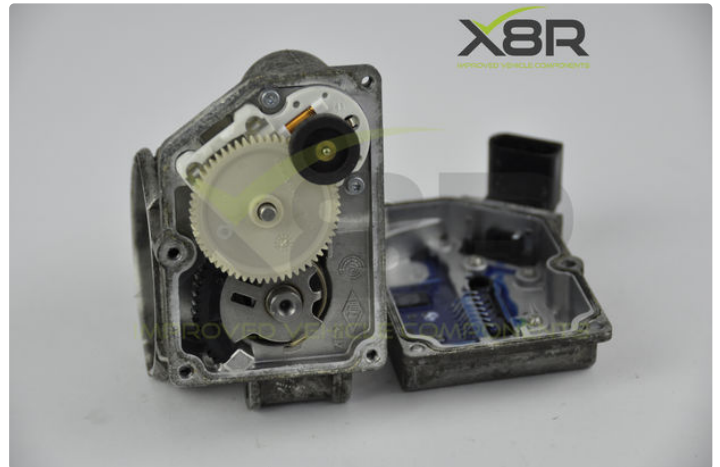
Step 2: Release the Motor From the Flap Housing

The first step is to locate the 4 x T20 Torx screws securing the motor housing to the flap housing. Unscrew these and safely store the screws.

Once the 4 screws are released, use one of the flat headed screwdrivers (start with the smaller one) to gently pry open the casing. If the casing is stiff to come away, pry it slightly and then use a stronger, larger flat head screw driver to get it the rest of the

way. There are two small prongs for the electrical connection that may cause some resistance when pulling apart. Be careful not to damage these when separating the unit.

Once it is split into two pieces it will reveal the gear cogs and the electrical connections.

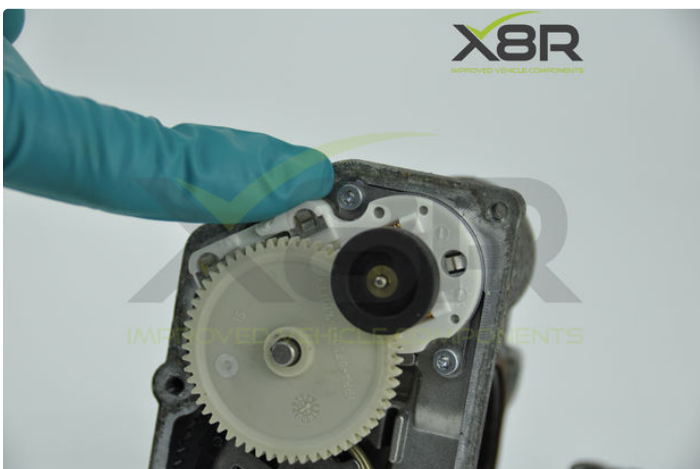
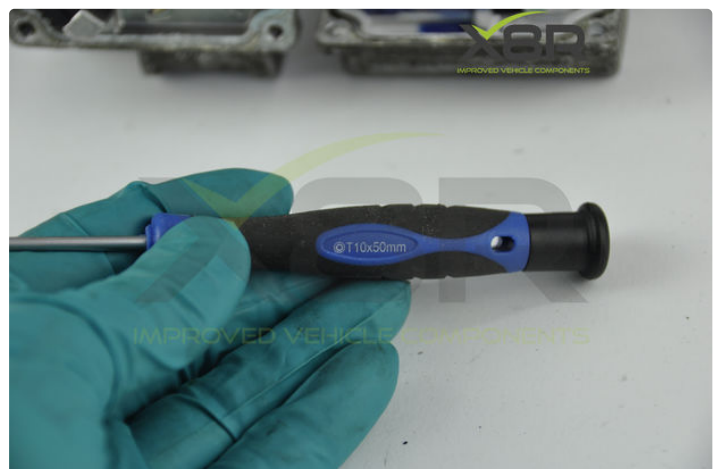
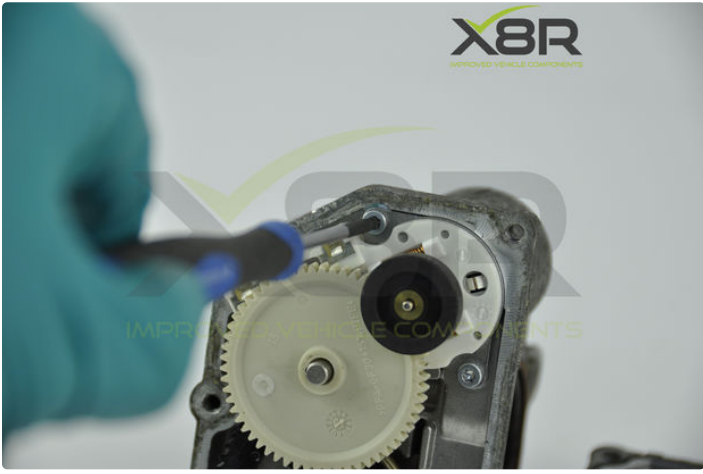
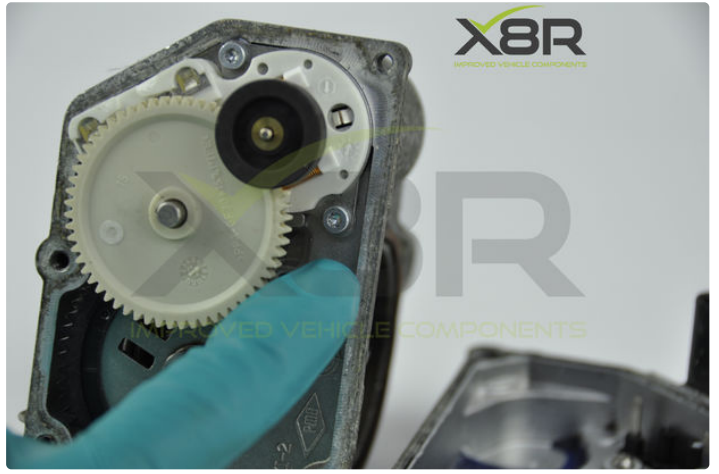
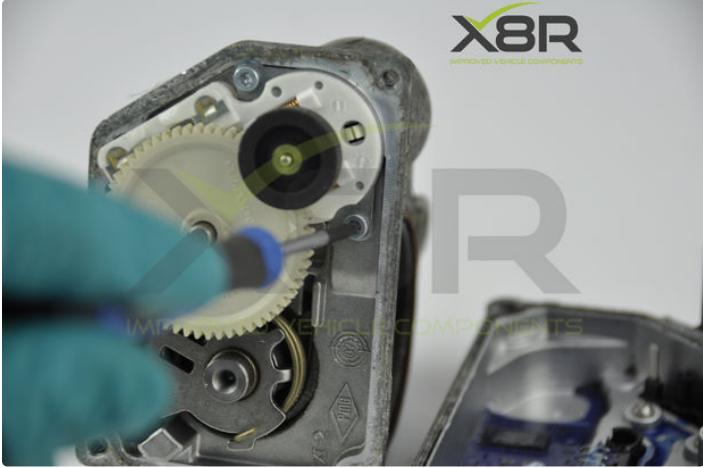
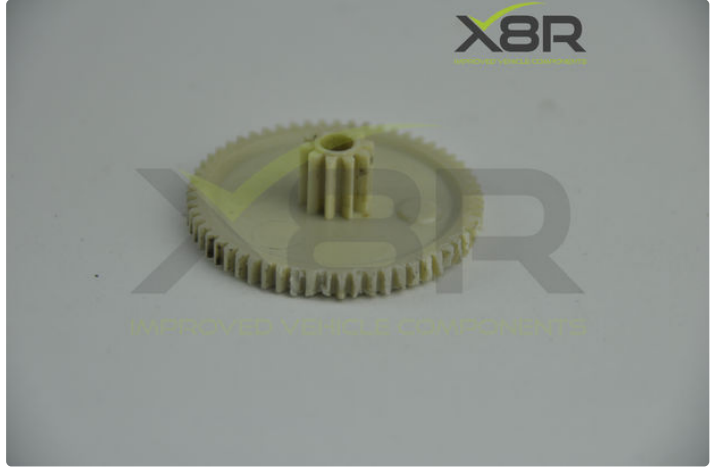
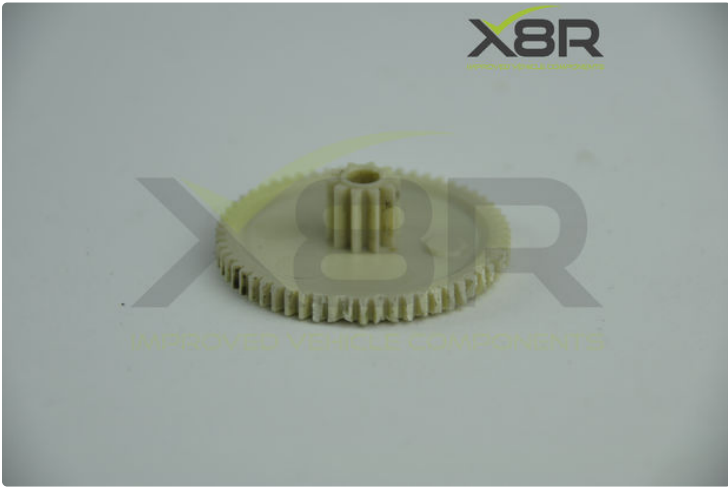
Step 3: Prepare to Remove the Main Cog

There are two T10 Torx screws on the inside of the housing which help to hold the cogs in place. Remove these and then the old main cog can be lifted upwards off of its spindle.

Once the cog is removed, you can see the damage caused to the Nylon plastic part caused by years of use.

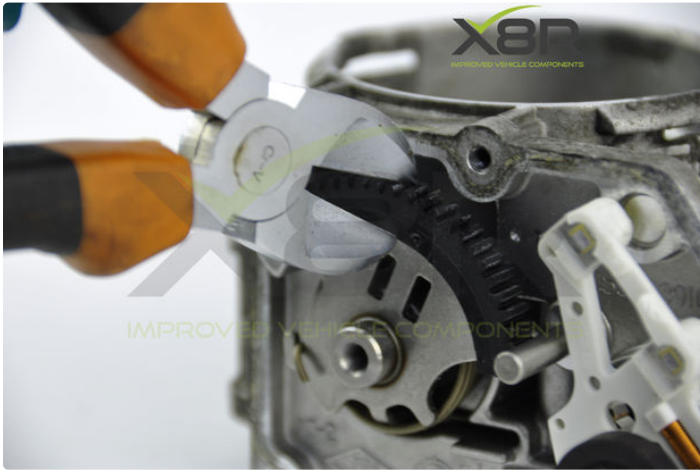
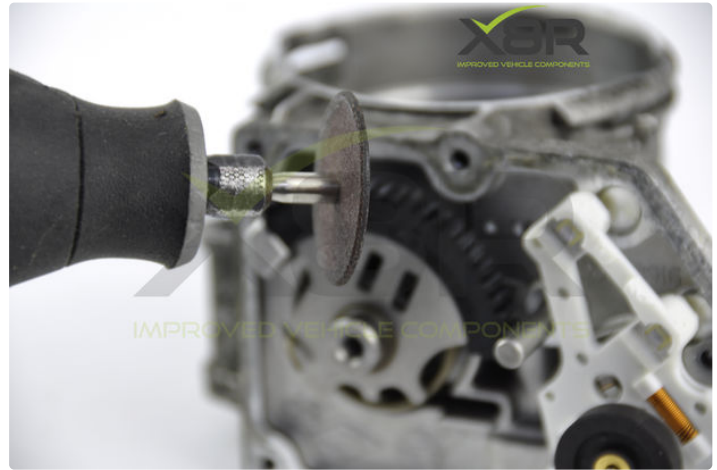
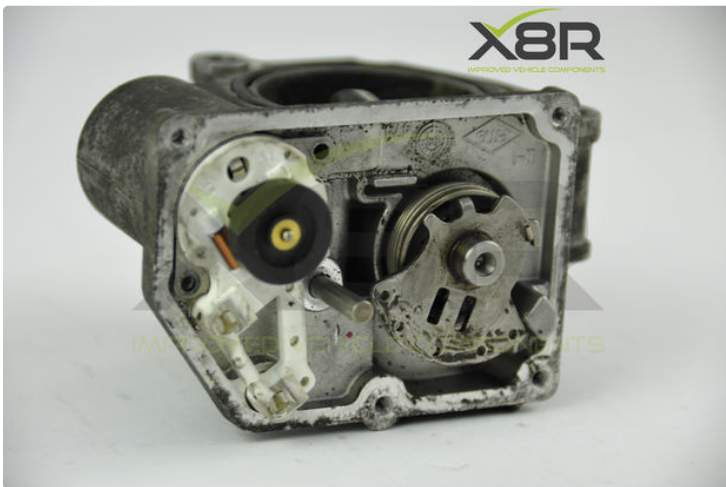
Step 4: Remove the Semi Circular Cog

The next step is to remove the semi circular cog on the flap spindle.

The only way to do this is to cut it away which will need to be done with either a cutting tool such as a Dremmel or with a pair of pliers/snips.

Once this is fully cut away, you will notice some holes in the metal piece. Make sure that any debris is cleared away from these holes before our item is fitted.

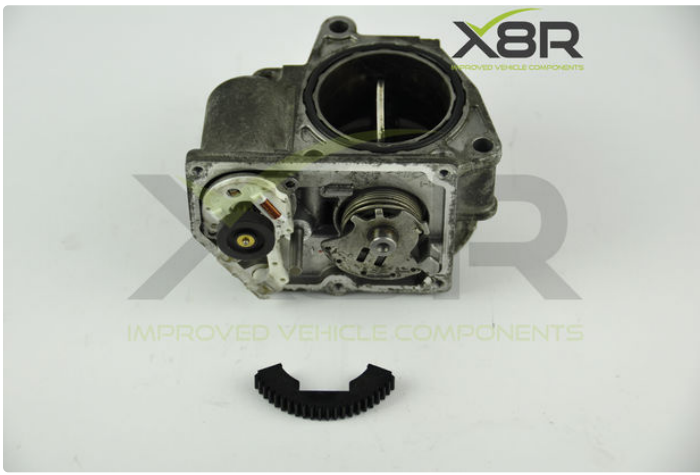
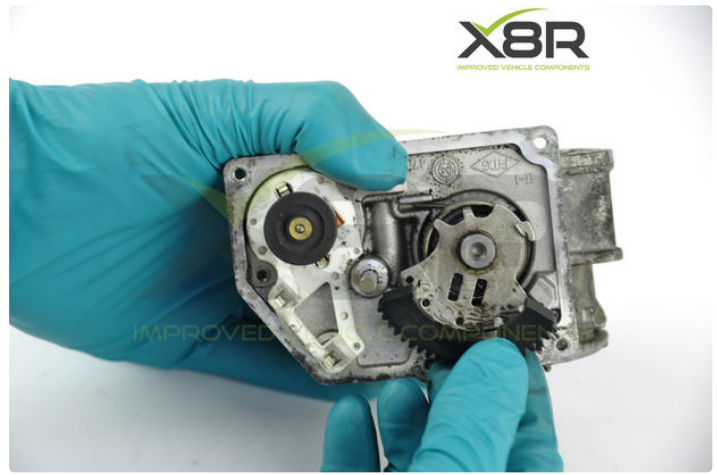
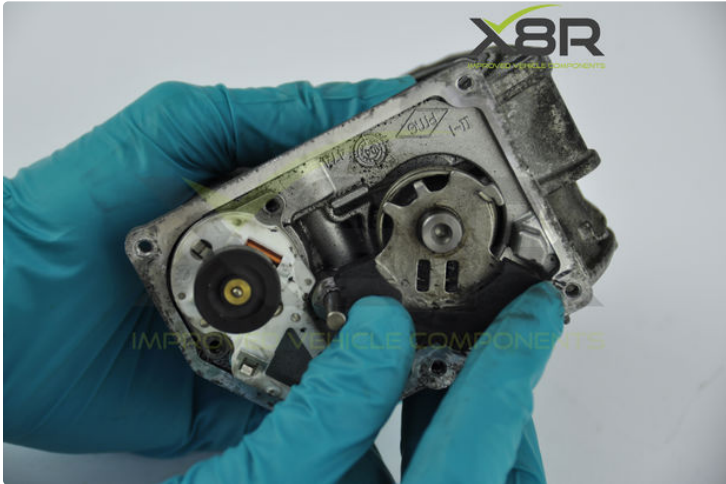
Step 5: Fit Our New Semi Circular Cog Piece

Firstly install the improved carbon fiber infused semi circular cog. This fits in exactly the same place as the old piece and has prongs on the underside which fit through the holes left in the metal and will just clip strongly into place.

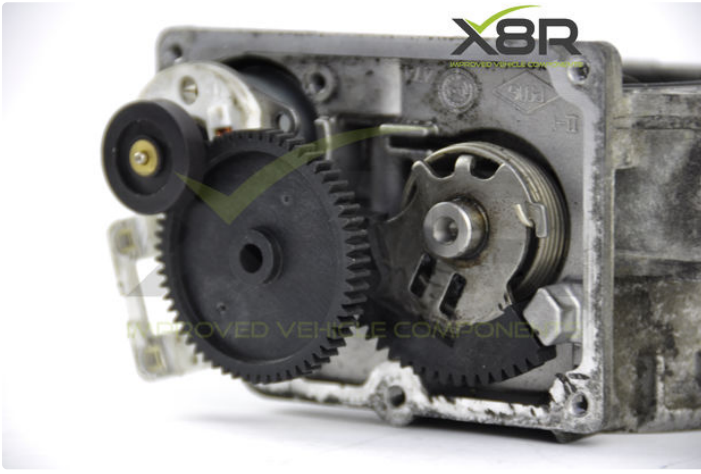
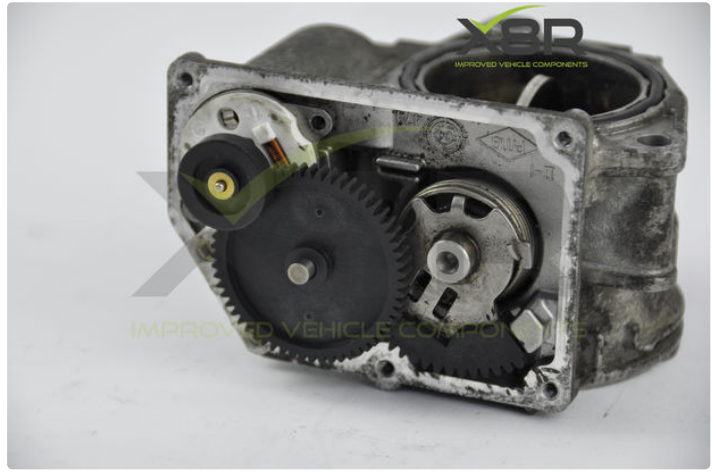
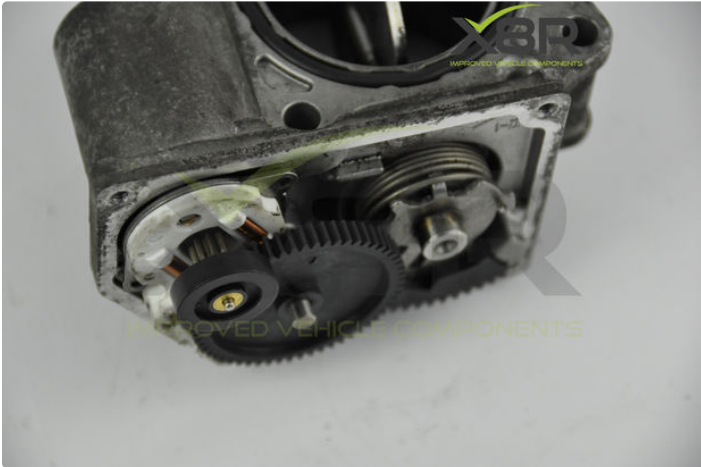
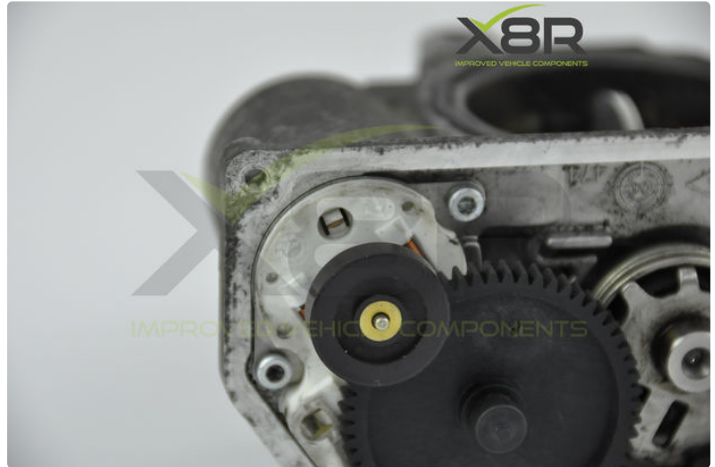
Step 6: Fit the Main Cog

Once the semi circular cog is secured in place, move onto the main cog. Again, this is Carbon fiber infused for strength and durability.

Lift up the small round black piece in the corner until the main cog can be slid down onto its spindle with the small cog piece underneath the main larger cog.

Once fitted, all the cogs should line up precisely.

The final step on this part is to replace the two T10 Torx screws on the corner piece of the unit.

Once the screws are in place, and everything is secure, test the function of the cogs by manually twisting the flap back and forwards to make sure the cogs rotate and then return to their starting position.

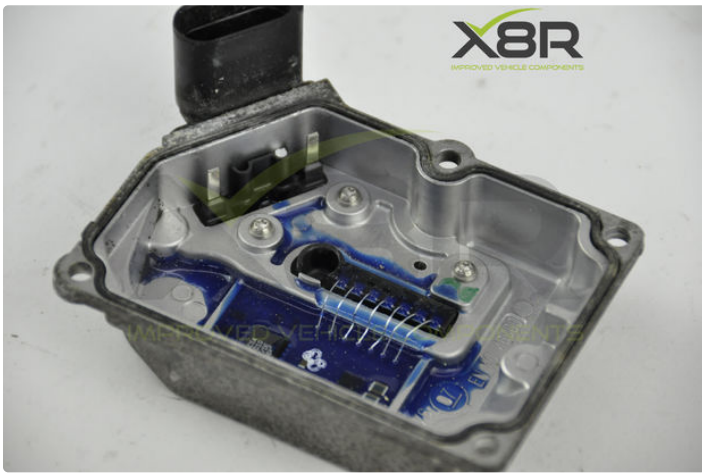
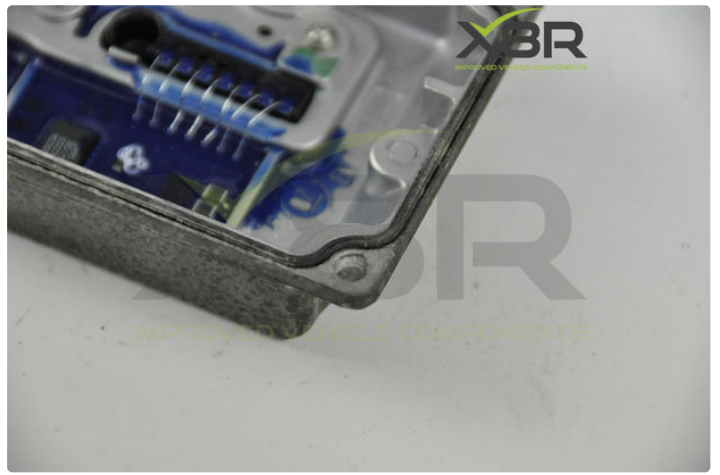
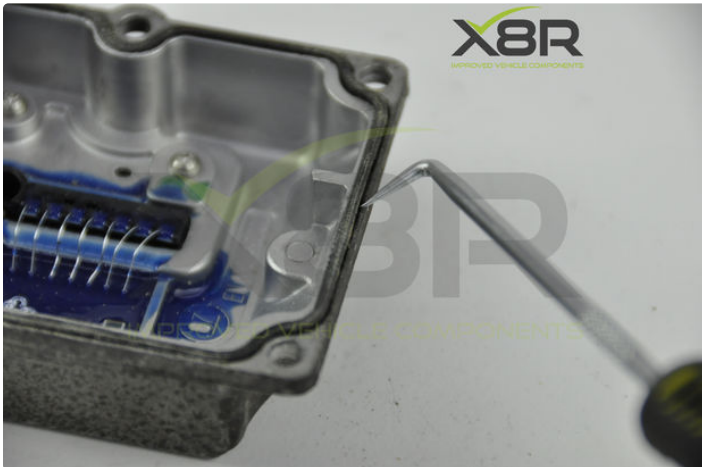
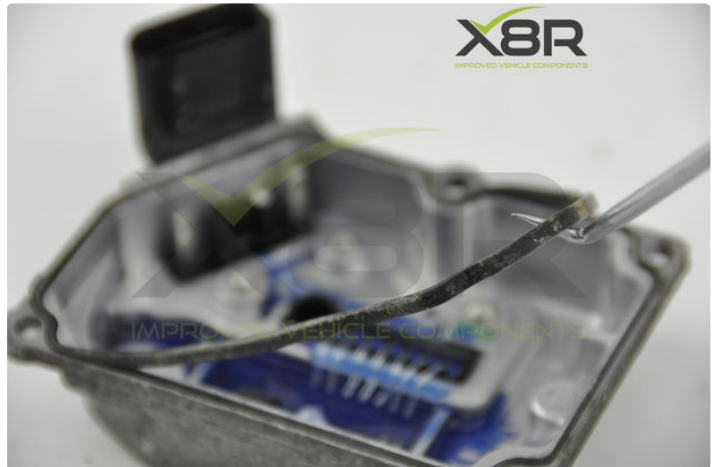
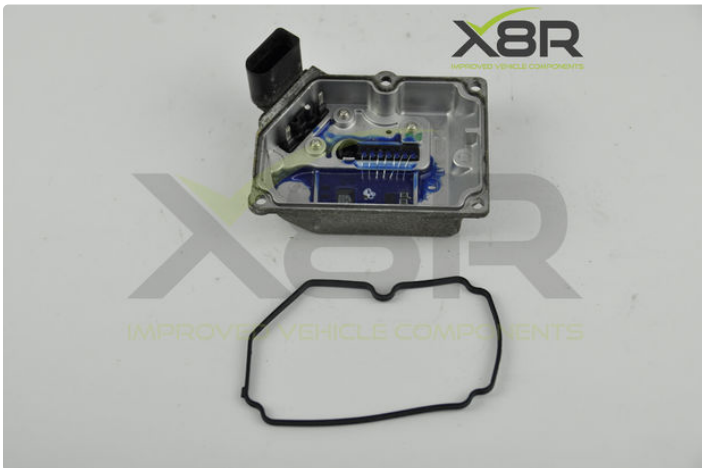
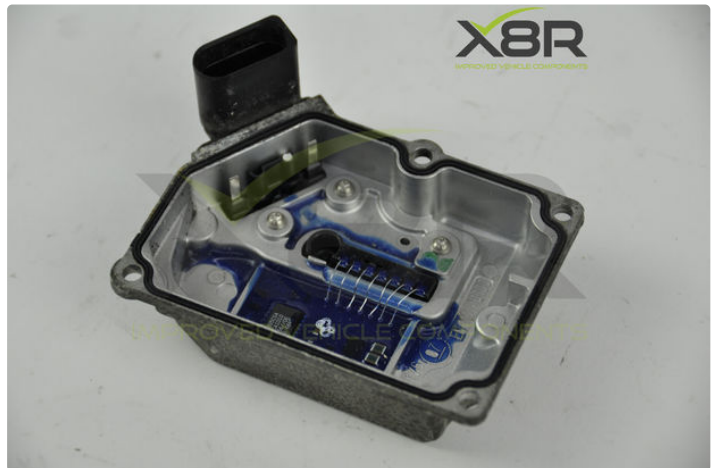
Step 7: Replace the Gasket

With the repair kit we also provide a new gasket for sealing the unit back together as the old one is usually worn and squashed having been in position for many years.

Using the pick tool mentioned before, gently lever up and pull the old gasket away from the rim of the casing. Clear any debris that may have gathered in the space left.

Our new gasket is precision made to fit directly in place of the original.

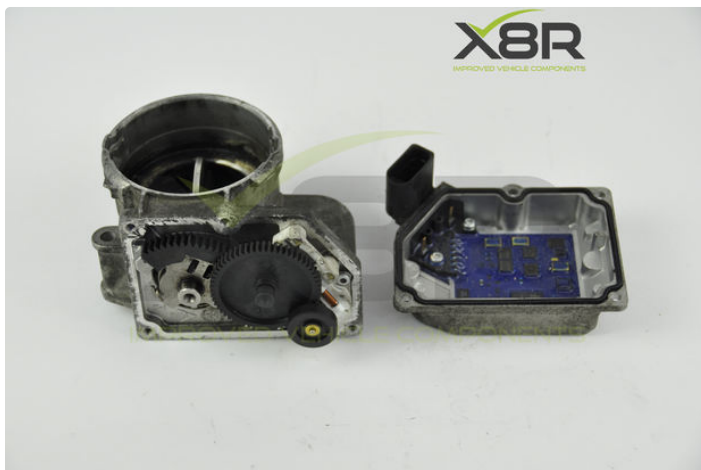
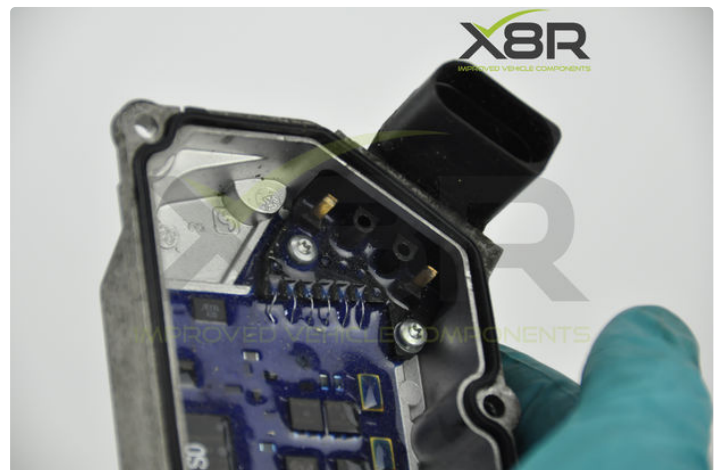
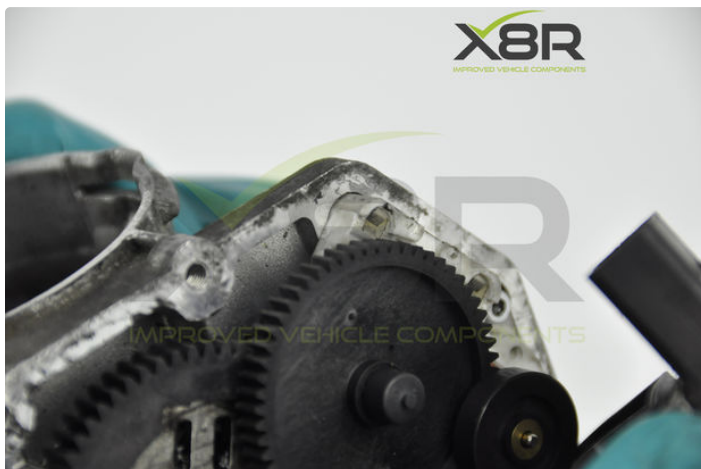
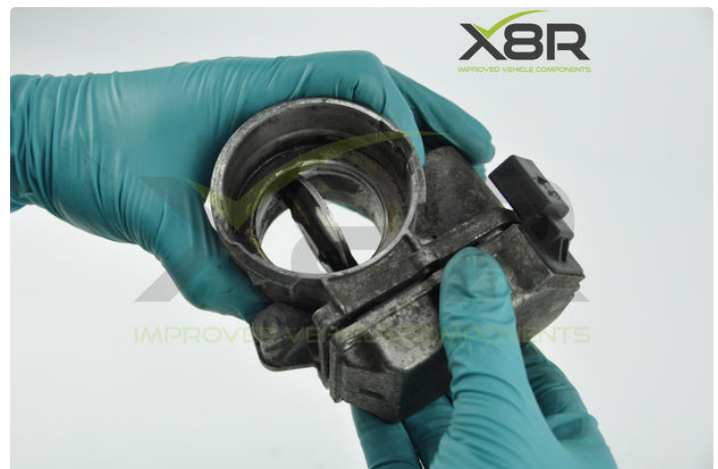
Step 8: Refit the Two Halves Back Together

Now that both halves have had their respective parts replaced, it is time to place them back together. Thankfully, there is only one way round that these parts can fit.

Use the electrical connector prongs to line up the two halves. These prongs slide into locating holes on the opposing half of the unit. Gently press these halves together making sure the gasket stays in its place.

Once the two halves are neatly pushed back together, you can then refit the 4 x T20 Torx screws. Any gaps that can be seen between the two halves prior to the screws being fitted should close up when the screws are tightly secured.
